COLUMBIA

ACCIDENT INVESTIGATION BOARD

REPORT VOLUME I
AUGUST 2003

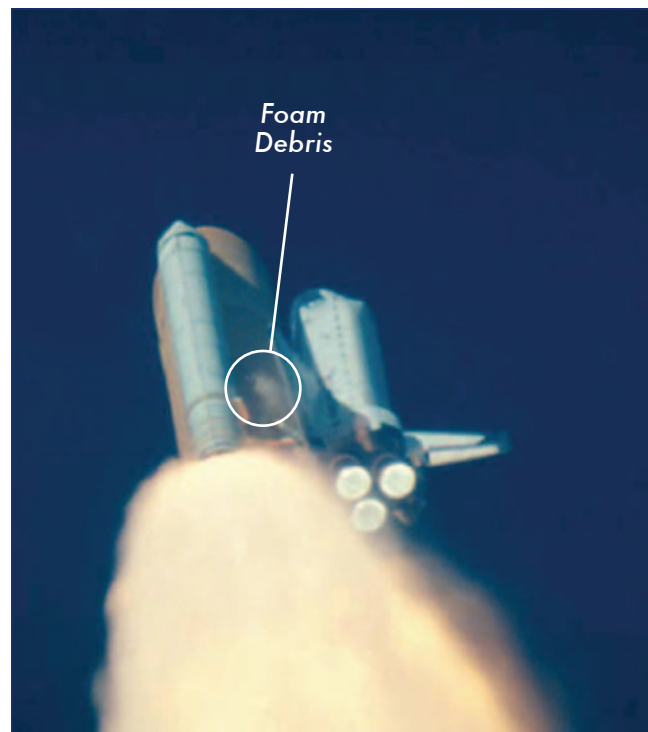
Figure 2.3-2. A shower of foam debris after the impact on *Columbia's* left wing. The event was not observed in real time.

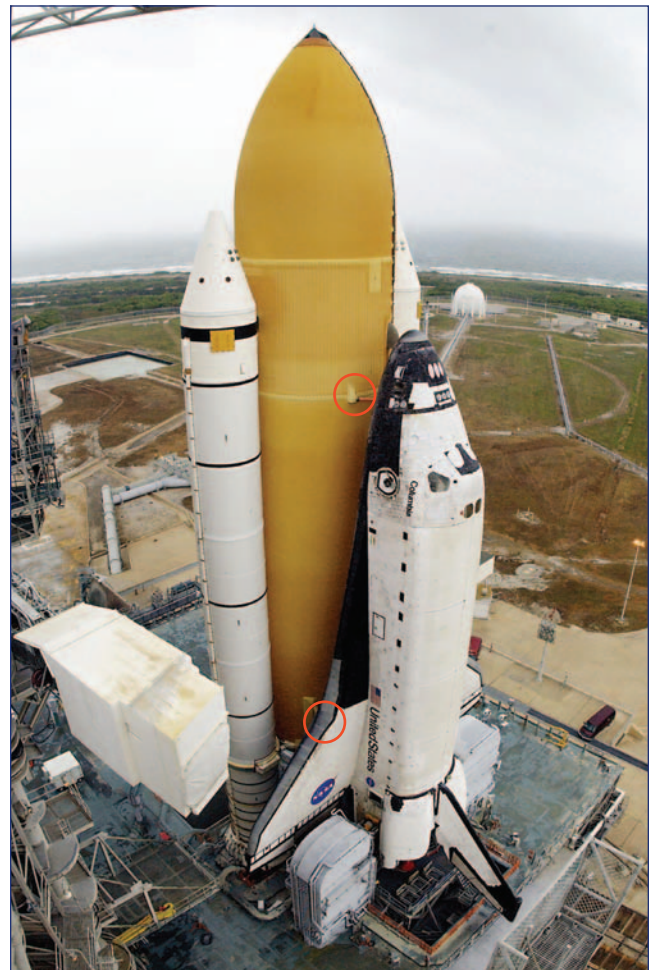
Figure 3.1-1. Columbia sitting at Launch Complex 39-A. The upper circle shows the left bipod (–Y) ramp on the forward attach point, while the lower circle is around RCC panel 8-left.

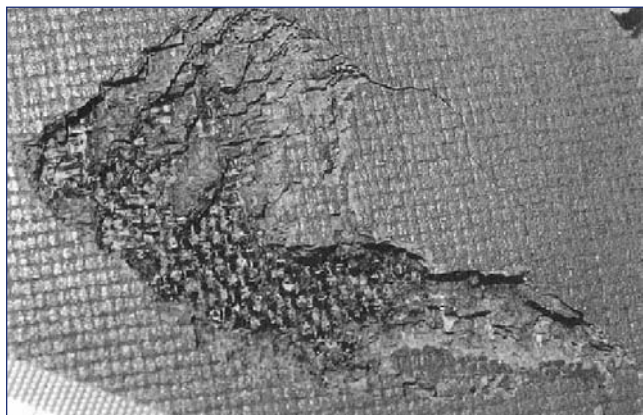
Figure 3.3-2. Damage on the outer surface of RCC panel 10-right from *Atlantis* after STS-45.

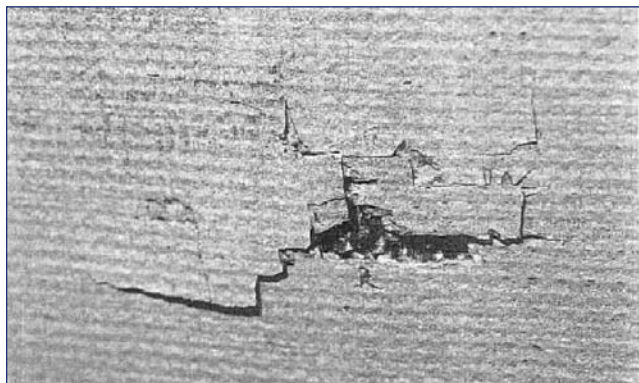
Figure 3.3-3. Damage on the inner surface of RCC panel 10-right from *Atlantis* after STS-45.

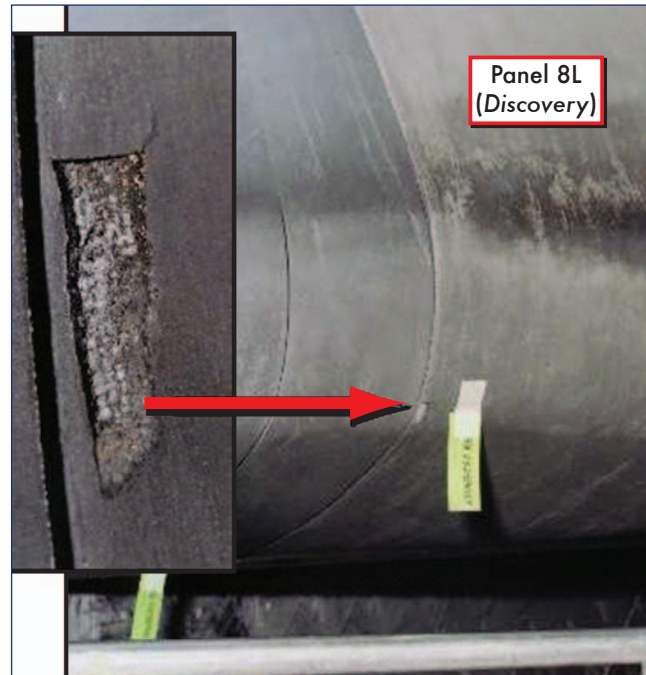
Figure 3.3-5. RCC panel 8-left from *Discovery* had to be scrapped after STS-103 because of the damage shown here.

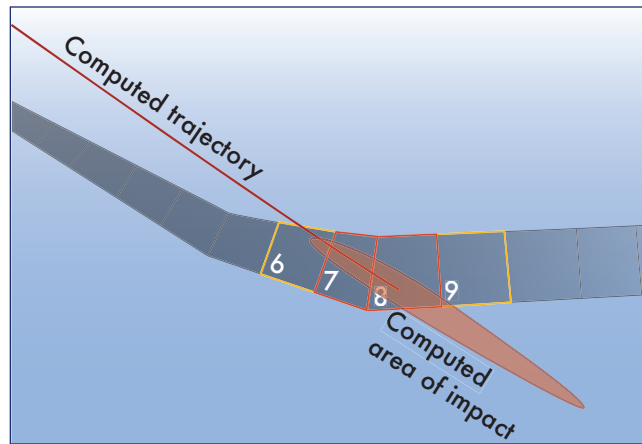
Figure 3.4-3: The best estimate of the site of impact by the center of the foam.

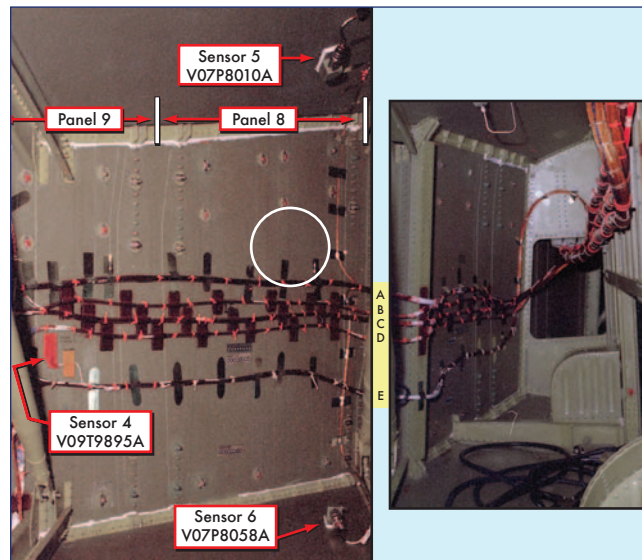
Figure 3.6-8. The left photo above shows the wiring runs on the backside of the wing leading edge behind RCC panel 8 – the circle marks the most likely area where the burn through of the wing leading edge spar initially occurred at EI+487 seconds. The right photo shows the wire bundles as they continue forward behind RCC panels 7 and 6. The major cable bundles in the upper right of the right photo carried the majority of the sensor data inside the wing. As these bundles were burned, controllers on the ground began seeing off-nominal sensor indications.

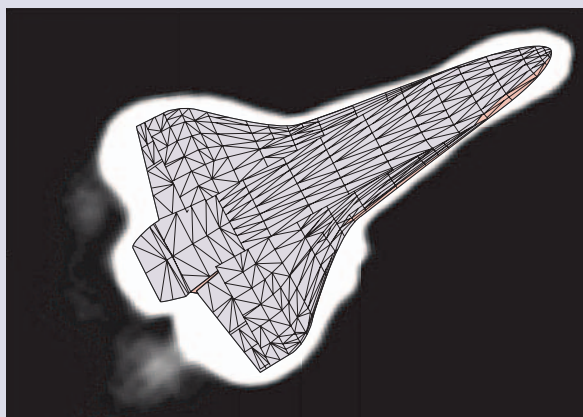
The image shows an unusual condition on the left wing, a leading-edge disturbance that might indicate damage. Several analysts concluded that the distortion evident in the image likely came from the modification and interaction of shock waves due to the damaged leading edge. The overall appearance of the leading-edge damage at this point on the trajectory is consistent with the scenario.

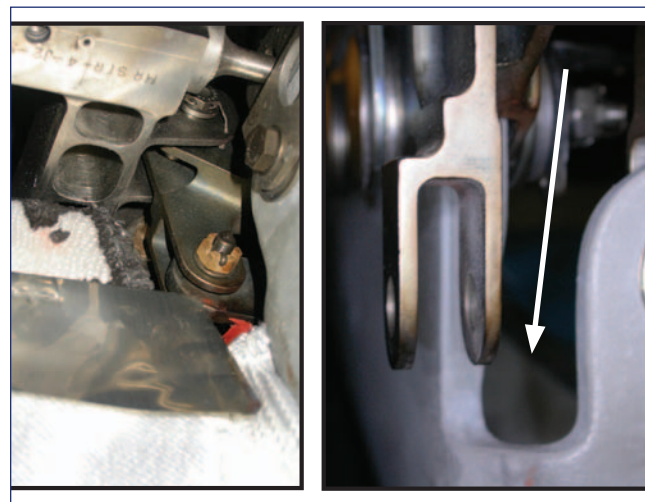
Figure 3.7-2. Each RCC panel has a U-shaped slot (see arrow) in the back of the panel. Once superheated air entered the breach in RCC panel 8, some of that superheated air went through this slot and caused substantial damage to the Thermal Protection System tiles behind this area.

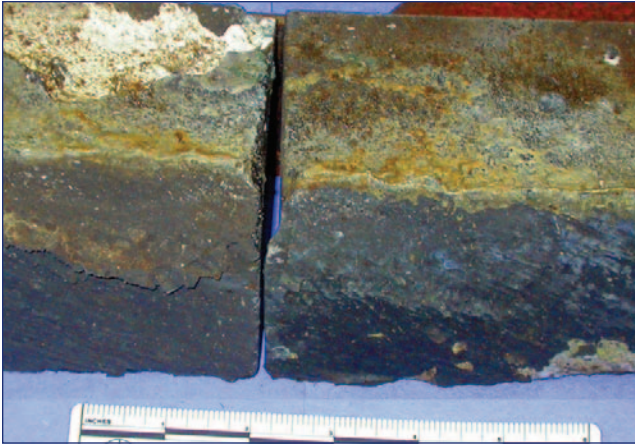
Figure 3.7-3. Superheated airflow caused erosion in tiles around the RCC panel 8 and 9 interface. The tiles shown are from behind the area where the superheated air exited the slot in Figure 3.7-2. These tiles showed much greater thermal damage than other tiles in this area and chemical analysis showed the presence of metals only found in wing leading edge components.

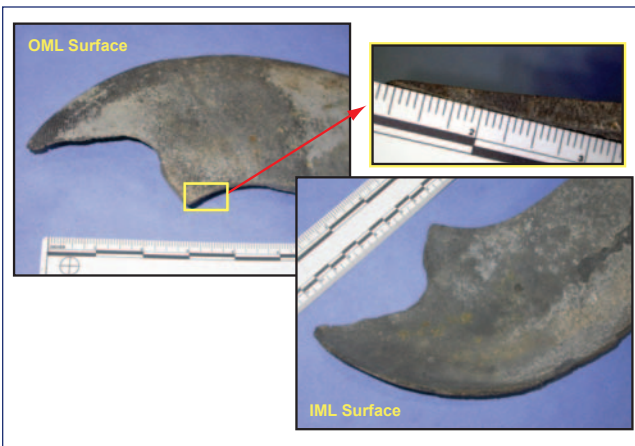
Figure 3.7-4. The outboard rib of panel 8 and the inboard rib of panel 9 showed signs of extreme heating and erosion. RCC erosion of this magnitude was not observed in any other location on the Orbiter.

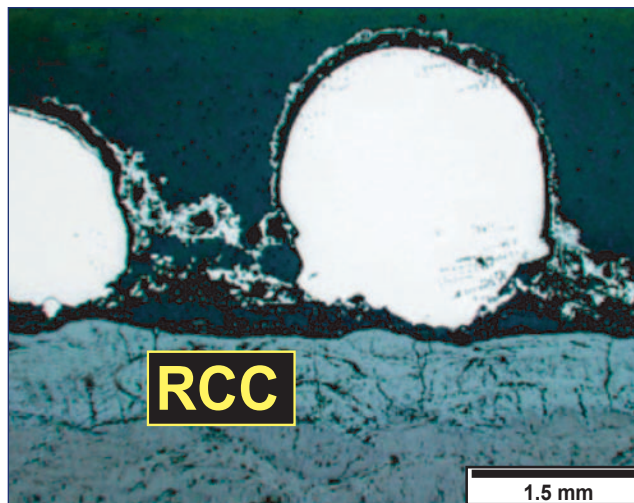
Figure 3.7-8. Spheroids of Inconel 718 and Cerachrome were deposited directly on the surface of RCC panel 8-left. This slag deposit pattern was not seen on any other RCC panels.

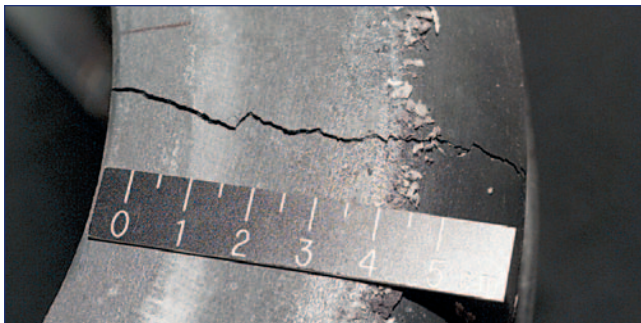
Figure 3.8-6. A 5.5-inch crack on the outboard portion of RCC Panel 6 during testing.

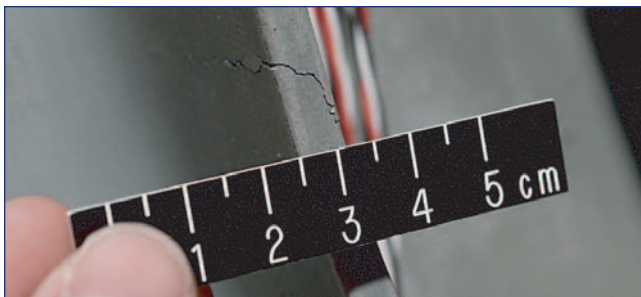
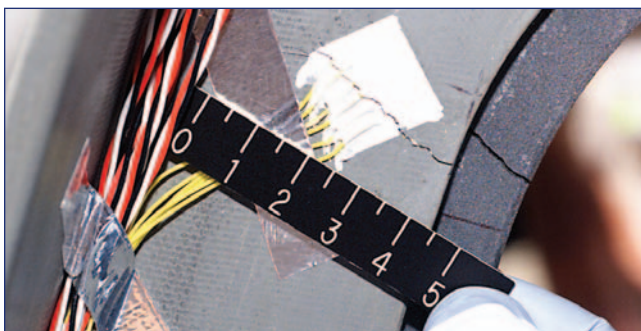
Figure 3.8-7. Two views of the crack in the T-seal between RCC Panels 6 and 7.

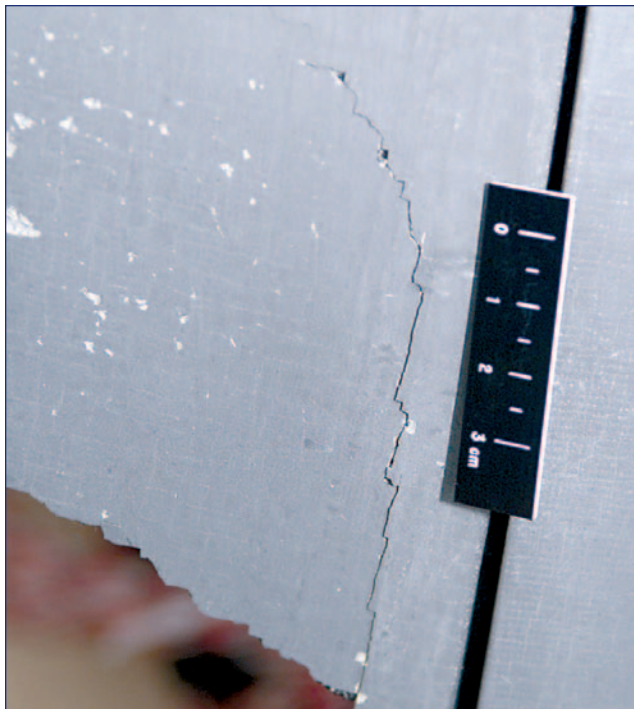
Figure 3.8-10. Numerous cracks were also noted in RCC Panel 8.

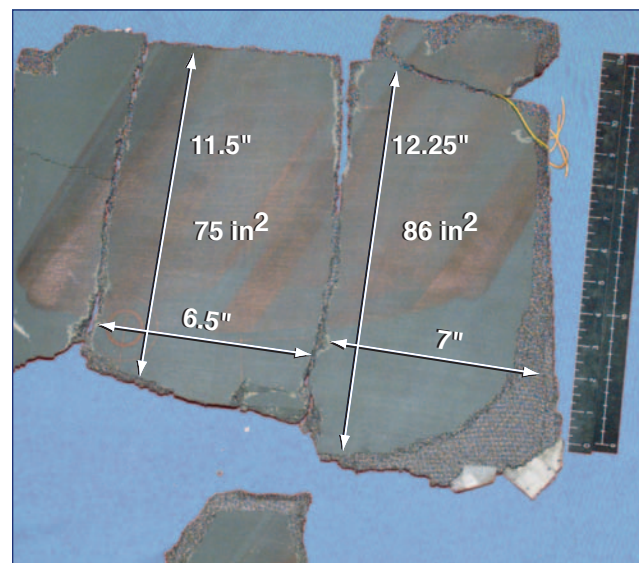
Figure 3.8-11. Three large pieces of debris from the panel face sheet were lodged within the hollow area behind the RCC panel.

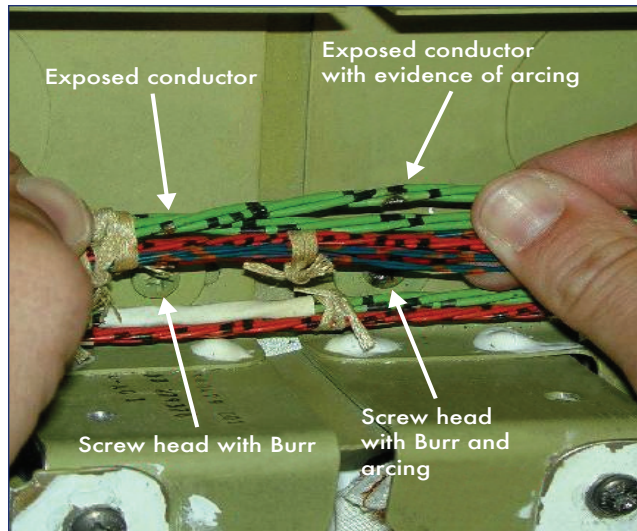
Figure 4.2-2. Arc tracking damage in Kapton wiring.
