**COMMITTEE FOR THE RE-INVESTIGATION OF
THE SMOLENSK AIR CRASH**

TECHNICAL REPORT

**This report contains facts regarding the crash of the TU-154M
No. 101 (Fight PLF101) that took place near
SMOLENSK NORTH airport, Russia on April 10th, 2010.**

WARSAW 2018

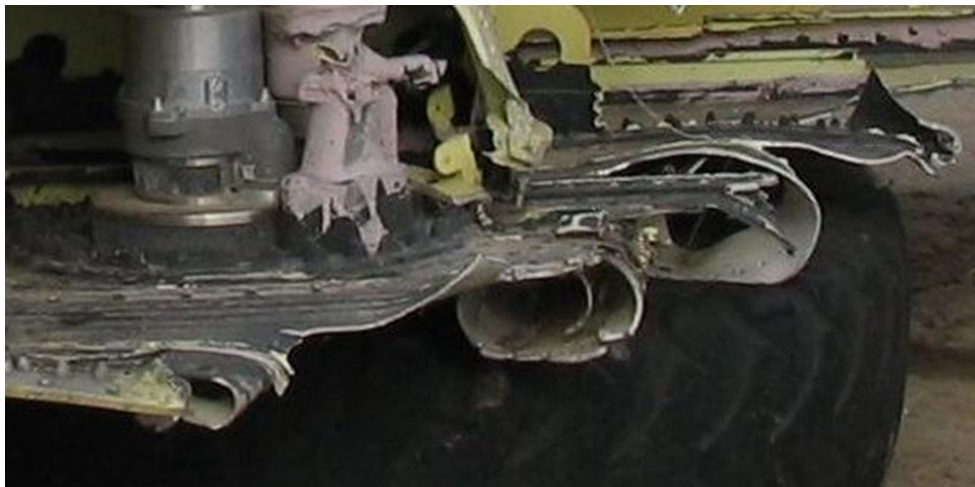
Fig. 2. Side view of the broken section of the left wing tip of the TU-154M no.101 showing significant explosive signatures (curled edges of up to 450°).

The location of the separation the left wing tip shows classical post-explosive signatures typical of explosive materials, including irregularly curled edges with more than one turn. The broken area of the left wing tip shows a large number of the characteristic signs indicating high internal pressure, including damage to rivet lines, separation of rivets, and clean separation of skin from the remaining parts. (Fig. 21 and Fig.22).

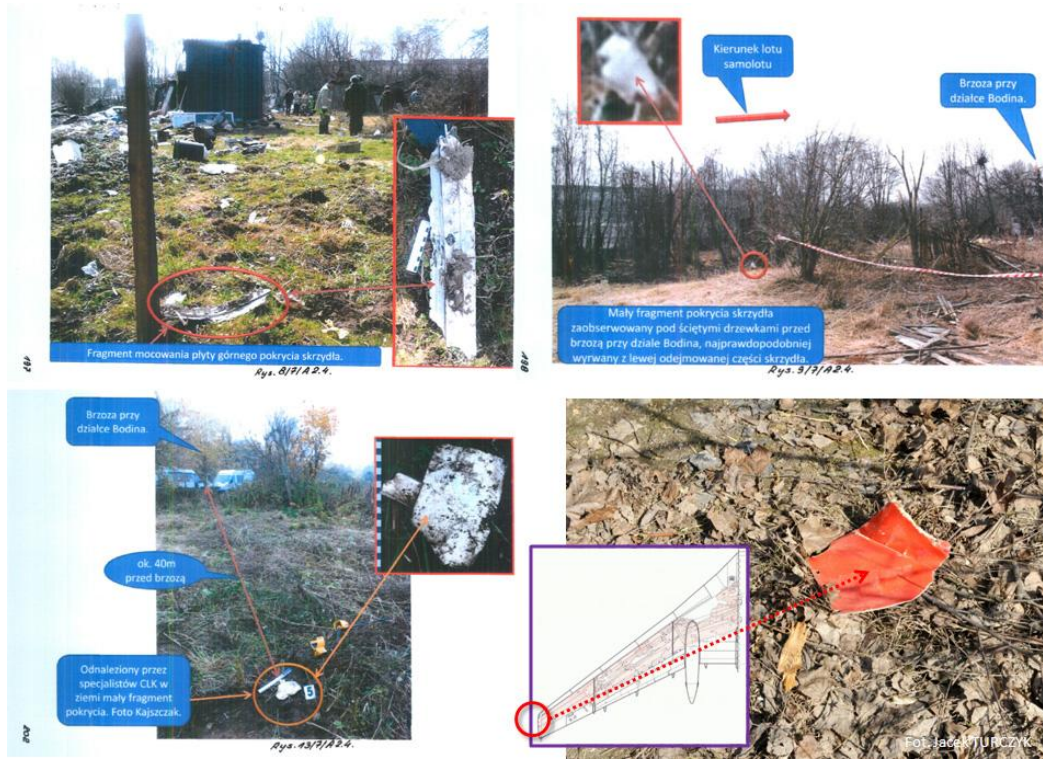
Many pieces of the left wing, in the vicinity of the Bodin birch (bb), were found before the tree in an area of 41 meters north and 17 meters south of the direction perpendicular to the flight direction and 43 meters to the east of the tree (Fig. nr.3)

Fig. 3. Debris of the detachable part of the left wing identified by the Committee and experts of the Prosecutor's Office.

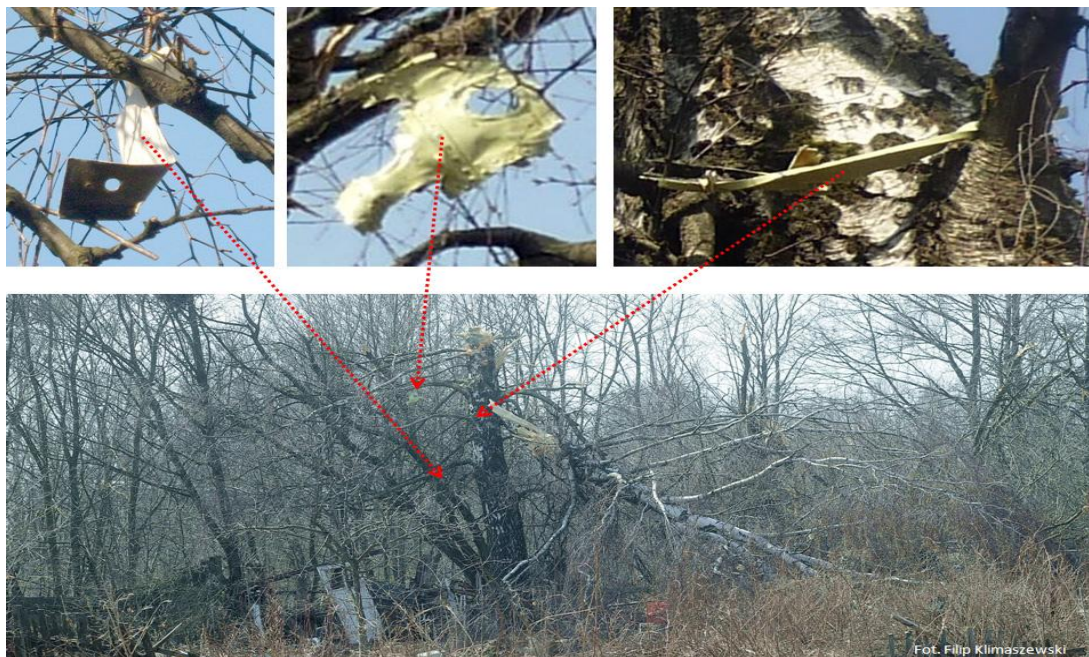
Three pieces of the detachable part of the left wing were hanging on the branches of the so called Bodin birch (Fig.4)

Fig. 4. Identified pieces of the detachable left wing part hanging on April 10, 2010 on the branches of the (Bodin) birch tree claimed to have cut the wing (noted "bb").

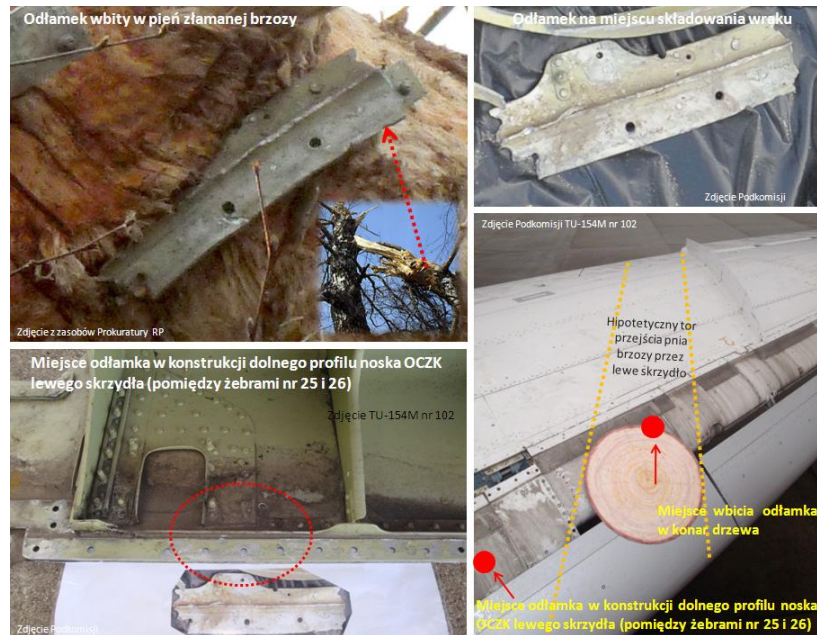
One of the elements rammed into the trunk of the Bodin birch does not come from the hypothetical place of contact between the wing and the birch; it was identified as an element in the construction of the plane being 70cm closer to the fuselage than the place of contact described by the MAK and Miller reports. (Fig. 5).

Fig. 5. The place in the wing construction of the piece rammed into the so called Bodin birch tree.

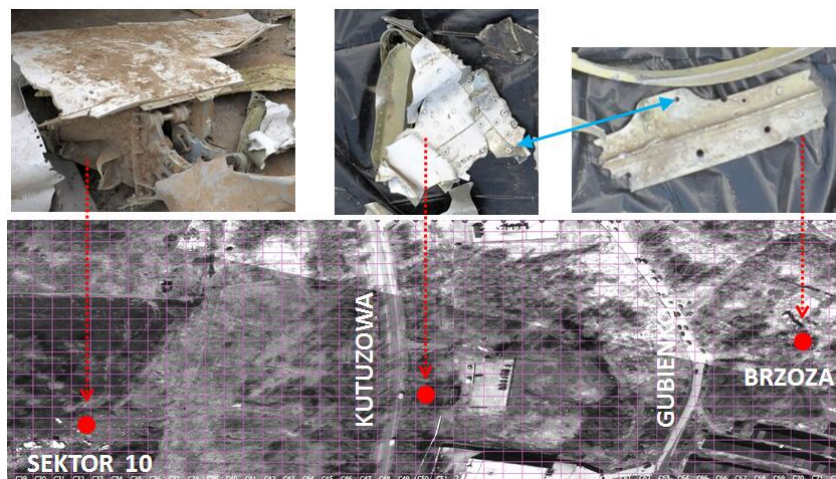
A piece of the skin of the nose, to which the piece rammed into the birch tree trunk was attached, was identified over 200m further in the direction of the flight path - next to the Kutuzov street. A fragment of the spar, to which this piece was attached, was identified 400m further in the direction of the flight path in sector 10. (Fig. 6).

Fig. 6. Position on the ground of neighboring elements in the wing construction to the debris rammed into the trunk of 'bb'.

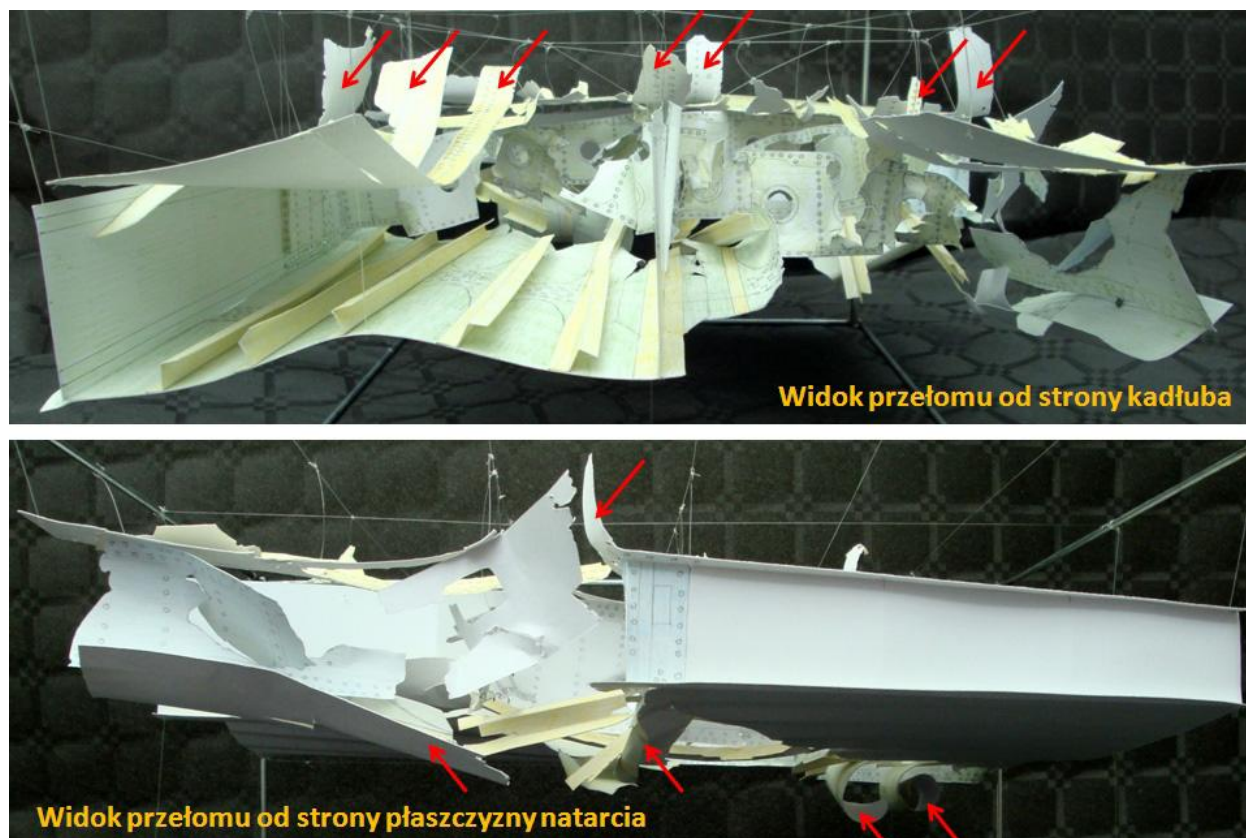
Elements of the skin of the left wing, which according to the MAK and Miller reports were supposed to have made contact with the bb tree are torn off and bent outwards; the upper side bent upwards, and the bottom side bent downwards. (Fig. 7).

Fig. 7. Place of separation of the left wing tip. Places in the outer and bottom skin have been marked with red arrows, which have been bent outwards.

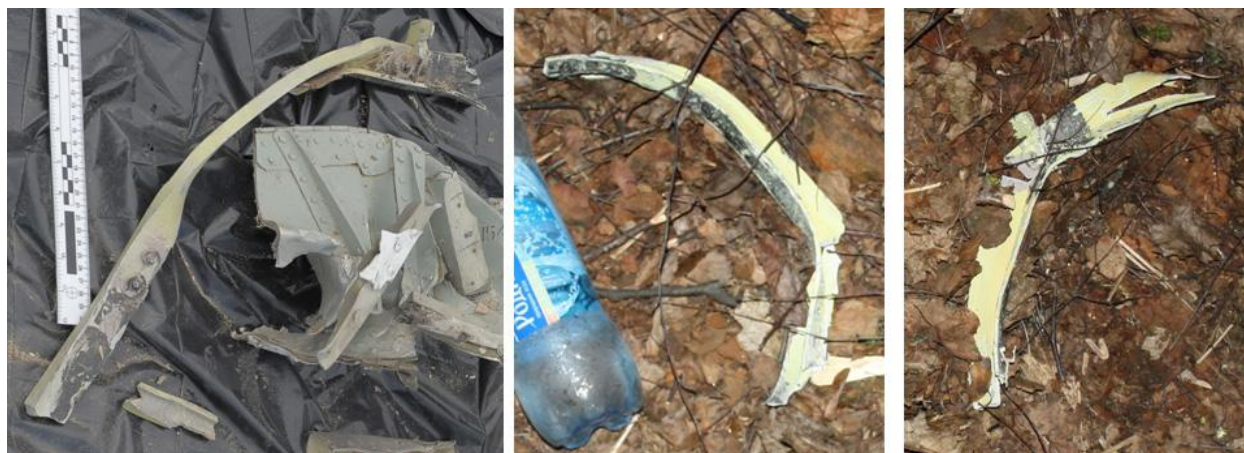
Fig.8. Pieces of stringers of the left wing curled outwards

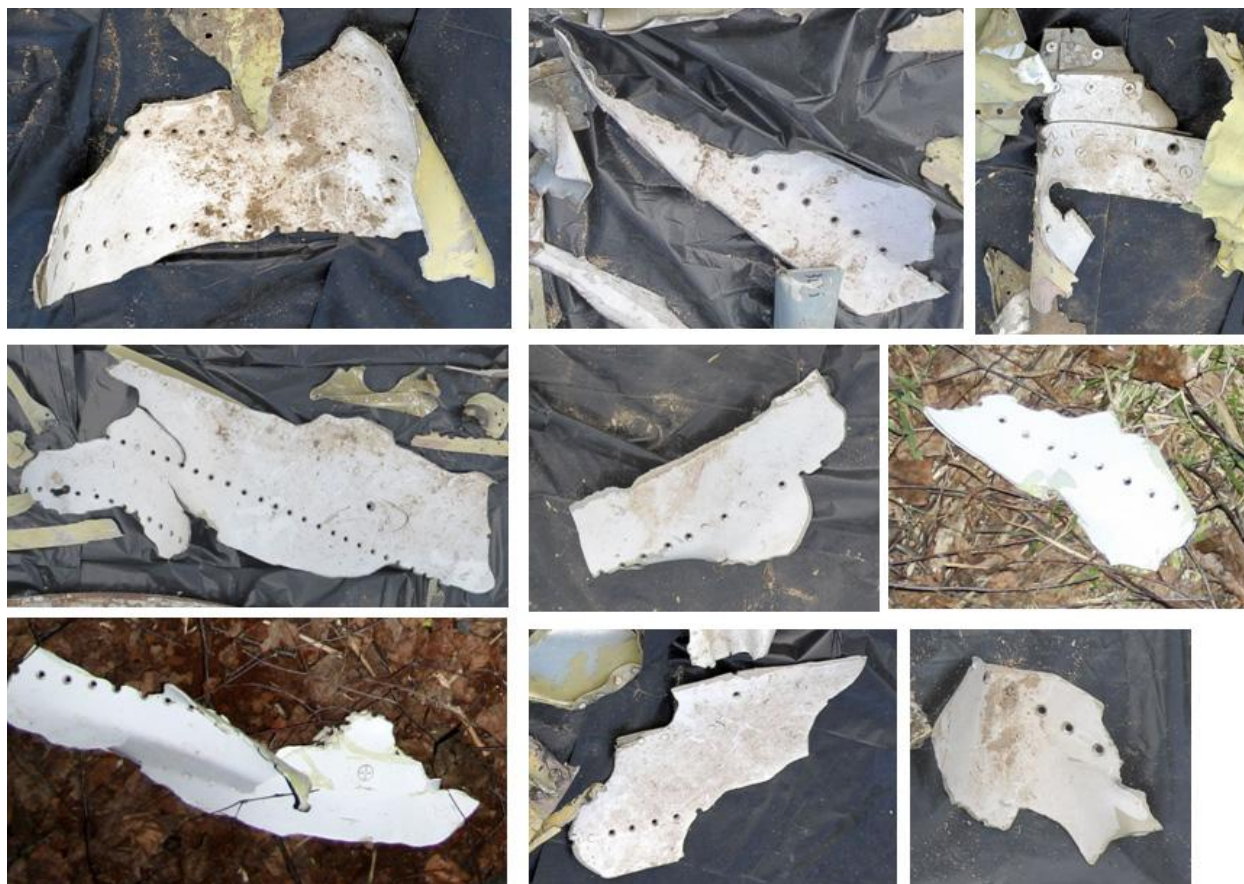
Elements of the plating of the removable part of the left wing, which according to the MAK and Miller reports were supposed to have made contact with the ‘bb tree’, are ripped out and bent outside the structure; on the top surface upwards (Fig. 9), and on the bottom surface downwards (Fig. 10).

Fig. 9. Pieces from the top skin curled outwards.

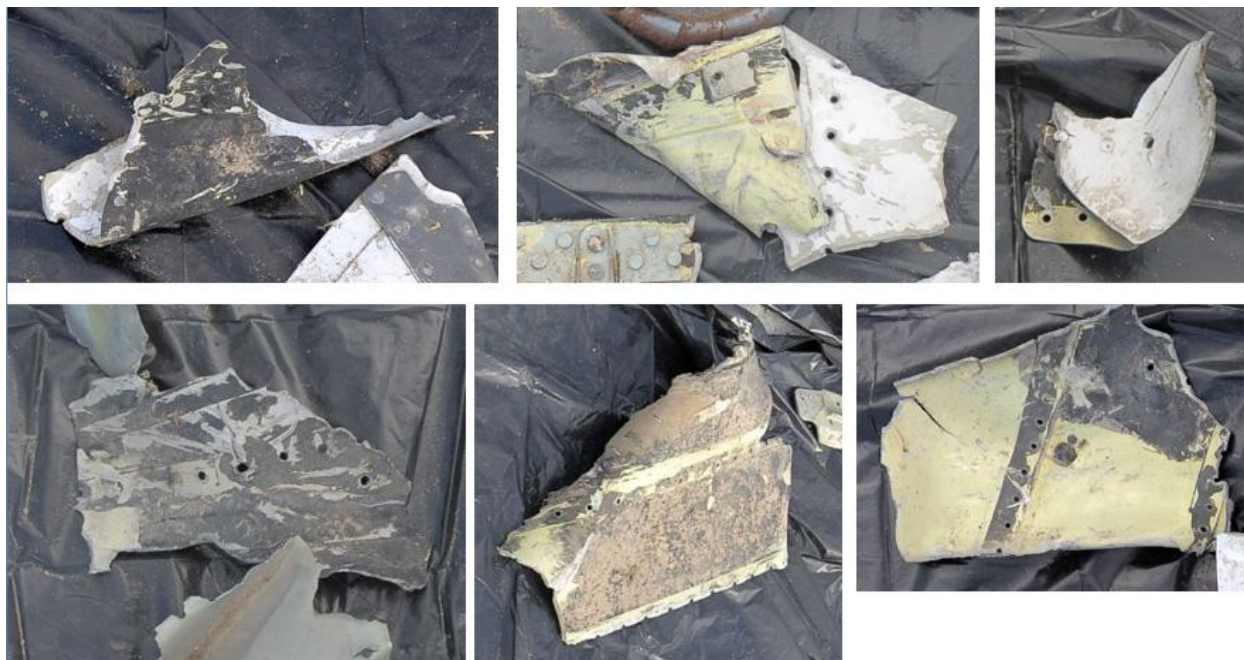
Fig. 10. Fragments of the bottom skin curled outside the structure.

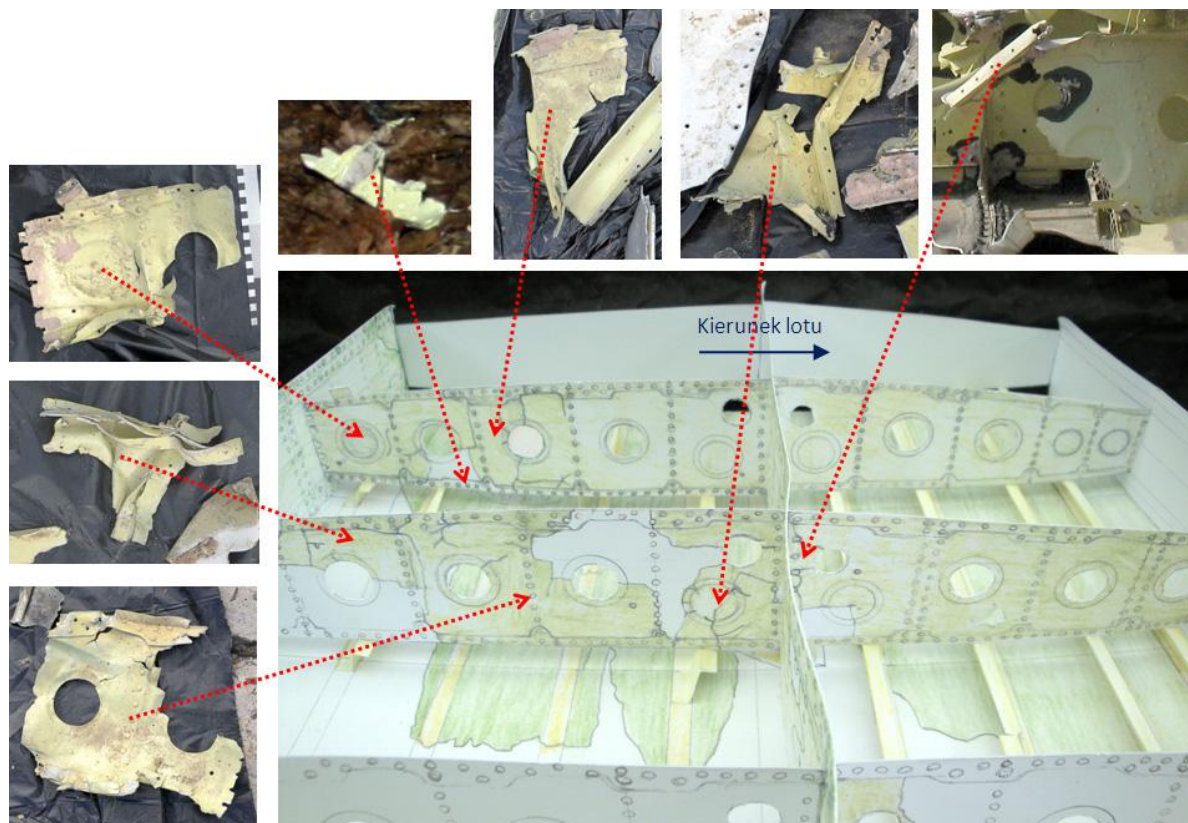
Some pieces of the left wing rib, which according to the MAK and Miller reports were supposed to have made contact with the 'bb tree', are torn off of the structure (Fig. 11)

Fig. 11. Condition of the ribs of the left wing according to the reconstruction made by the Committee. The blue arrow denotes the direction of the flight.

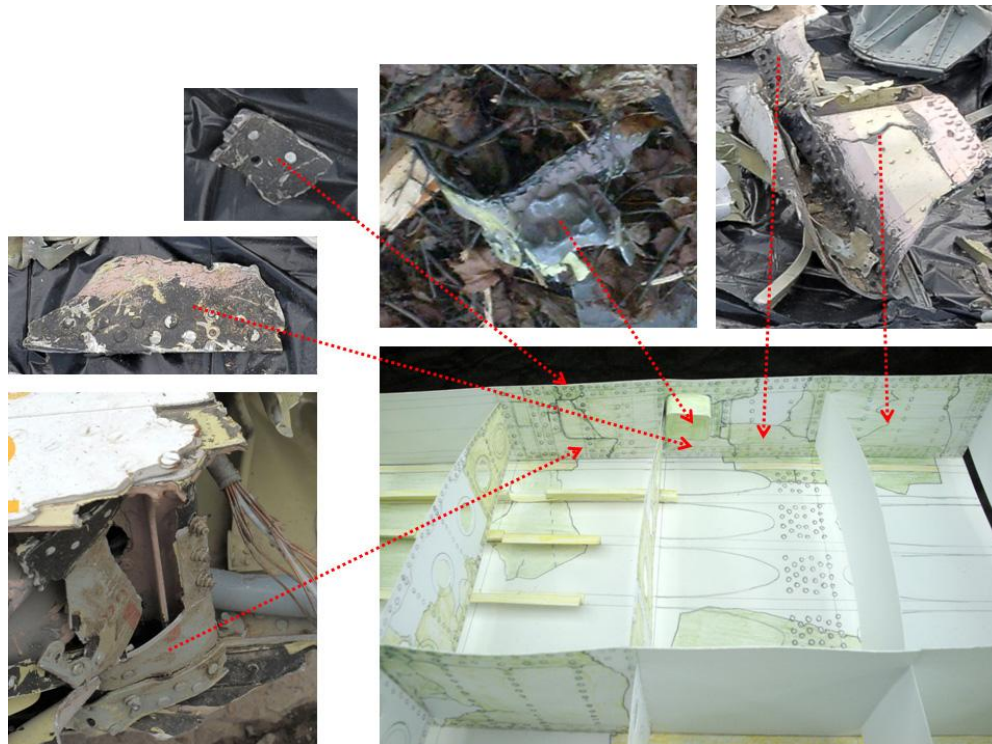
Some pieces of the wing spars from the detachable part of the left wing, which according to the MAK and Miller reports were supposed to have made contact with the 'bb tree', are torn off or bent outwards (Fig. 12, 13 and 14)

Fig. 12. Condition of spar no.1 of the left wing according to the reconstructed model made by the Committee, based on pictures and videos.

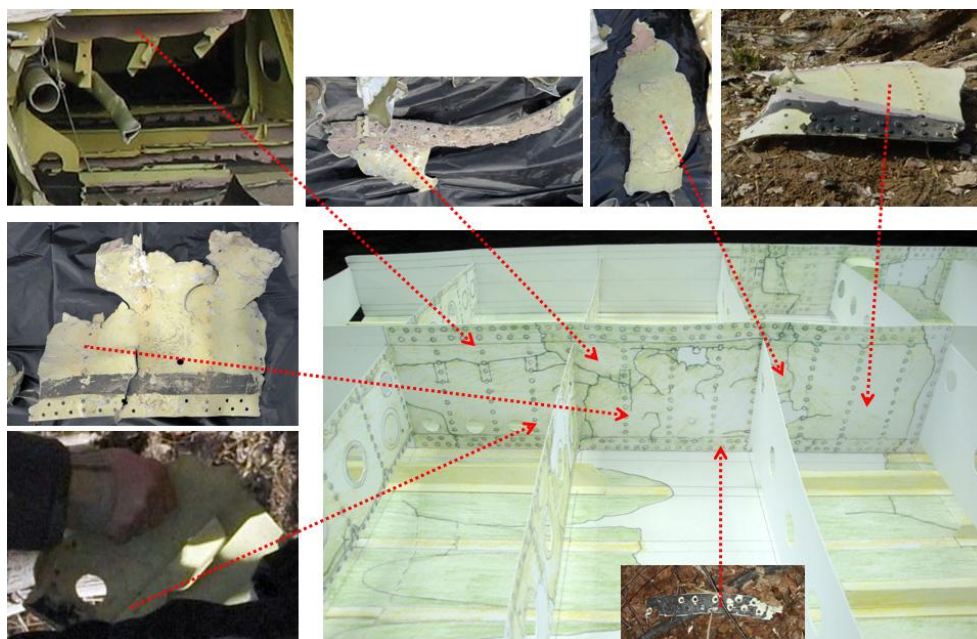
Fig. 13. Condition of spar no.2 of the left wing according to the reconstructed model made by the Committee, based on pictures and videos.

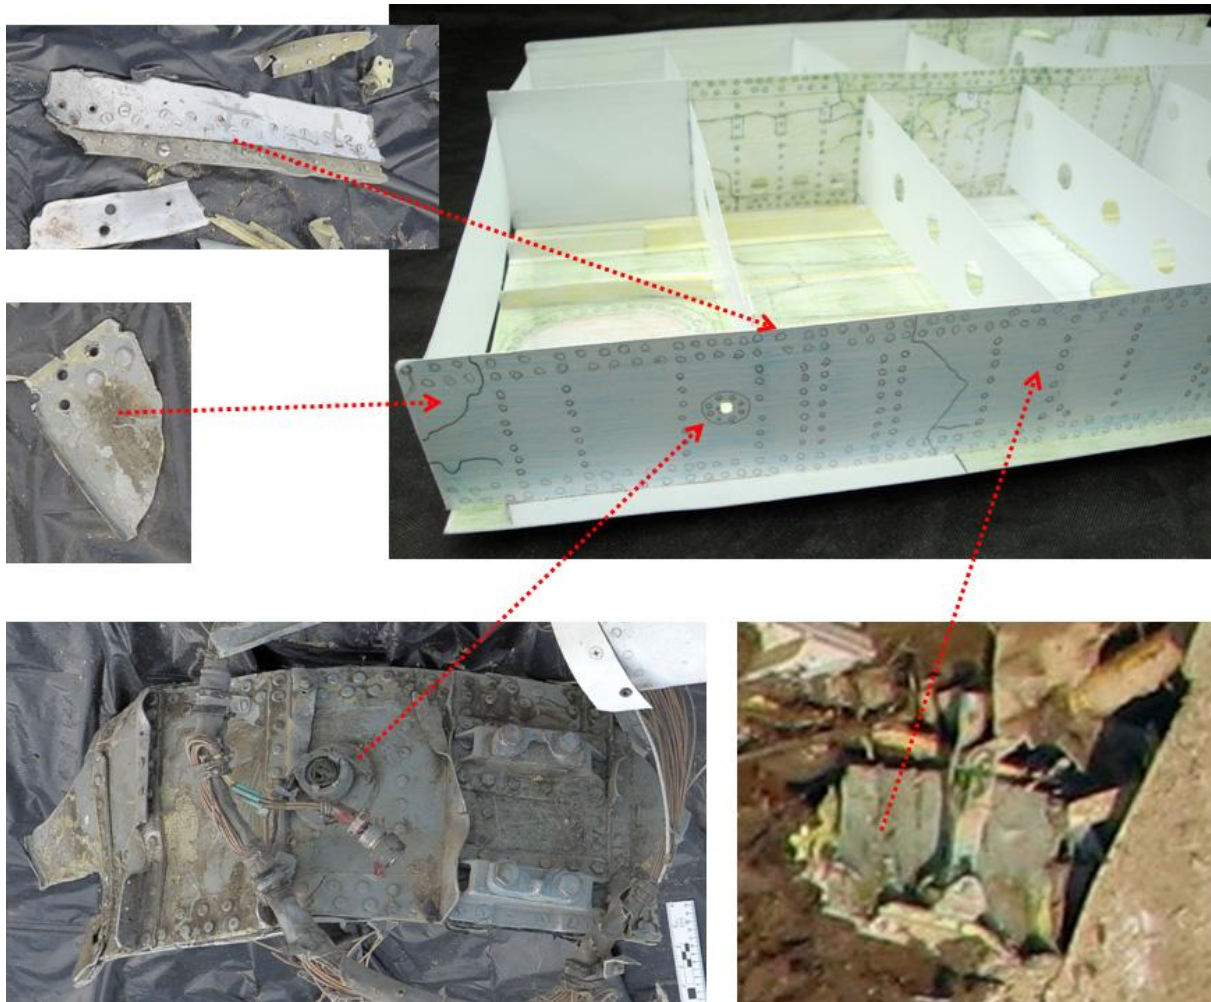
Fig. 14. Condition of the spar no.3 of the left wing according to the reconstructed model made by the Committee.

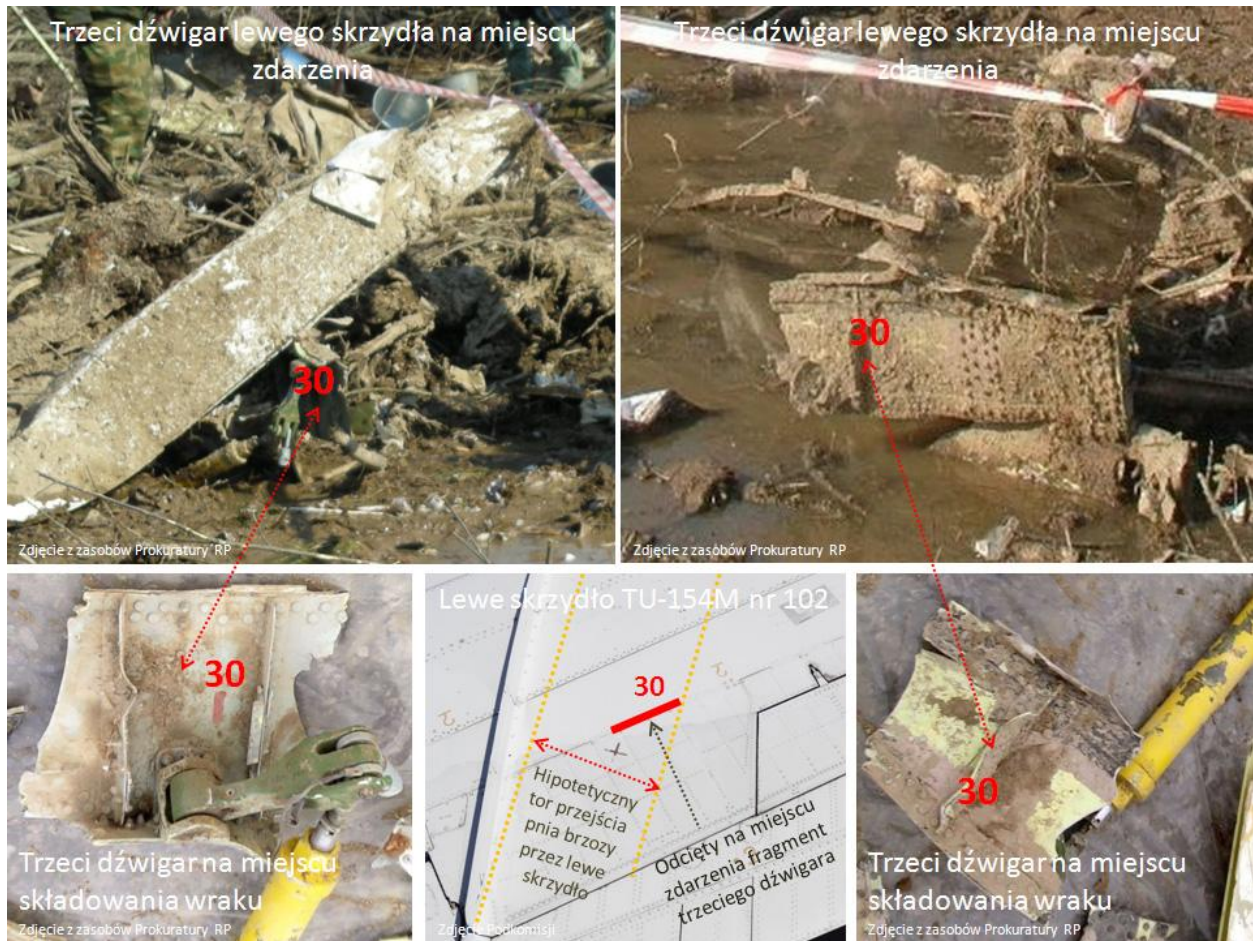
A fragment of spar no.3 of the left wing, which according to the MAK and Miller reports was supposed to be cut by the so called Bodin birch tree, was found on the main crash site 450m behind the 'bb tree' and then cut. Its separated pieces were found in various places of the debris storage place (Fig. 15).

Fig. 15. View of the same part of spar no.3 from the detachable part of the left wing on the main crash site (top two pictures) and place of storage of the debris (bottom left and right pictures). The bottom middle picture is a drawing of the left wing of TU-154M, No. 102, where the red arrows show the hypothetical trail of the 'bb tree' through the left wing, while the black arrow shows the location of the part of the third spar.

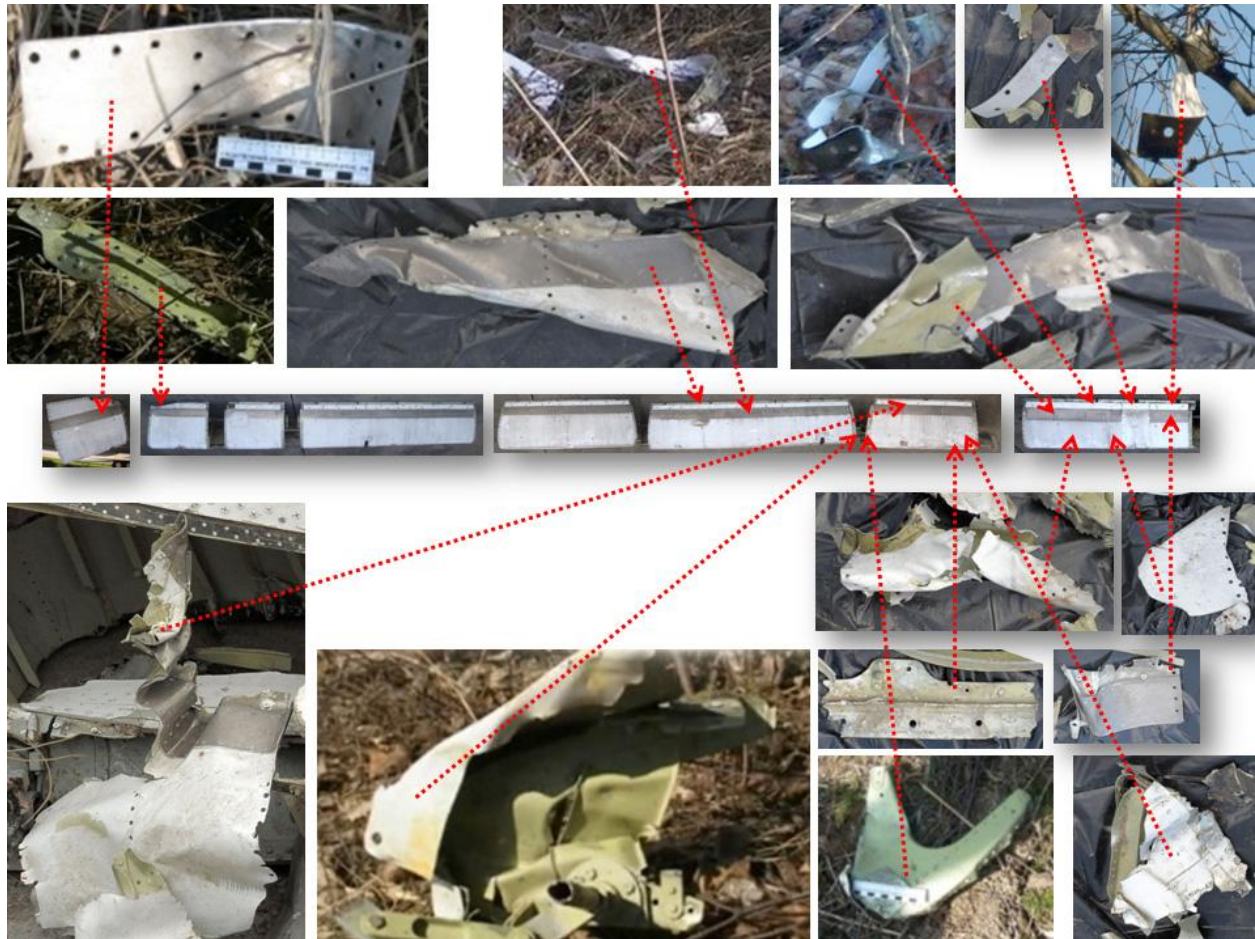
Some elements of the nose of the left wing, which according to the MAK and Miller reports were supposed to have made contact with the Bodin birch 'bb tree', are torn off or bent outwards (Fig. 16)

Fig. 16. Condition of the nose of the left wing according to the model reconstruction made by the Committee.

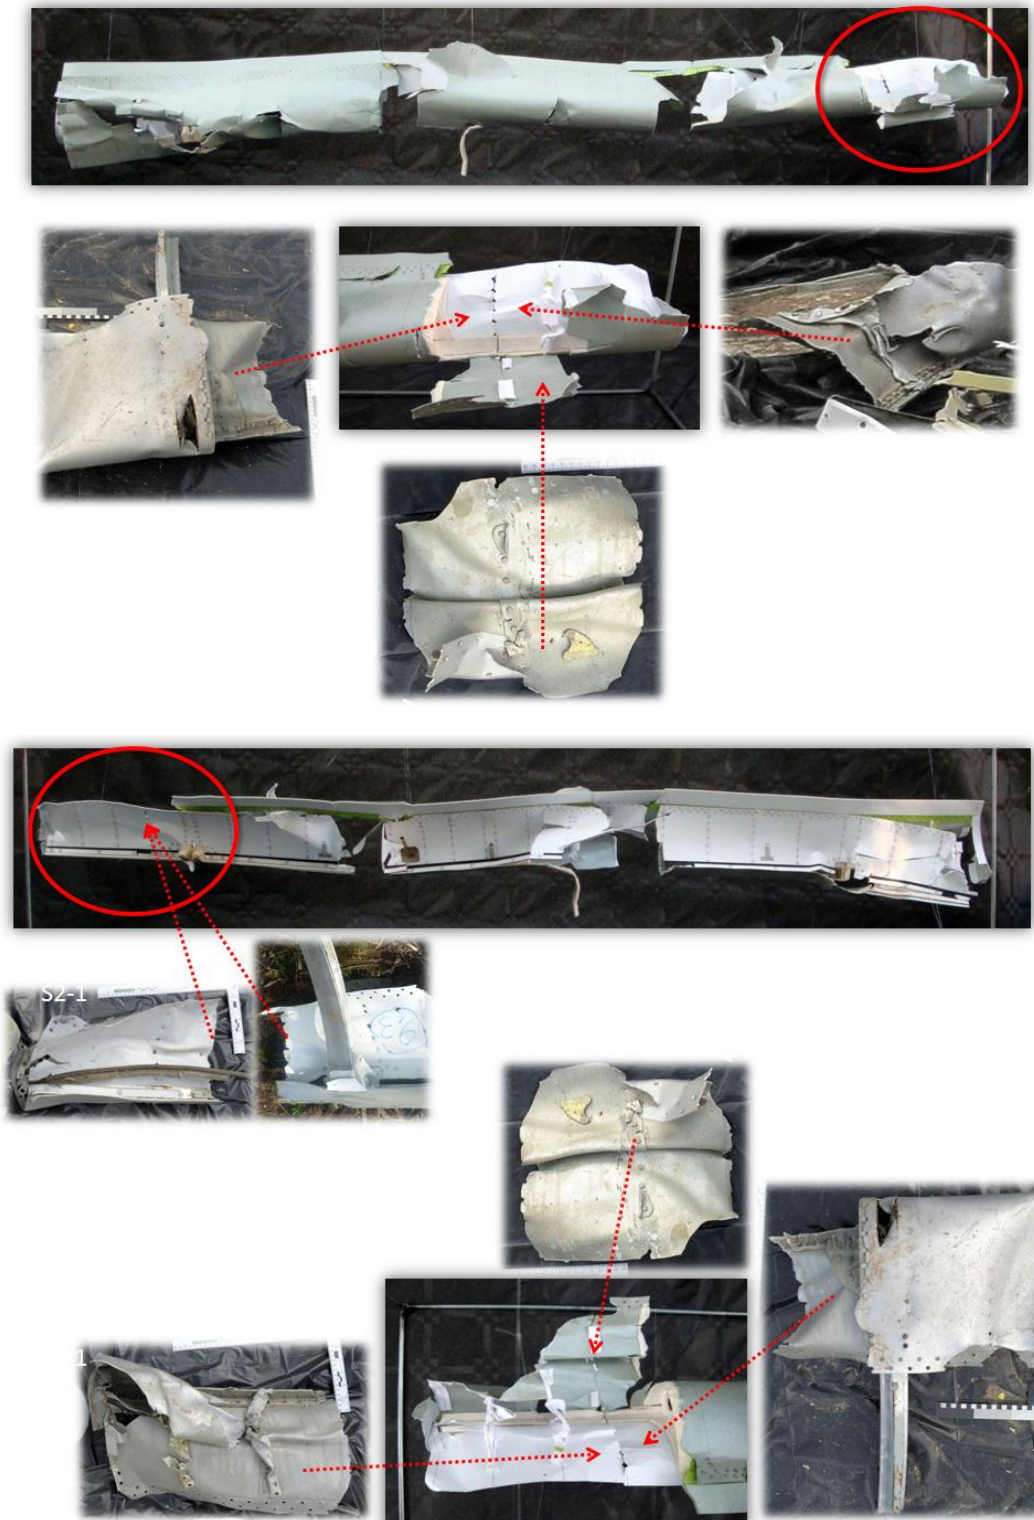
Some pieces of the second section of the left wing slats, which according to the MAK and Miller reports were supposed to have made contact with the so called 'bb' tree, are torn off or bent outwards; the upper side upwards, the bottom side downwards, and from the side of the angle of contact to the front (Fig. 17).

Fig. 17. Condition of the second section of the left wing slat according to the reconstructed model made by the Committee (is this also based on pictures and videos?)

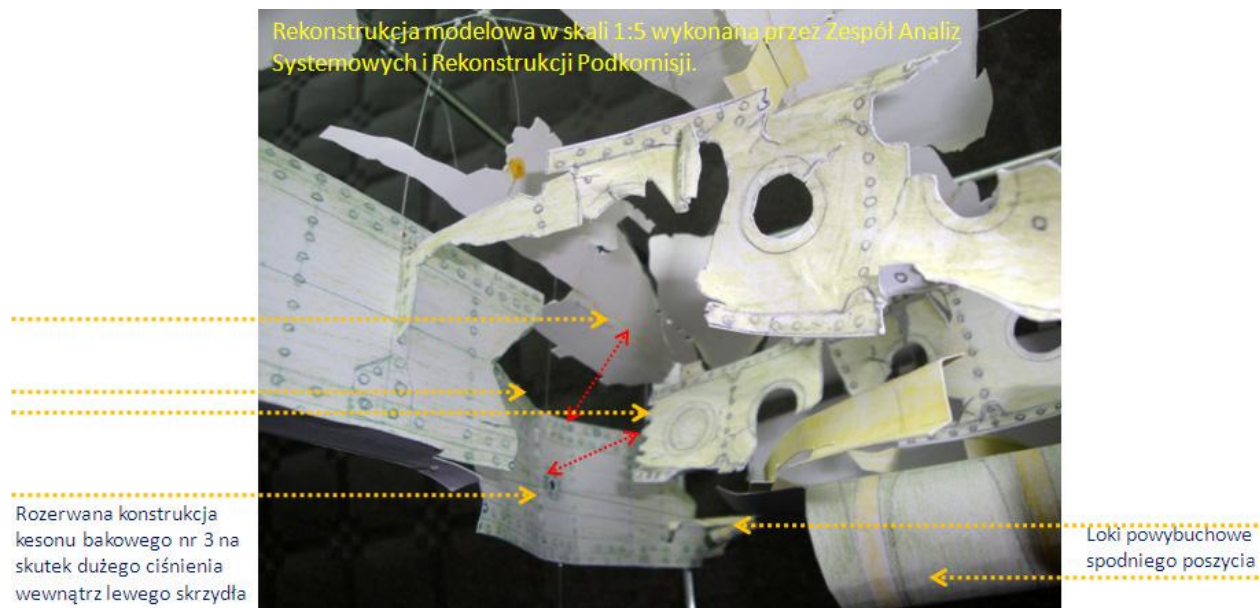
The reconstruction of the console of the left wing made by the Committee/KBWLLP, in the place where according to the MAK and Miller reports was supposed to have made contact with the ‘bb’ tree, shows clear signs of deformation as a result of high internal pressure with the epicenter being between ribs 27-32 (Fig. 18.)
(Source: Reconstruction of the console of the detachable left wing part with elements of the external construction, which have traces of deformations due to high internal pressure and an epicenter between ribs 27-32.)

Fig. 18. Reconstruction of the console of the subtracted part of the left wing with elements of the internal structure, bearing traces of deformation through the impact of high internal pressure with an epicenter between ribs No. 27-32.

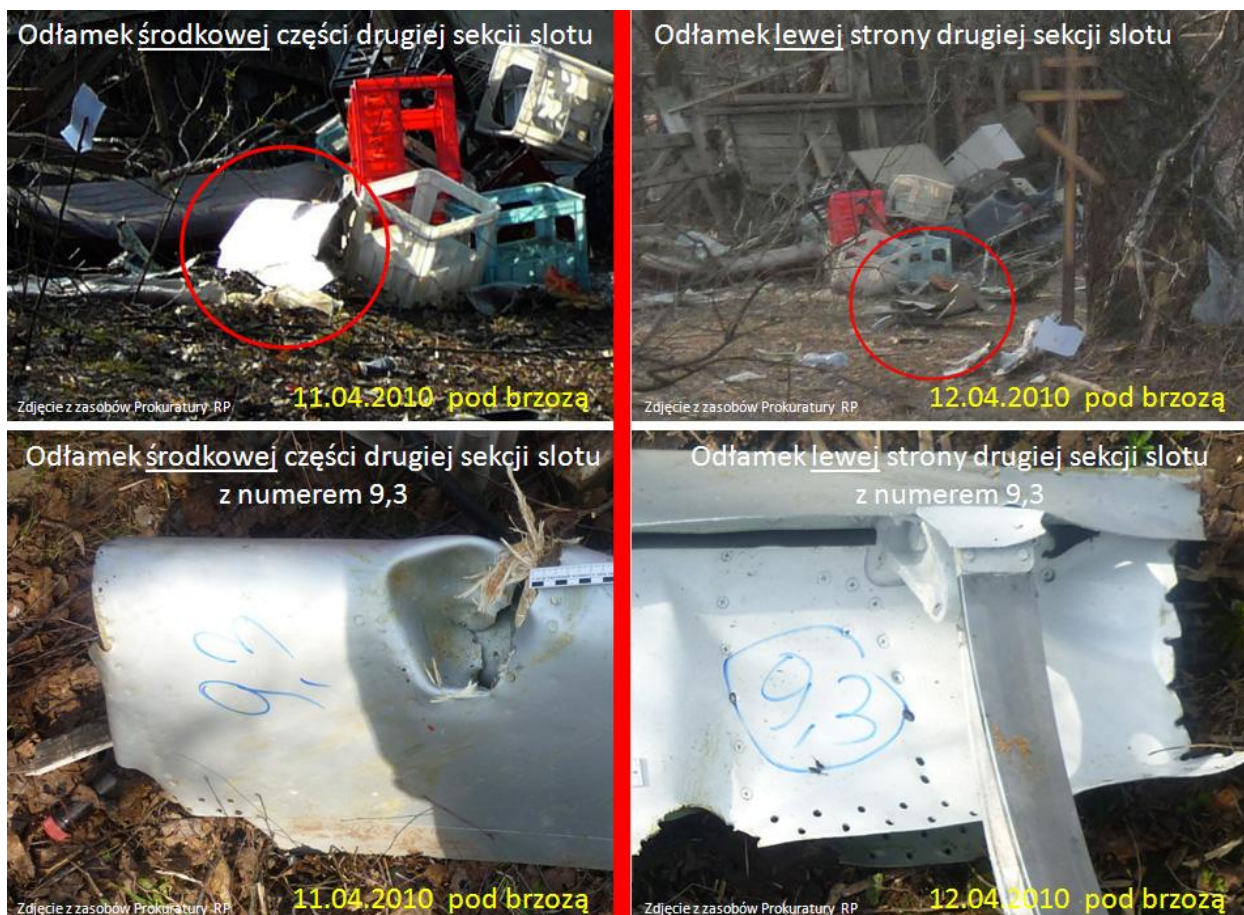
Example: One of the pieces of the 2nd section of the slot, which fell into a ditch next to the road leading from the garages to Gubienko street (approx.20m behind the birch tree), was moved on April 11, 2010 under the ‘bb’ tree. On April 12, it was swapped with another piece stemming from the line of separation, which fell into the ditch next to the street leading from the garages to Gubienko Street (approx. 50m behind the birch). Picture 19.

Fig. 19. Fragments of 2 sections of the slot moved from the original location on the ground under the tree claimed to have made contact with the wing.

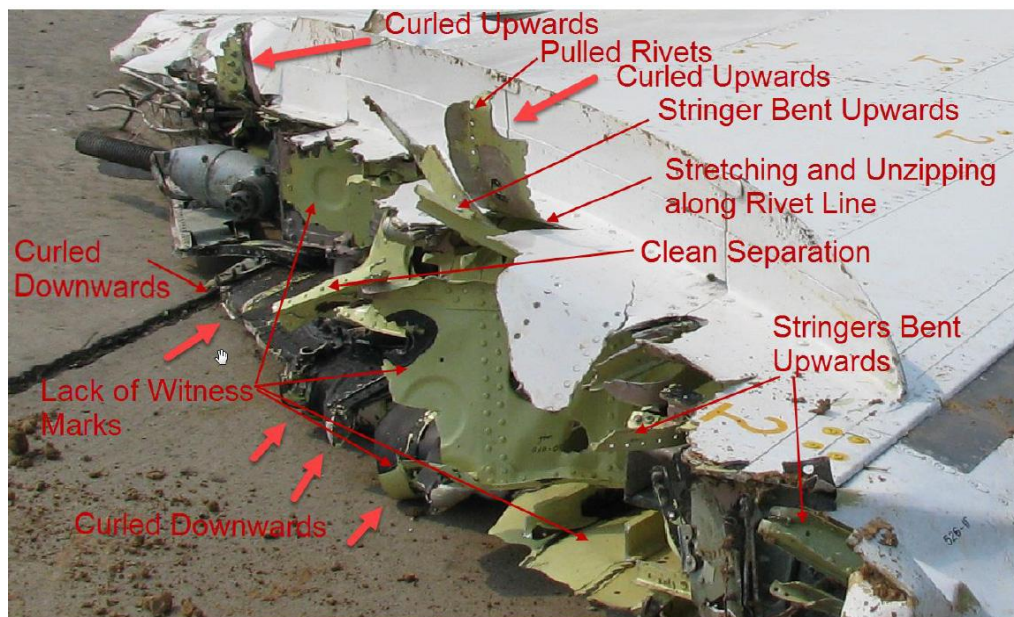
Fig. 21. The area of separation of the left wingtip of the TU-154M, PLF101 showing obvious and significant signs of explosion as well as many other characteristic signs of explosion.

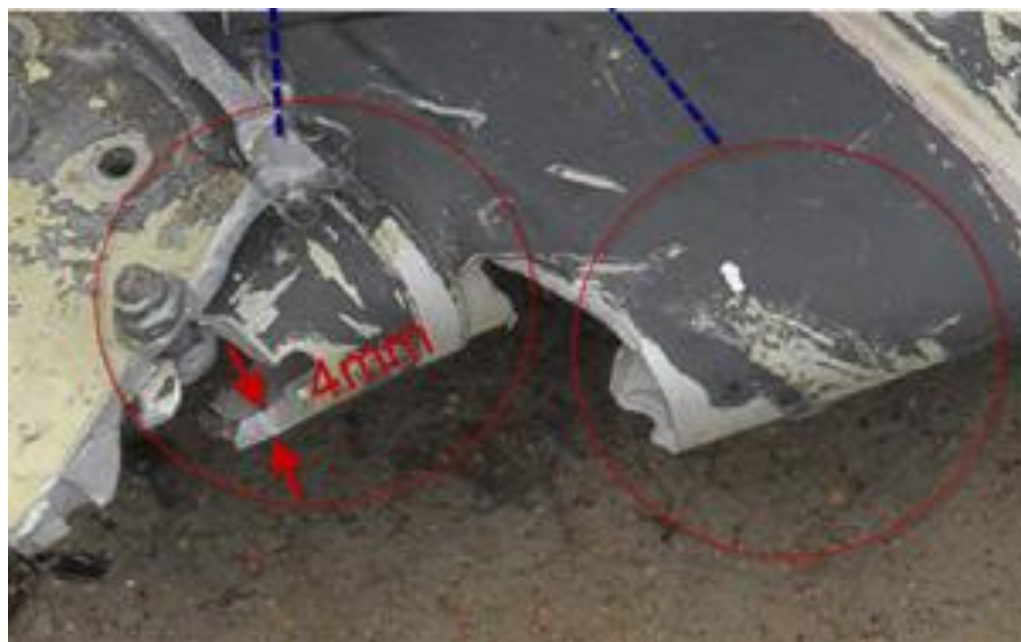
Fig. 22. A close-up of the photograph from Fig. 21 with visible post-shock curls with the axis of curl in the direction of flight.

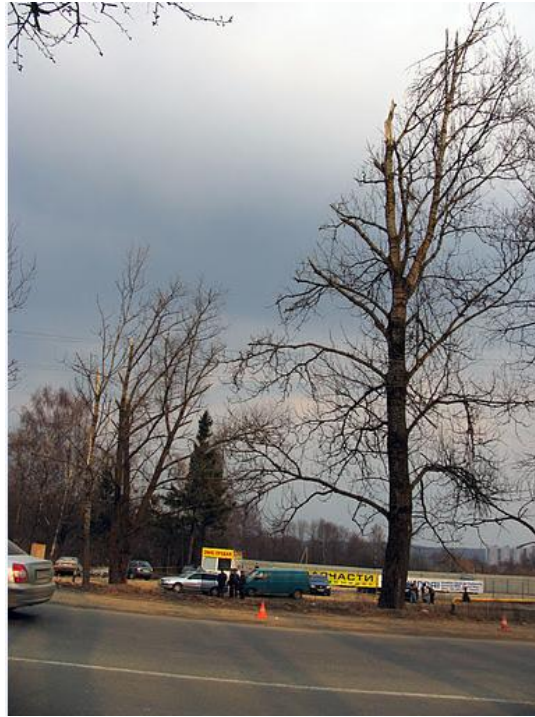
Fig. 28. A damaged tree on the East side of Kutuzov Street.

A look at the damage to the trees on both sides of the street can determine the altitude of the plane just before reaching the street to be 28m, and the path of the left wing's roll at 120 degrees.

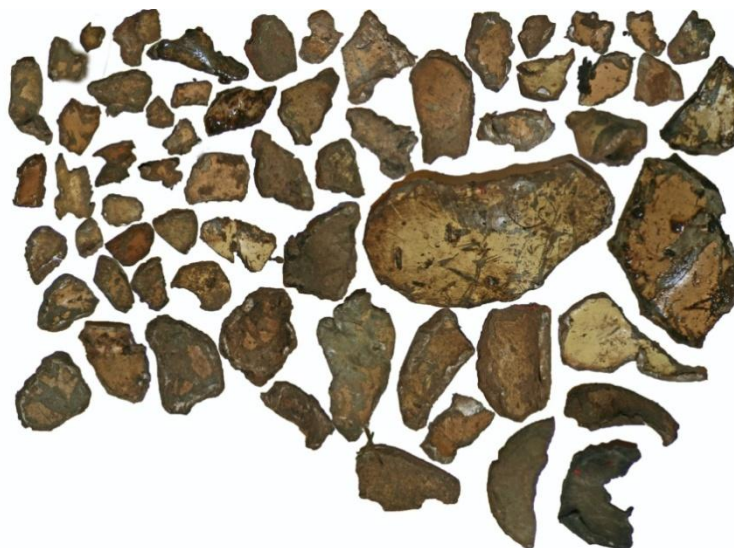
Numerous pieces of the plane were found during a terrain analysis, performed by Polish archeologists in Smolensk in October 2010, in sector 13, behind Kutuzov Street and before the main crash site (fig 32). These pieces, ranging in size from a couple to tens of square centimeters, had traces of thermal and mechanical effects (fig 33).

Fig. 33. Collected pieces of the Tu-154M taken from the ground 100m before the main crash site, having visibly undergone thermal change.

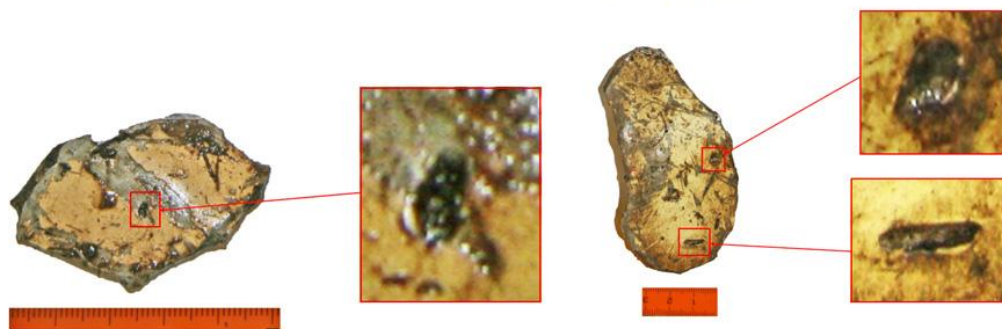
Fig. 34. Comparison of micro craters on the surface of the debris found by archeologists and debris created after the pyrotechnical experiments.

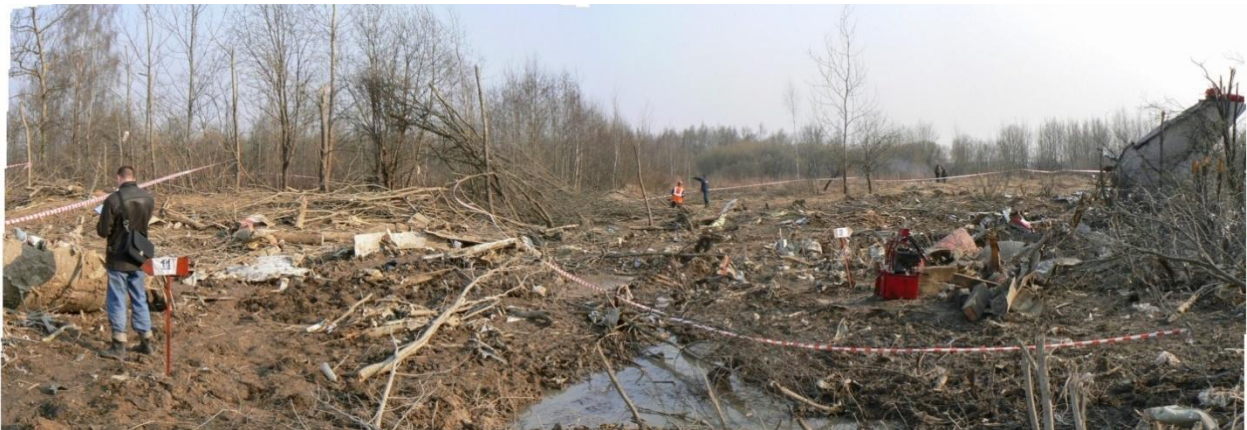
Fig. 36. A picture of the main crash site.

An explosion in the left part of the center wing caused the destruction of the majority of the outer skin, ribs and spar no.1 of the fuel box no.4. Those elements of the plane on the main crash site (Fig. 36) have clear shear marks and visible effects of the blast wave being the result of an explosion. The pictures below reconstruct the mechanism and scale of destruction of the left center wing.

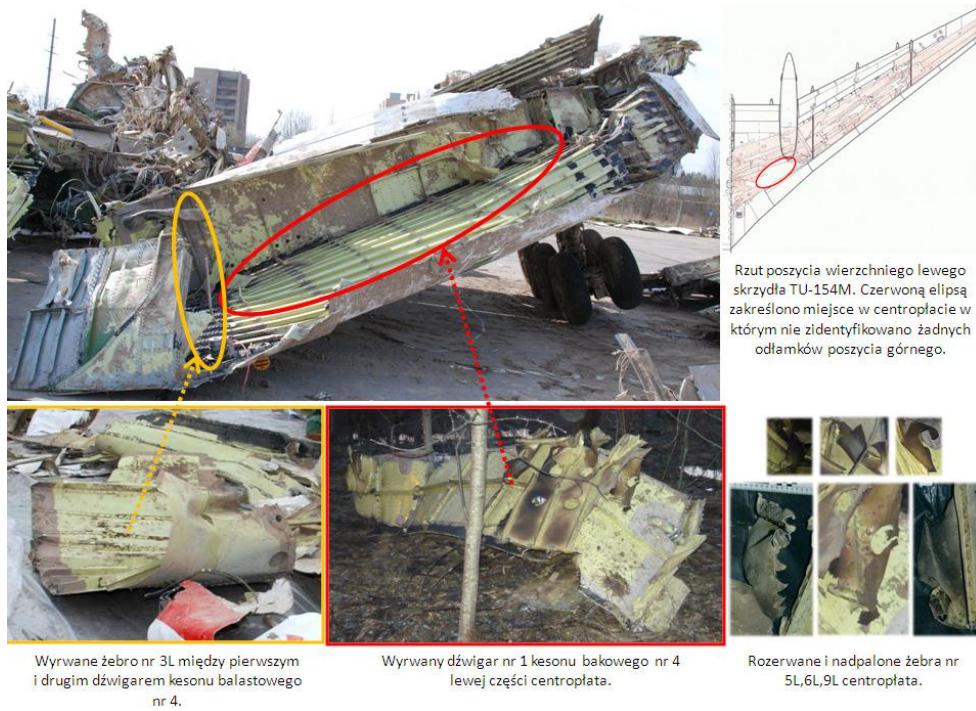
Fig. 37. Note the ripped spar no.1 of the fuel box no.4 of the left part of the center wing with clear signs of high temperature, as well as the destruction of burned ribs visible on the right side of the picture. Other parts from this area found outside the fire zones were also found with similar signs.

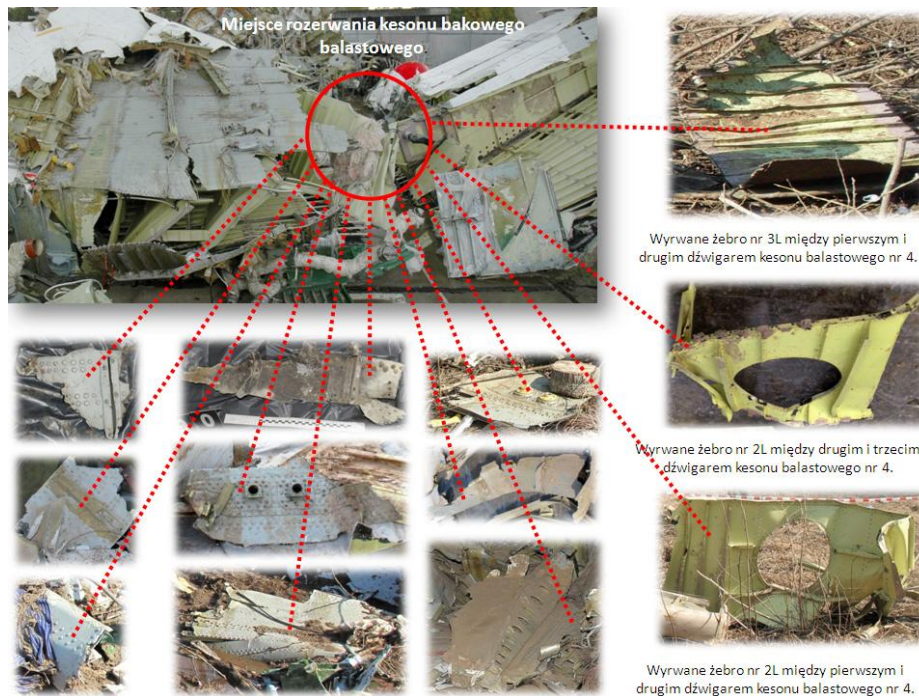
Fig. 38a. The place of the destruction of the ballast box and destroyed elements.

The tearing and destruction of the fuel box could not have been a result of a hydraulic impact, caused by the impact with the ground, especially considering the small amount of fuel and limited space. One has to consider the elements of skin, ribs, and rear spar, which were torn off/ripped apart likely due to high internal pressure. (Fig. 38 and fig. 40).
