**COMMITTEE FOR THE RE-INVESTIGATION OF
THE SMOLENSK AIR CRASH**

TECHNICAL REPORT

**This report contains facts regarding the crash of the TU-154M
No. 101 (Fight PLF101) that took place near
SMOLENSK NORTH airport, Russia on April 10th, 2010.**

WARSAW 2018

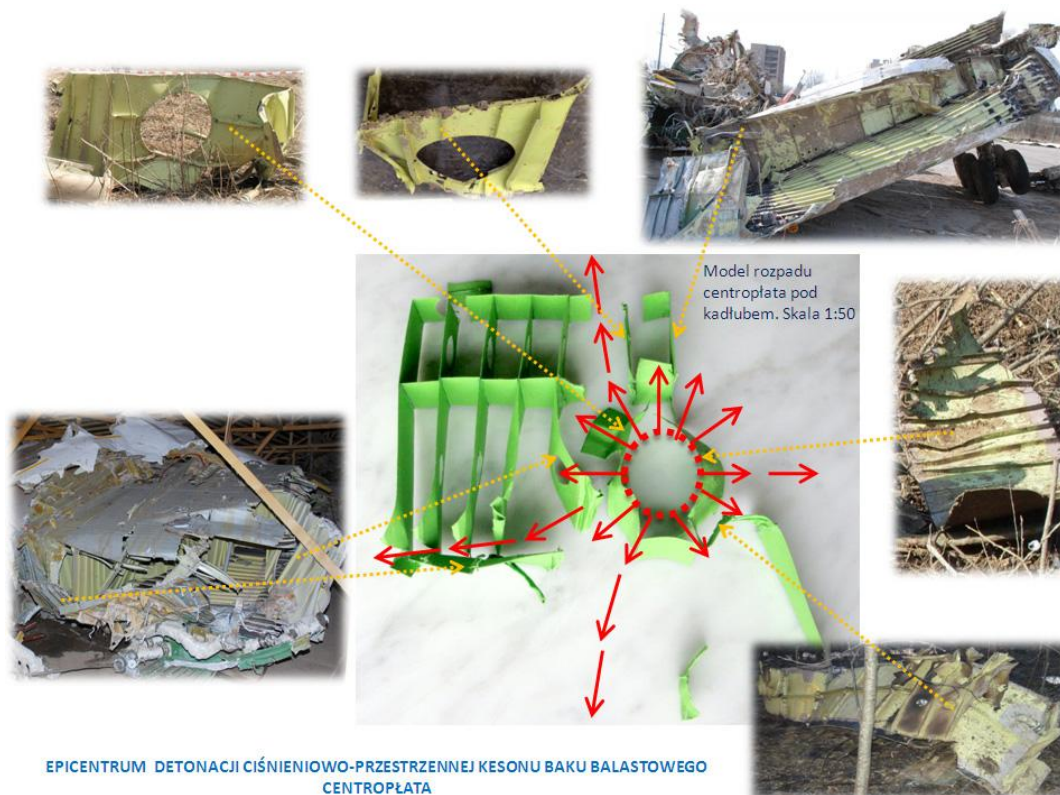
Fig. 38b. Epicenter of the wing box breakage. Study by the Committee.

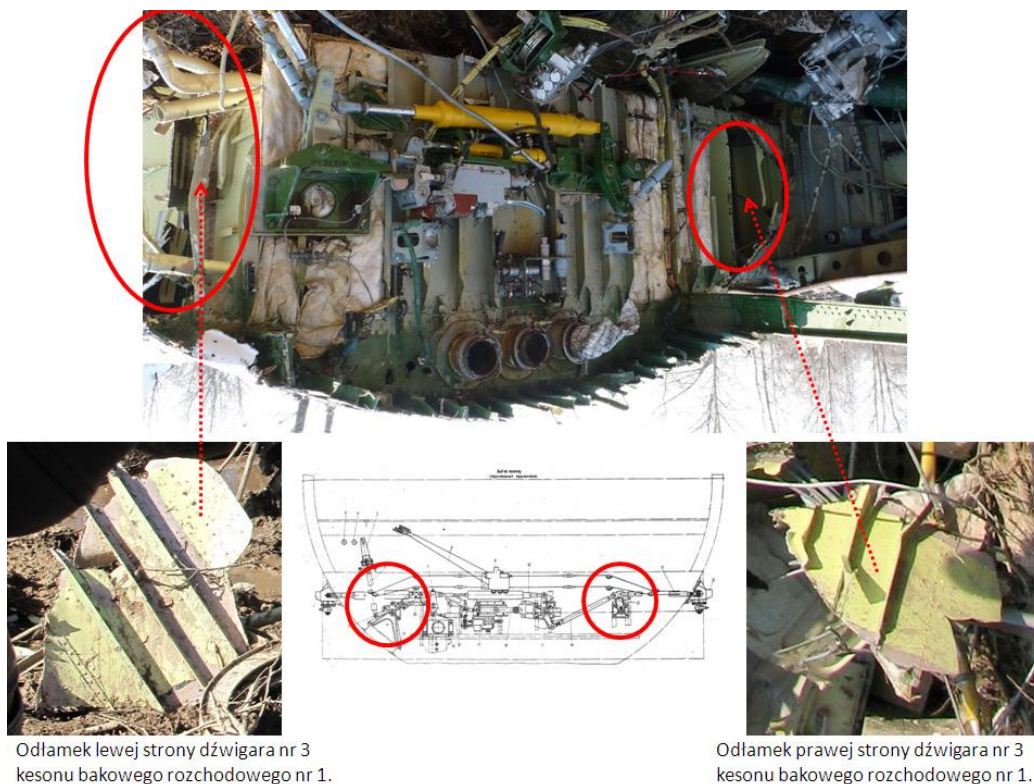
The tearing and destruction of the fuel box could not have been a result of a hydraulic impact, caused by the impact with the ground, especially considering the small amount of fuel and limited space. One has to consider the elements of skin, ribs, and rear spar, which were torn off/ripped apart likely due to high internal pressure. (Fig. 38 and fig. 40).

Fig. 40 Pieces of the left and right side of spar no.3 of fuel box no.1.

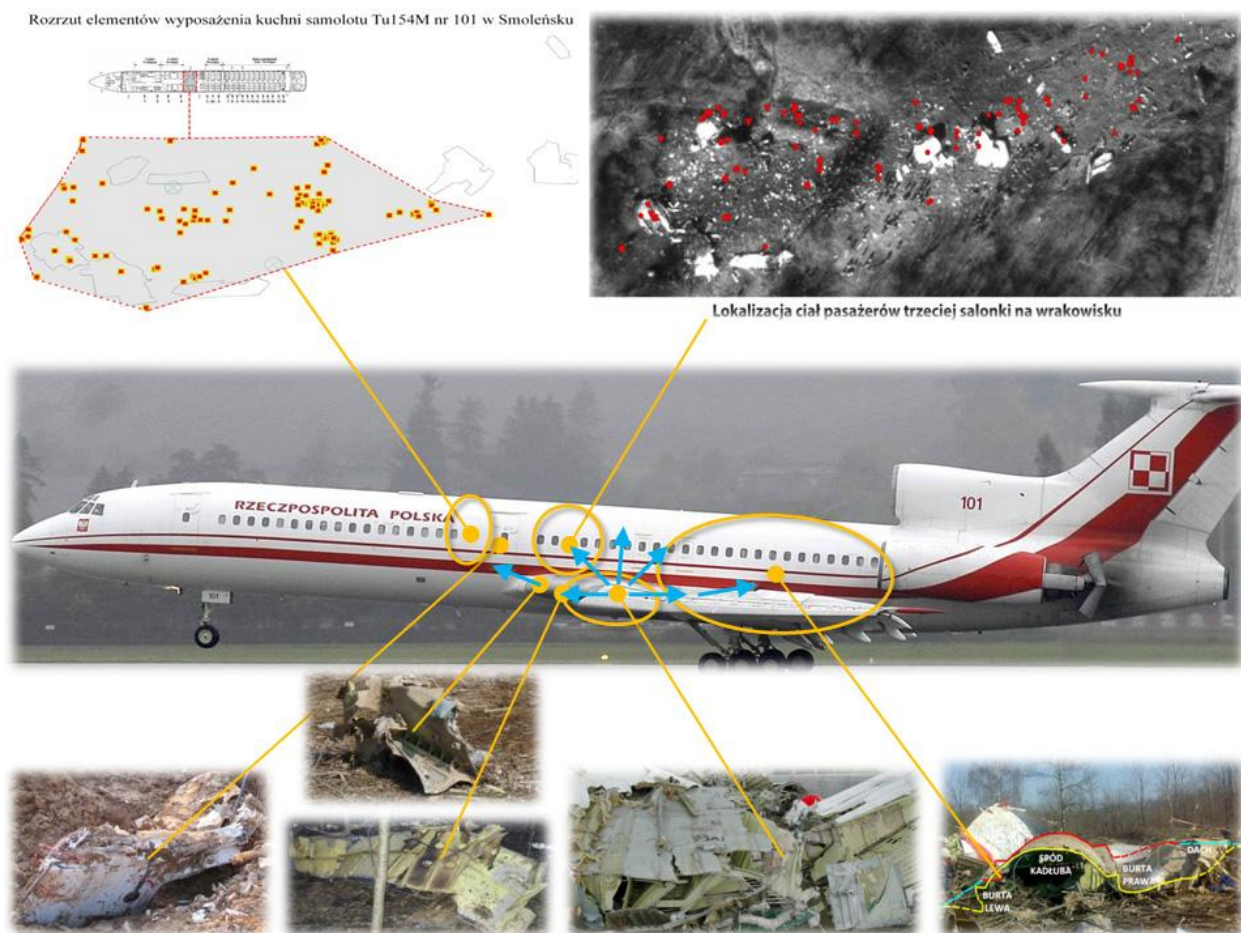
Fig. 42. The effects of the explosion of the ballast tank caisson. From the left of the top picture: galley area, left passenger door no 2. (823), third salon, fragments of the left part of the center wing, and passenger compartment. The bottom left picture shows the left door rammed into the ground. The right bottom picture shows the rear fuselage after the crash with both sides opened outwards.

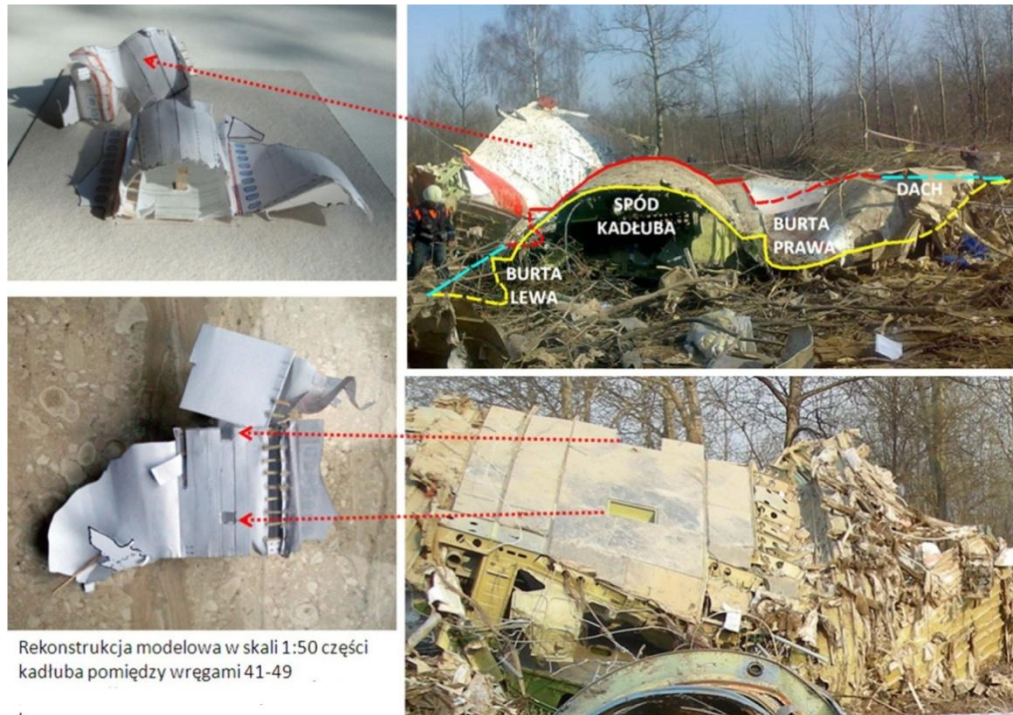
The part of the fuselage between the center wing and the tail was found in an upside-down position with both sides of the plane curled outwards. Studies by Sandia laboratories in the US, and simulations done at Akron University show that the fuselage is exposed to high internal pressure when in air. The sides of the plane curled outwards were cut up by the Russian services the day after the crash.

Fig. 44. Image of the fuselage destruction with both sides of the fuselage opened and thrown outwards.
