Mad River Reach Assessment and Restoration Strategy

DRAFT REPORT

July 2018

Inter-Fluve
Hood River, OR

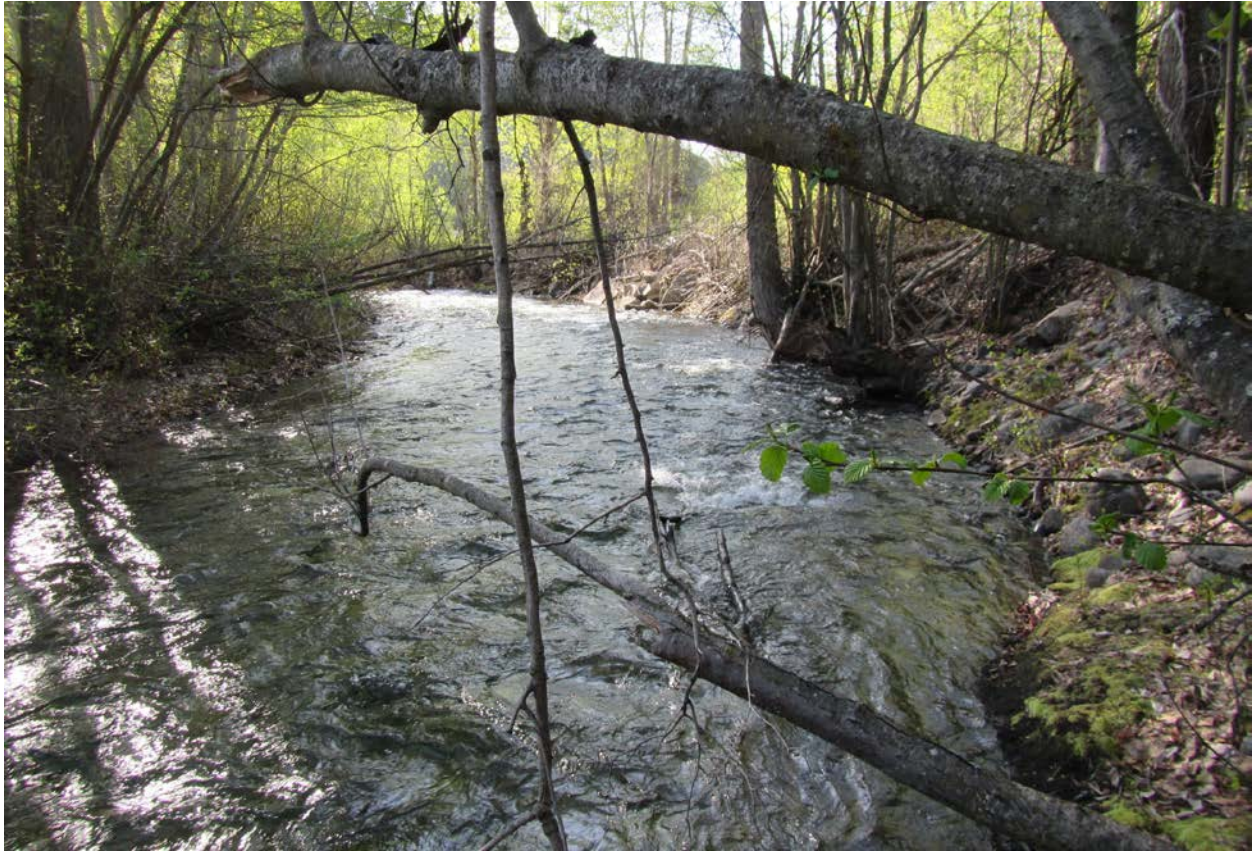
Figure 19. Looking downstream at RM 0.15. River right: outside meander, partially vegetated stabilized cobble-boulder bank topped with a levee; River left: vegetated floodplain pocket with small gravel-cobble point bar (partially inundated during spring flows). (Photo: IFI, 4/25/2017)

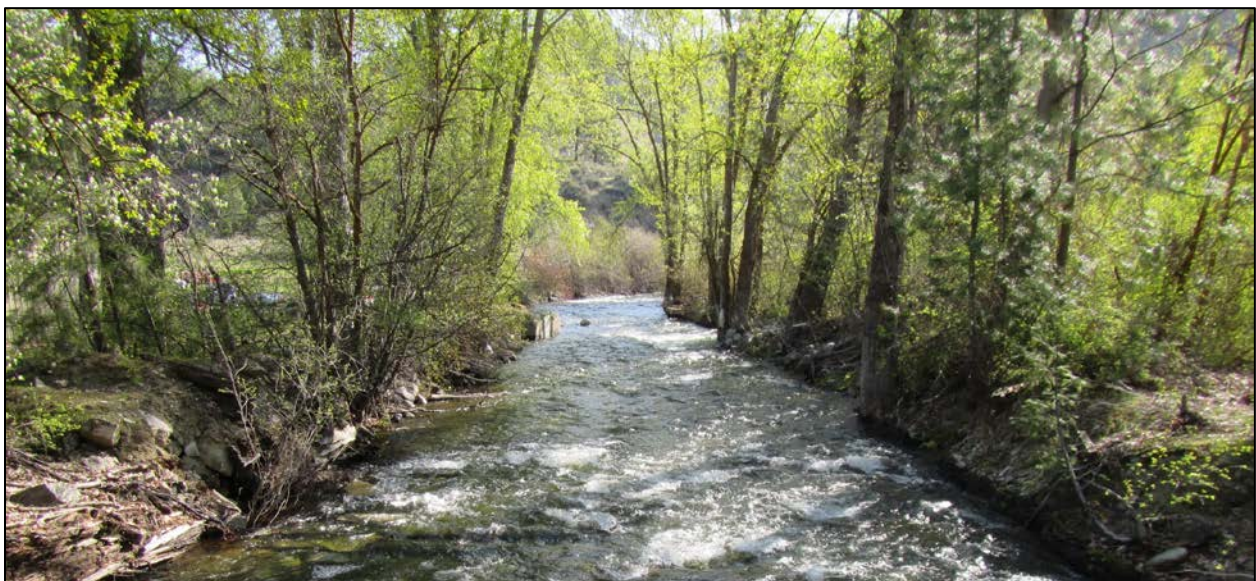
Figure 21. Riparian vegetation strip at RM 0.3. (Photo: IFI 4/25/2018)

The lack of mature or large trees (21-32-inch dbh), narrowness of the vegetated riparian zone, and lack of lateral channel process limits local source and recruitment potential of large woody materials (LWM) into the channel. A total of only 11 pieces of wood and no log jams were observed in the channel during the survey (10/24/2017). All 11 pieces were in the small size class (9 to 12-inch dbh). No quality large woody material (>12-inch dbh and at least 35 feet long) were observed in the channel (Figure 21). Due to the small size and scarcity of large wood material (LWM), it plays only a minor temporary role in aquatic habitat and geomorphic complexity in Reach 1. The lack of LWM in Reach 1 is the result of past riparian vegetation removal, lack of mature trees in the riparian corridor, lack of channel migration capacity, and periodic “cleaning” of wood from the channel. Clearing large wood from the channel has been a common practice in places where infrastructure such as bridges or culverts exist.

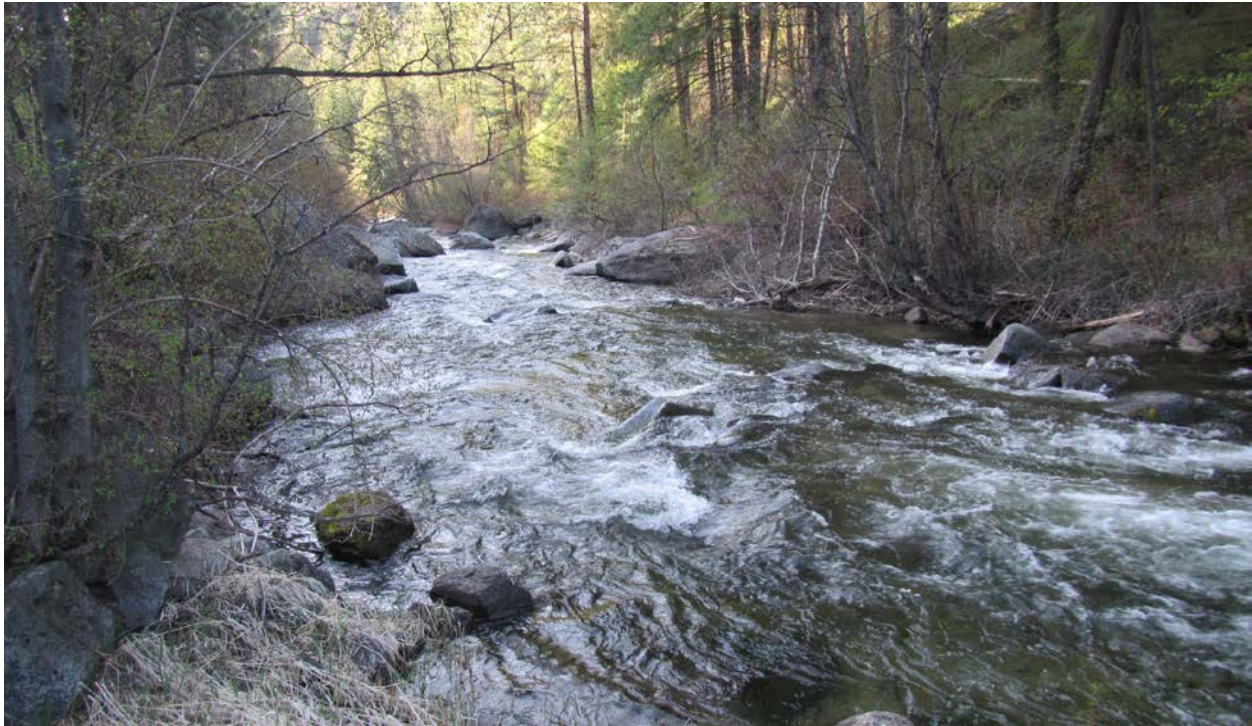
Figure 27. Reach 2 at RM 1.48, a hillslope and road confined section - looking downstream. (Photo: IFI, 4/25/2018)

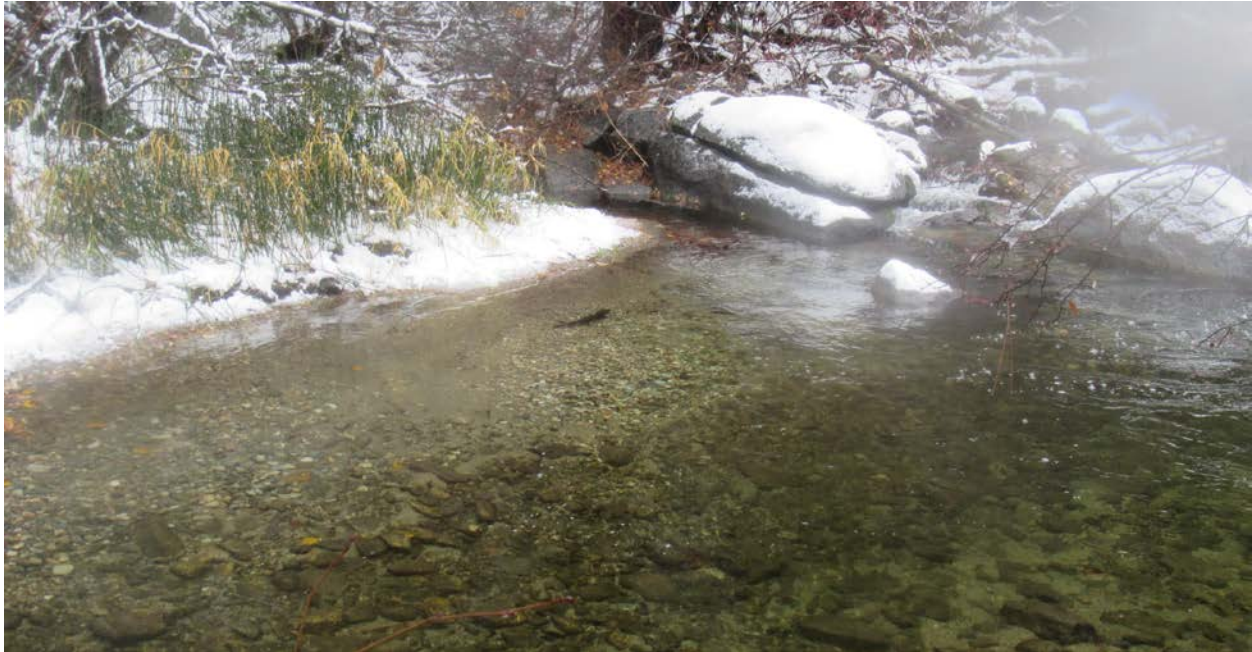
Figure 29. Spawning gravel accumulation at edge of pool behind boulders (with spawning fish) at RM 1.45. (Photo: IFI 11/9/2017)

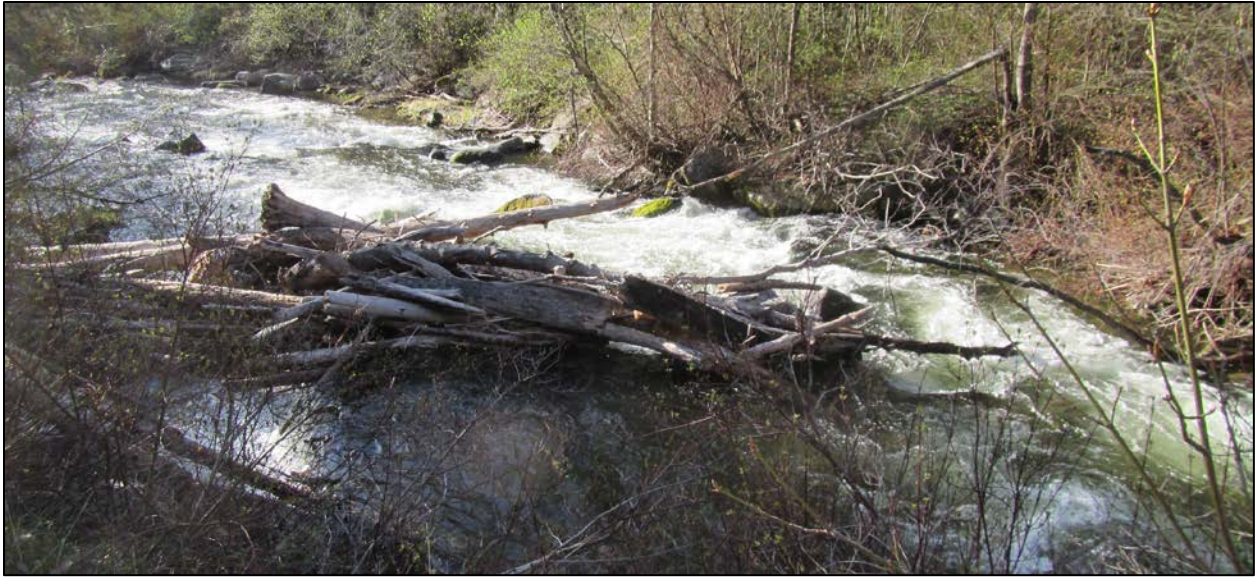
Only one log jam was observed and it contained just one large piece of wood and 9 small pieces (Figure 31). This indicates that Reach 2 is lacking in in-stream quality Large Woody Material (LWM) and riparian recruitment potential. As a result, LWM currently plays only a minor role in localized aquatic habitat and geomorphic complexity. Where it does exist, channel complexity is improved. The lack of LWM and jams in Reach 2 today is likely the result of past riparian vegetation removal for the construction of the Mad River Road and periodic “cleaning” of wood from the channel. Clearing LWM from the channel has been a common practice in places where infrastructure such as roads and bridges exist.

Figure 32. Large wood jam at RM 1.19 in Reach 2. (Photo: IFI, 4/25/2018)

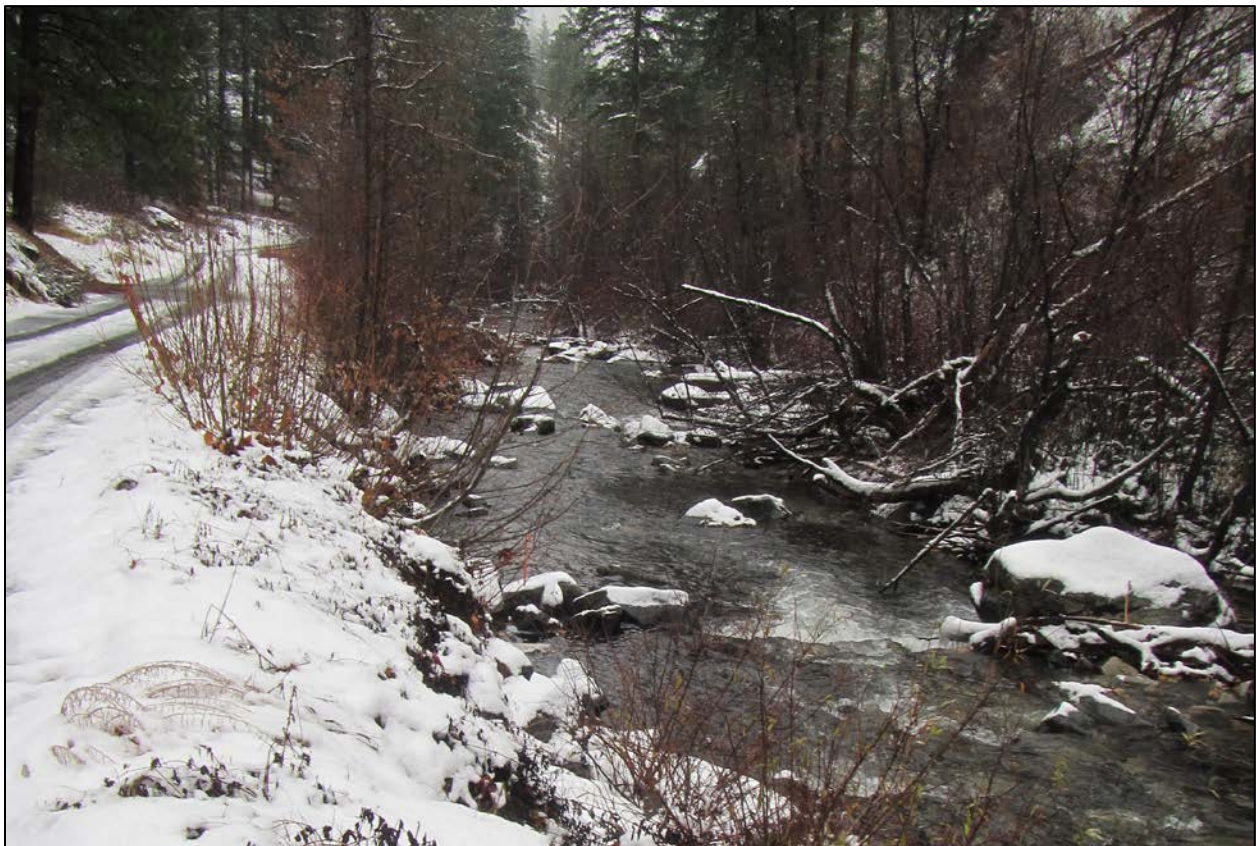
Figure 37. Mad River confined by hillslope and road at RM 2.45. (Photo: IFI 11/9/2017)

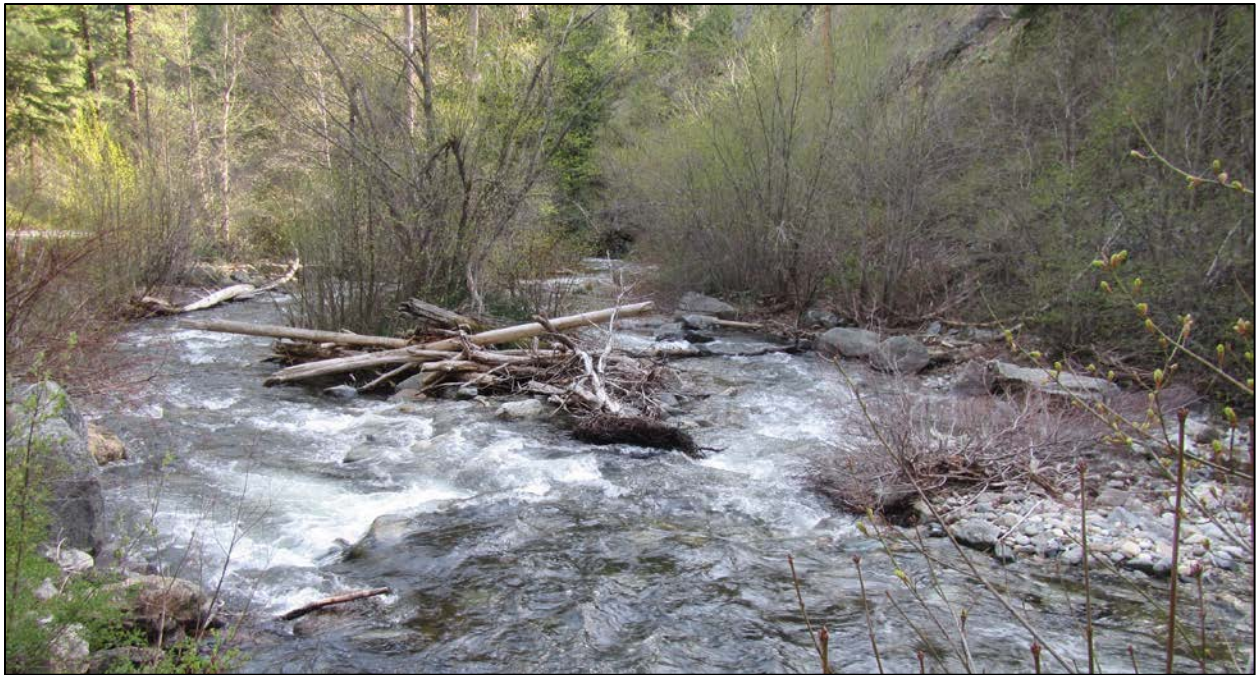
Figure 38. Mad River at RM 2.95 - split flow at wood accumulation. (Photo: IFI 4/24/2018)

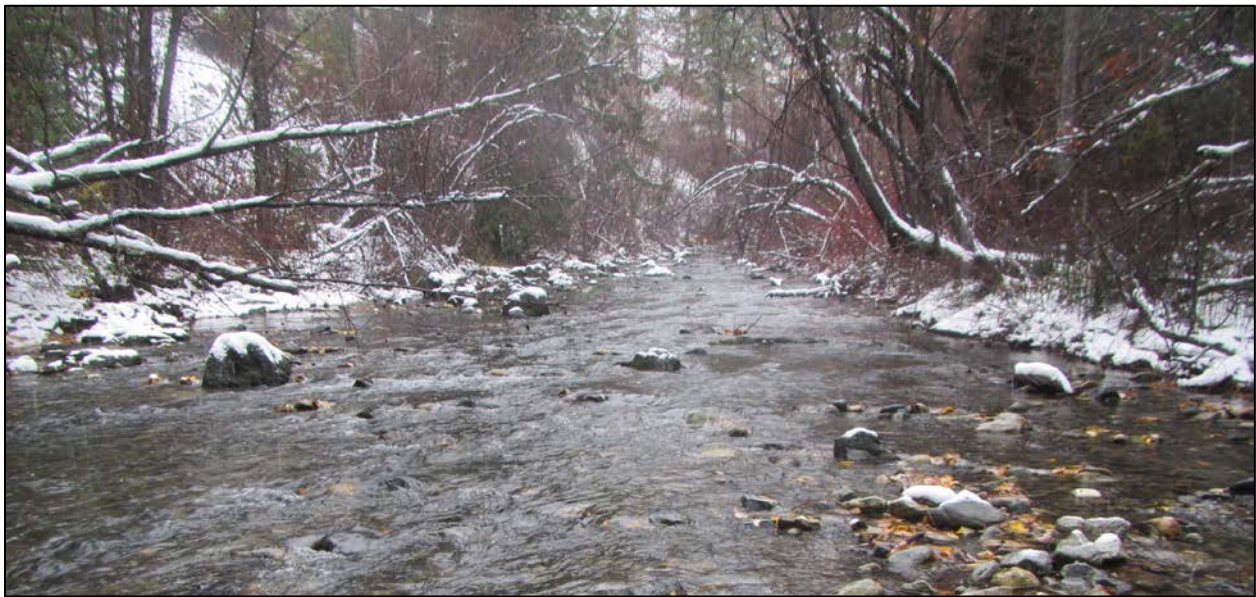
Figure 40. Extended riffle (~800 feet long), photo looking upstream at RM 2.75. (Photo: IFI 11/9/2017)

Channel complexity in Reach 3 is impaired. The 2017 Habitat Assessment (see Appendix ???) measured 82% of the channel as extended riffles while only 1% is pool habitat, 17% is glides, and 1% is side channels. The pools occur where boulders create a grade control or scour. The bed of the channel is dominated by coarse alluvium (cobble and small boulders). Only small pockets of coarse sand and gravel were observed in eddies and pools behind boulders and/or wood accumulations.

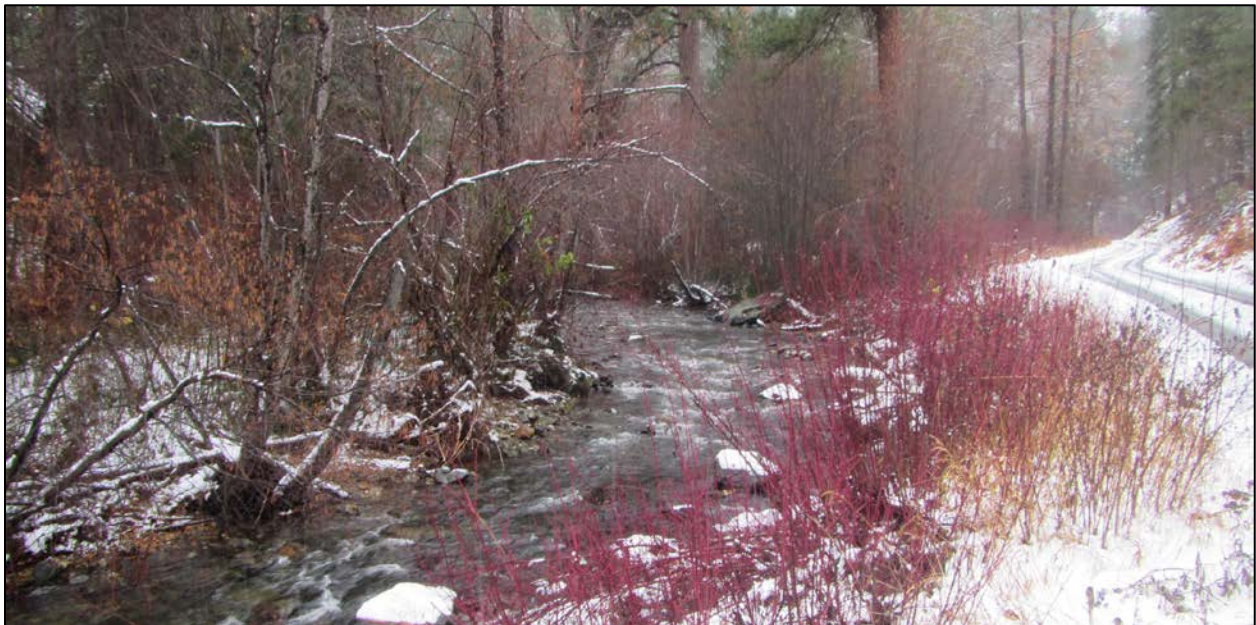
Figure 46. Mad River Road occupying valley floor and the associated impaired riprapped channel bank. (Photo: IFI 4/9/2017)

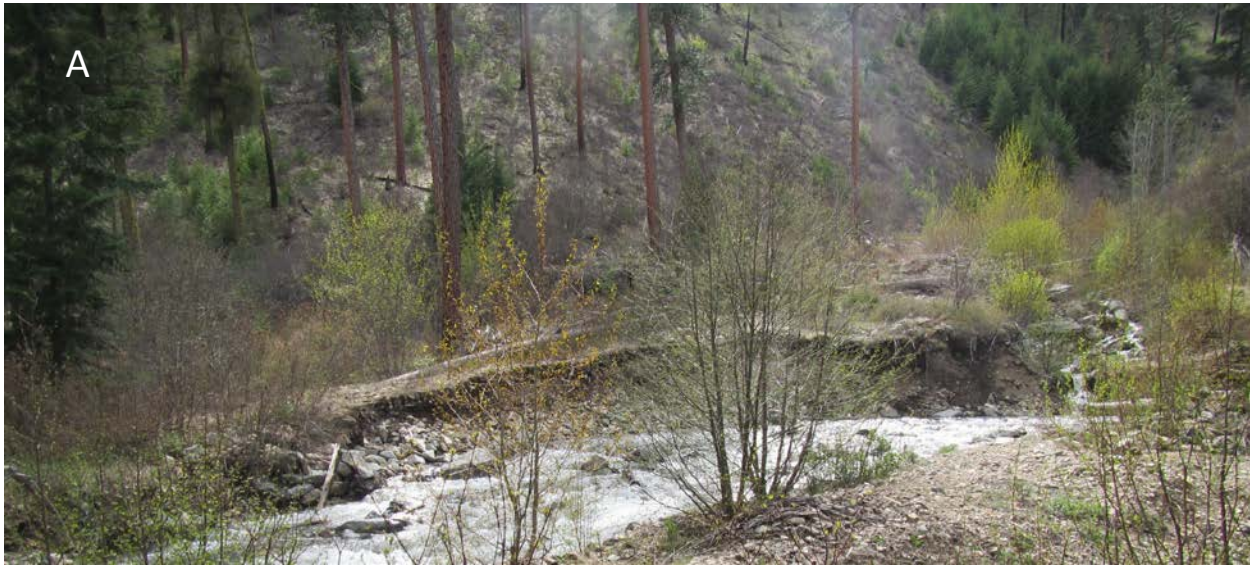
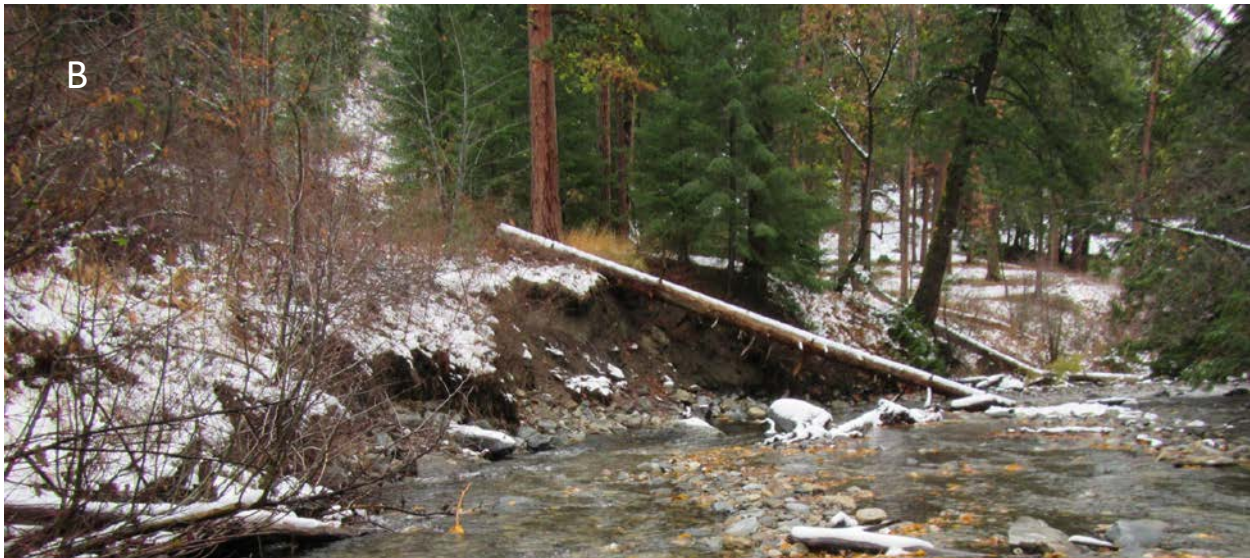
Figure 50. Sediment sources: A) debris fan on river right at RM 4.27, B) terrace & fan bank on river left at RM 4.07. (Photos: IFI 11/10/2017)

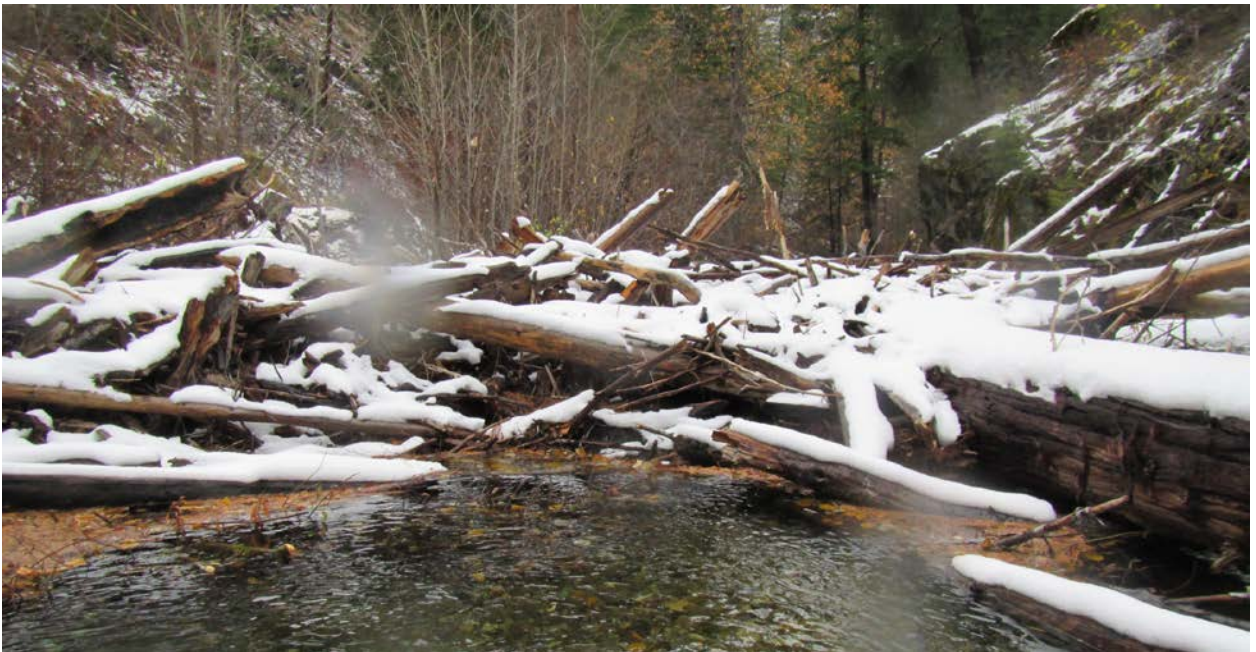
Figure 52. Channel-spanning LWM jam at RM 3.18 (Photo: Inter-Fluve, November 2017)

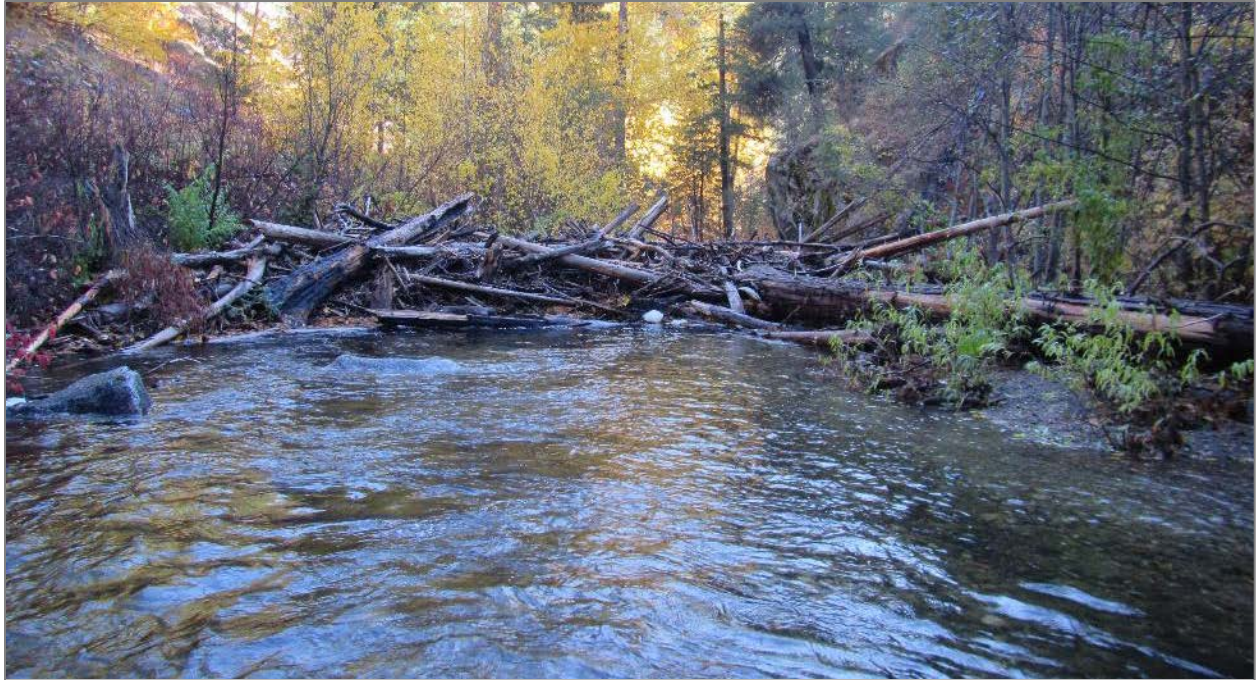
Figure 10. Looking downstream at a channel-spanning log jam that may act as a barrier for certain species or life stages at some flows.

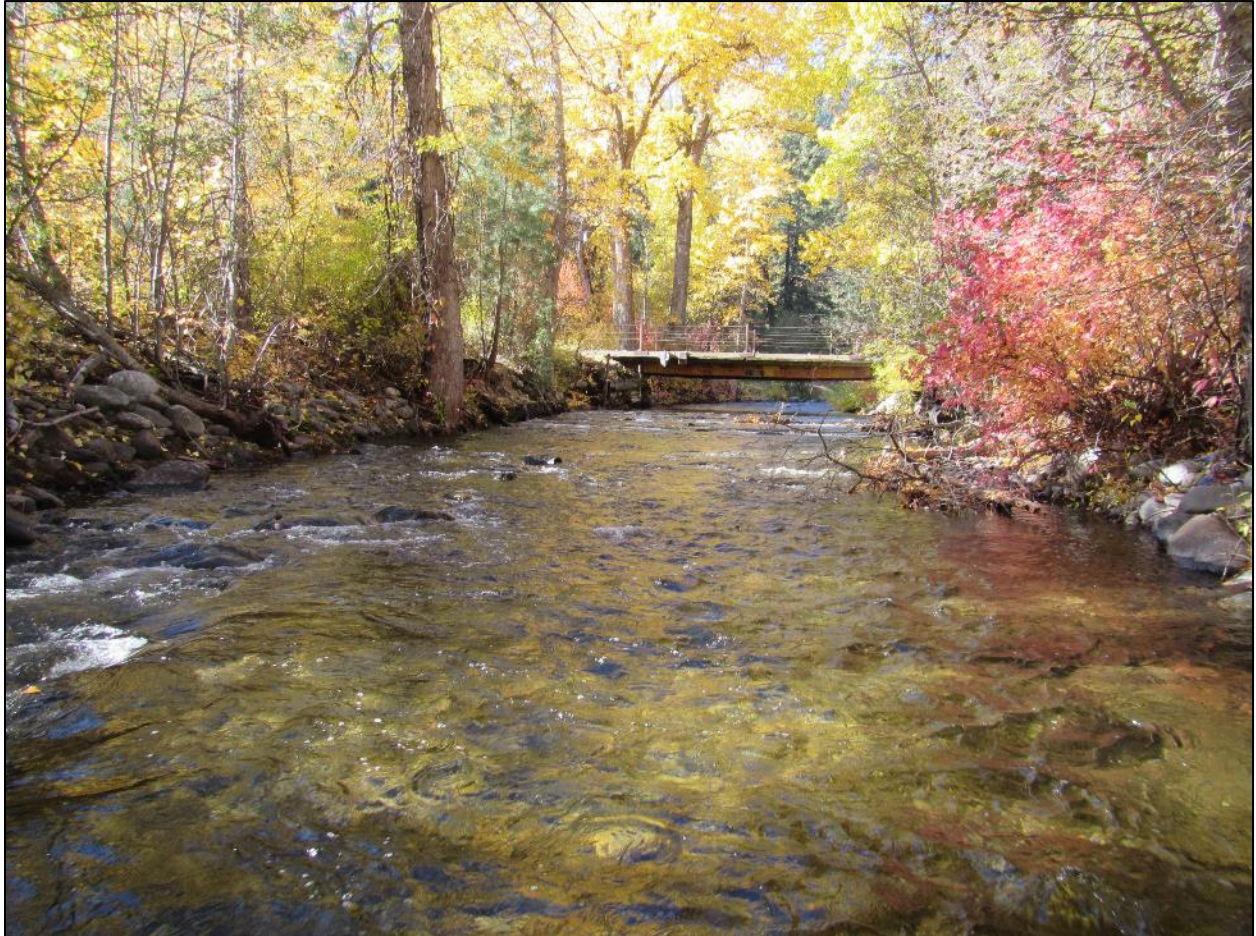
Figure 15. Representative view of Reach 1. Human disturbance within the channel and riparian area are most frequent in this reach. (Photo: IFI staff – 10/24/2017)

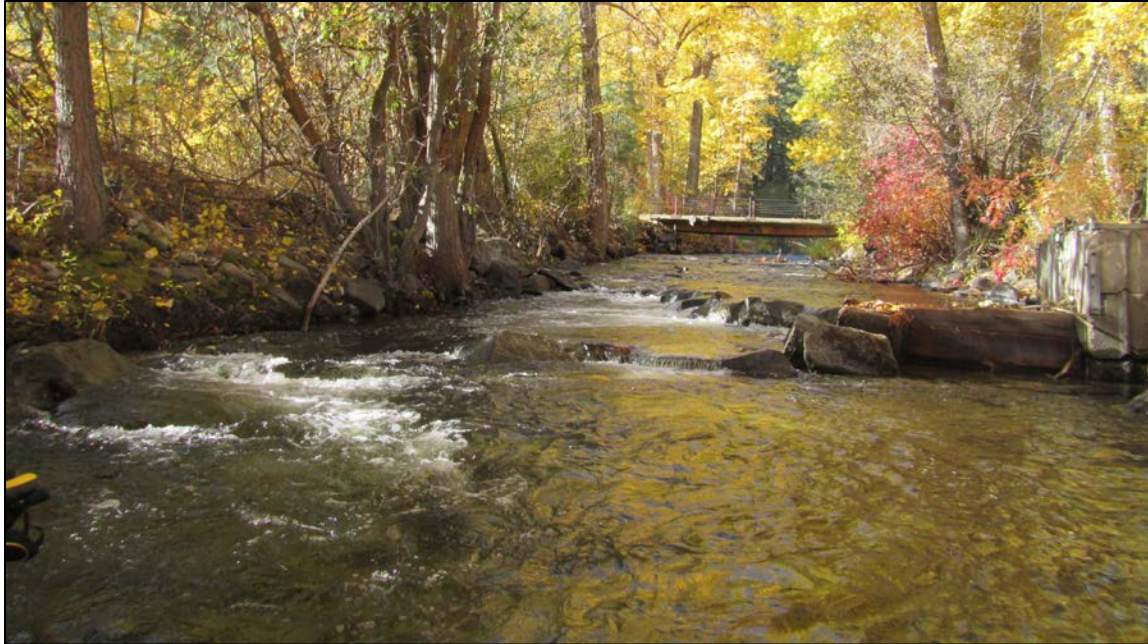
Figure 18. Pools occur in Reach 1 where large boulders added to the channel result in downstream scour. (Photo: IFI staff – 10/24/2017)

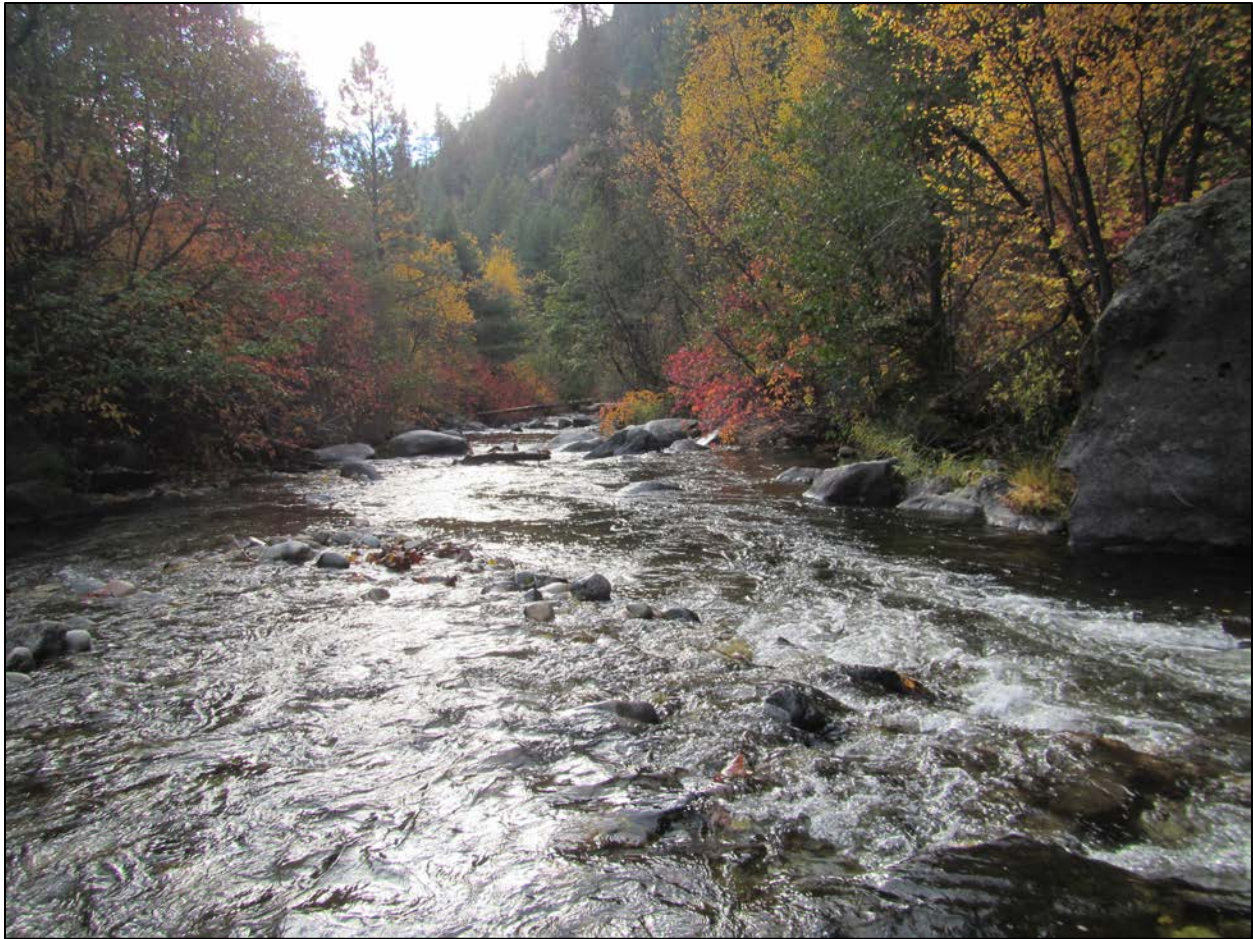
Figure 23. Representative view of Reach 2. The reach has long riffle/cascades with large boulders present in the channel. (Photo: IFI staff – 10/25/2017)
