**Final Report**

# **NDE Detectability of Fatigue Type Cracks in High-Strength Alloys**

6. Performing Organization Code 3	
7. Author(s) Brent K. Christner, Ward D. Rummel				8. Performing Organization Report No. MCR-83-568	
9. Performing Organization Name and Address Martin Marietta Corporation Denver Aerospace, P.O. Box 179 Denver, Colorado 80201				10. Work Unit No. NASA-MSFC

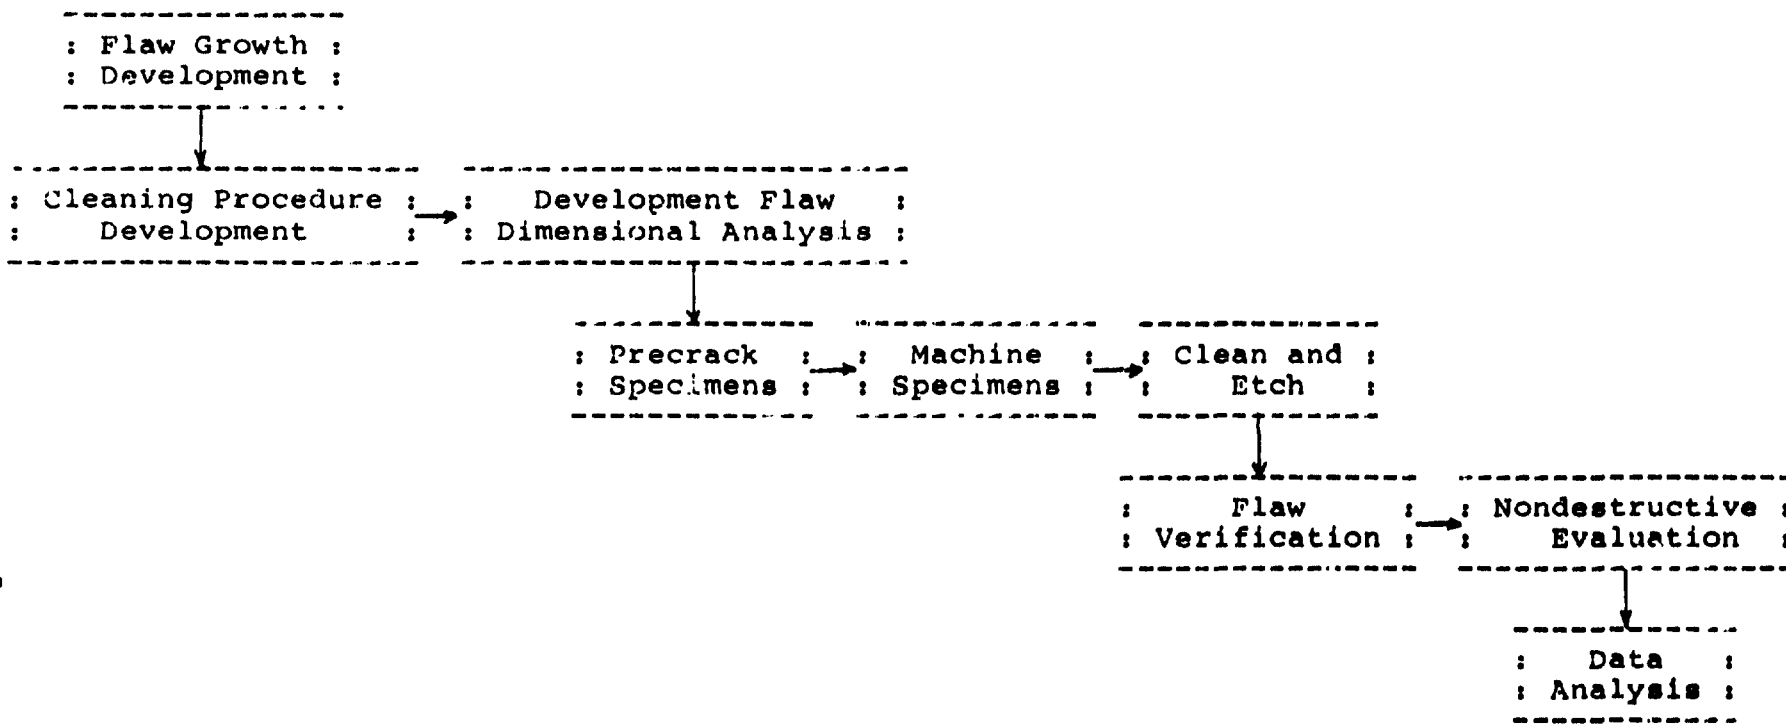
The sequence of the performance of these tasks is shown in Figure 1.

Each program task repeated for the Inconel 718 and Haynes 188 programs except as noted below.

1. Flaw growth process development and validation.
2. Specimen cleaning procedure development and validation.
3. Test specimen preparation.
4. NDE validation of test specimens and documentation.
5. NDE reliability assessment using test specimens.
6. Data analysis and final reporting.

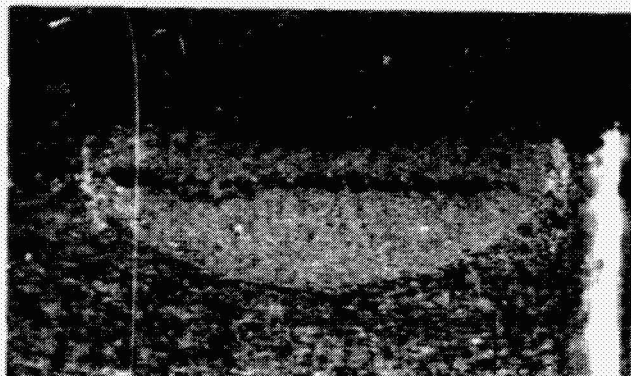
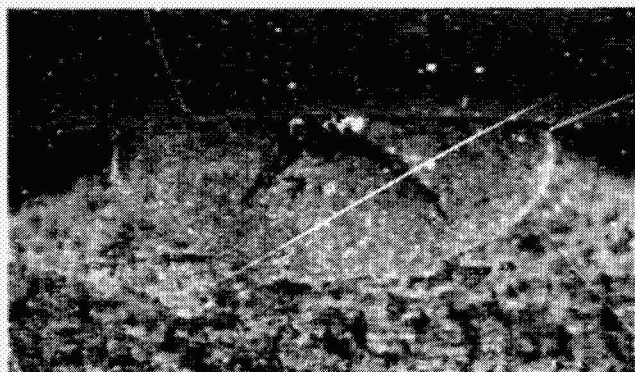
Figure 2 - Side View of Crack Starter Notch Shape and  
Final Crack Configuration for Inconel 718  
Case A and Case B Flaws

$a/2c = 0.34$  (Before Machining)

INCONEL 718 - CASE A FLAW

Development Flaw # 1TB/5

Flaw Depth - 0.086"

$a/2c = 0.37$  (Before Machining)

INCONEL 718 - CASE B FLAW

Development Flaw # 1TA/5

In both alloys, two different starter notch configurations were used to produce flaws with varying aspect ratios. Bending fatigue, as applied to the panels in this program, produces a ratio of rate of crack depth growth to crack length growth of approximately 0.3. The aspect ratio of the finished crack (before machining to remove the starter notch) can be altered from 0.3 by the shape of the starter notch. The aspect ratio can be increased above 0.3 to a maximum of approximately 0.5 by using a very short, deep starter notch. Cracks with a final aspect ratio less than 0.3 can be grown by using a long shallow starter notch. Machining to remove the starter notch, reduces the final crack aspect ratios as a function of the depth of material removed. In both the Inconel 718 and Haynes 188 panels, the target aspect ratios (after machining) were 0.15 (Case A) and 0.25 (Case B). To obtain the shorter crack lengths, cracks proportionately longer than the desired length were grown and machined to near the bottom of the crack. As a consequence, the aspect ratios of these cracks tend to drop off due to the flattening of the crack that occurs near the bottom of the flaw. Cross-section macrophotographs of representative development flaws, illustrating the starter notch shapes used for each case and the corresponding crack configurations are shown in Figures 2 and 3.

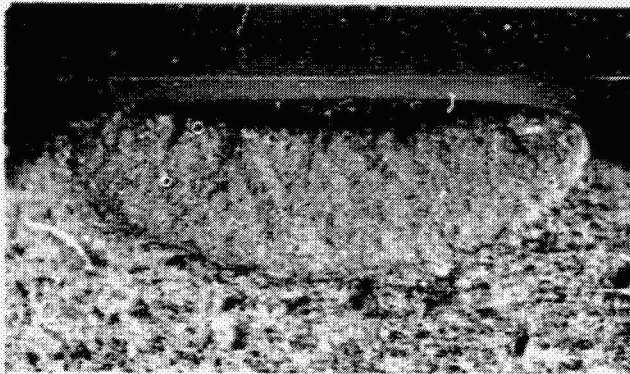
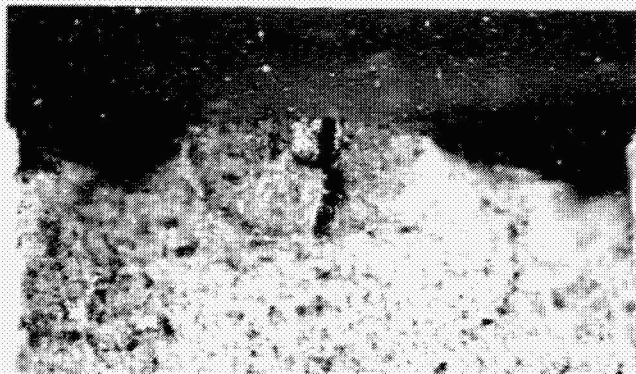
Figure 3 - Side View of Crack Starter Notch Shape and  
Final Crack Configuration for Haynes 188  
Case A and Case B Flaws

$a/2c = 0.33$  (Before Machining)

HAYNES 188 - CASE A FLAW

Development Flaw # GL/1

Flaw Depth - 0.086"

$a/2c = 0.44$  (Before Machining)

HAYNES 188 - CASE B FLAW

Development Flaw # ET/4

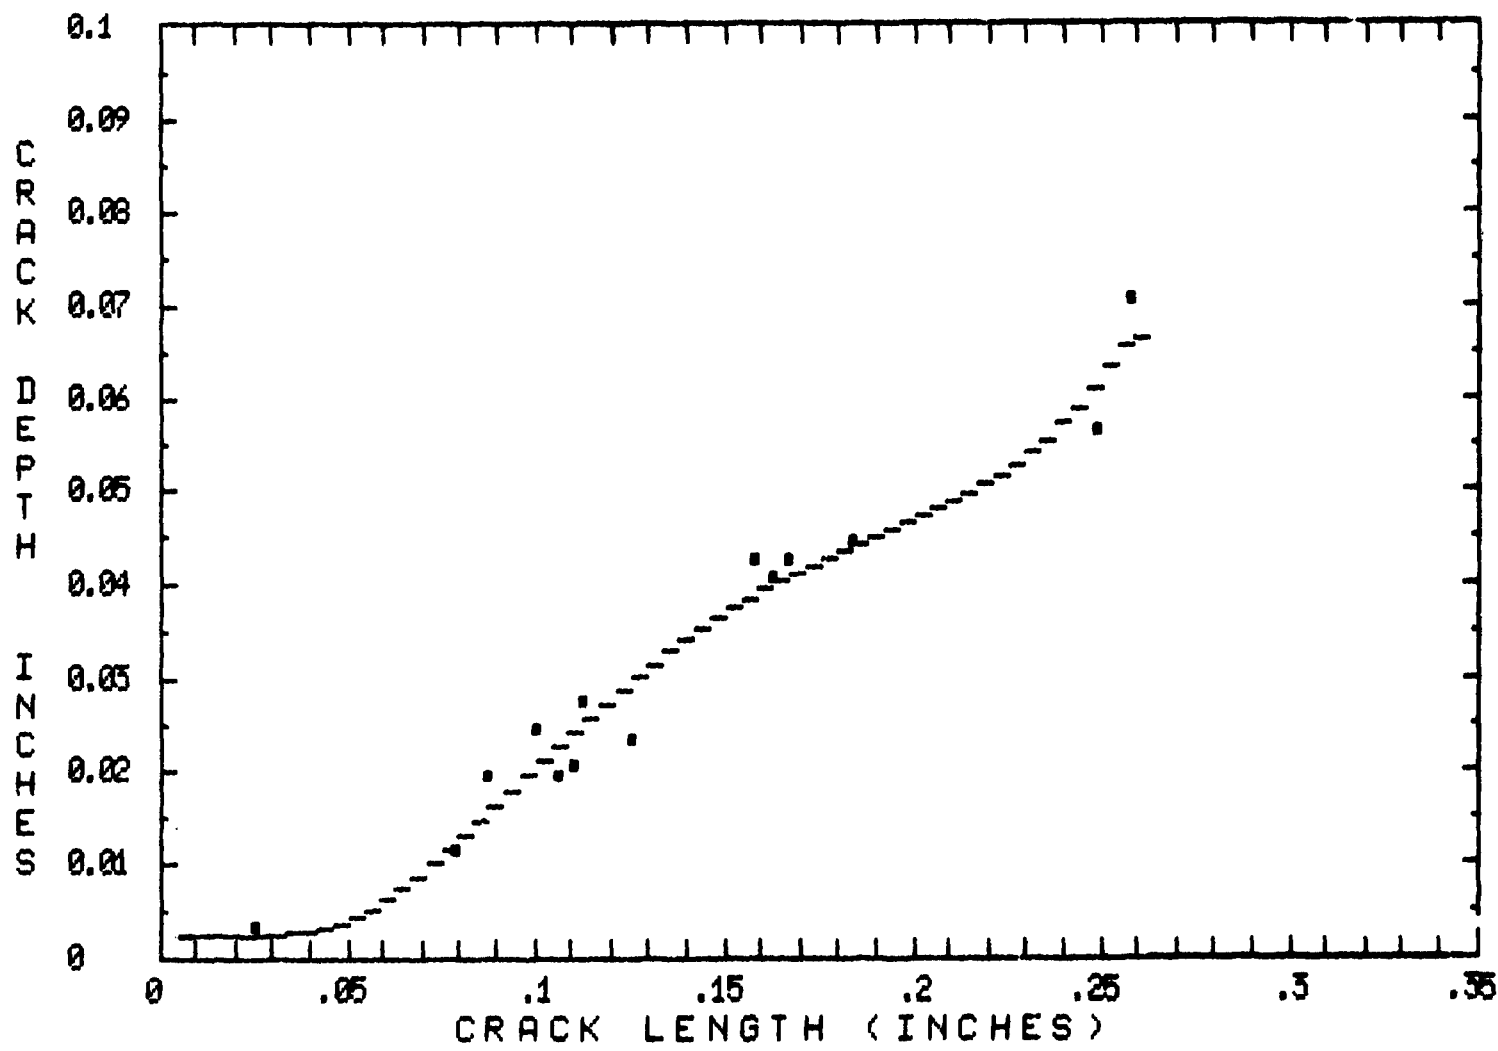
DEVELOPMENT CRACK FINAL DIMENSIONS  
CASE A FLAWS

Figure 4 - Final Dimensions (After Machining) of Inconel 718  
Case A Development Flaws

The equations for the polynomials generated from the analysis of the development flaws were used for predicting crack depths in the reliability test specimens. Figures 4 through 7 show the plots of final crack dimensions made for the development flaws. Tables listing the complete dimensional data for the development cracks for both alloys are included in Appendix A.

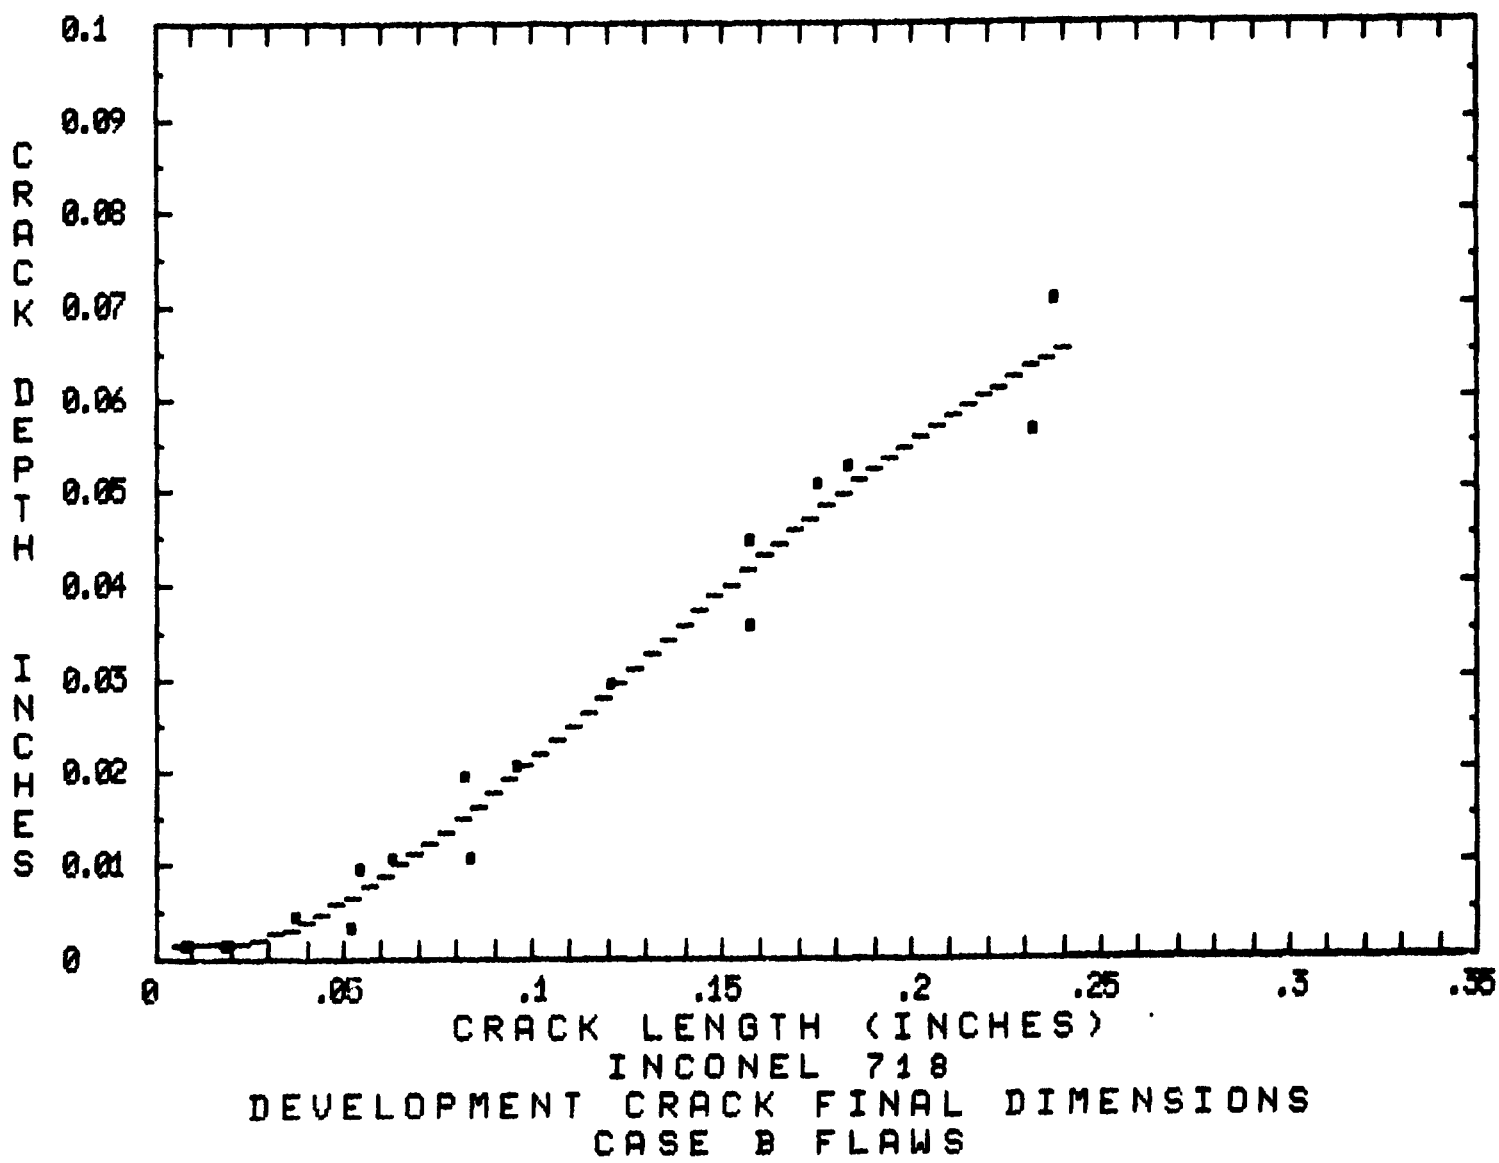
Figure 5 - Final Dimensions (After Machining) of Inconel 718  
Case B Development Flaws

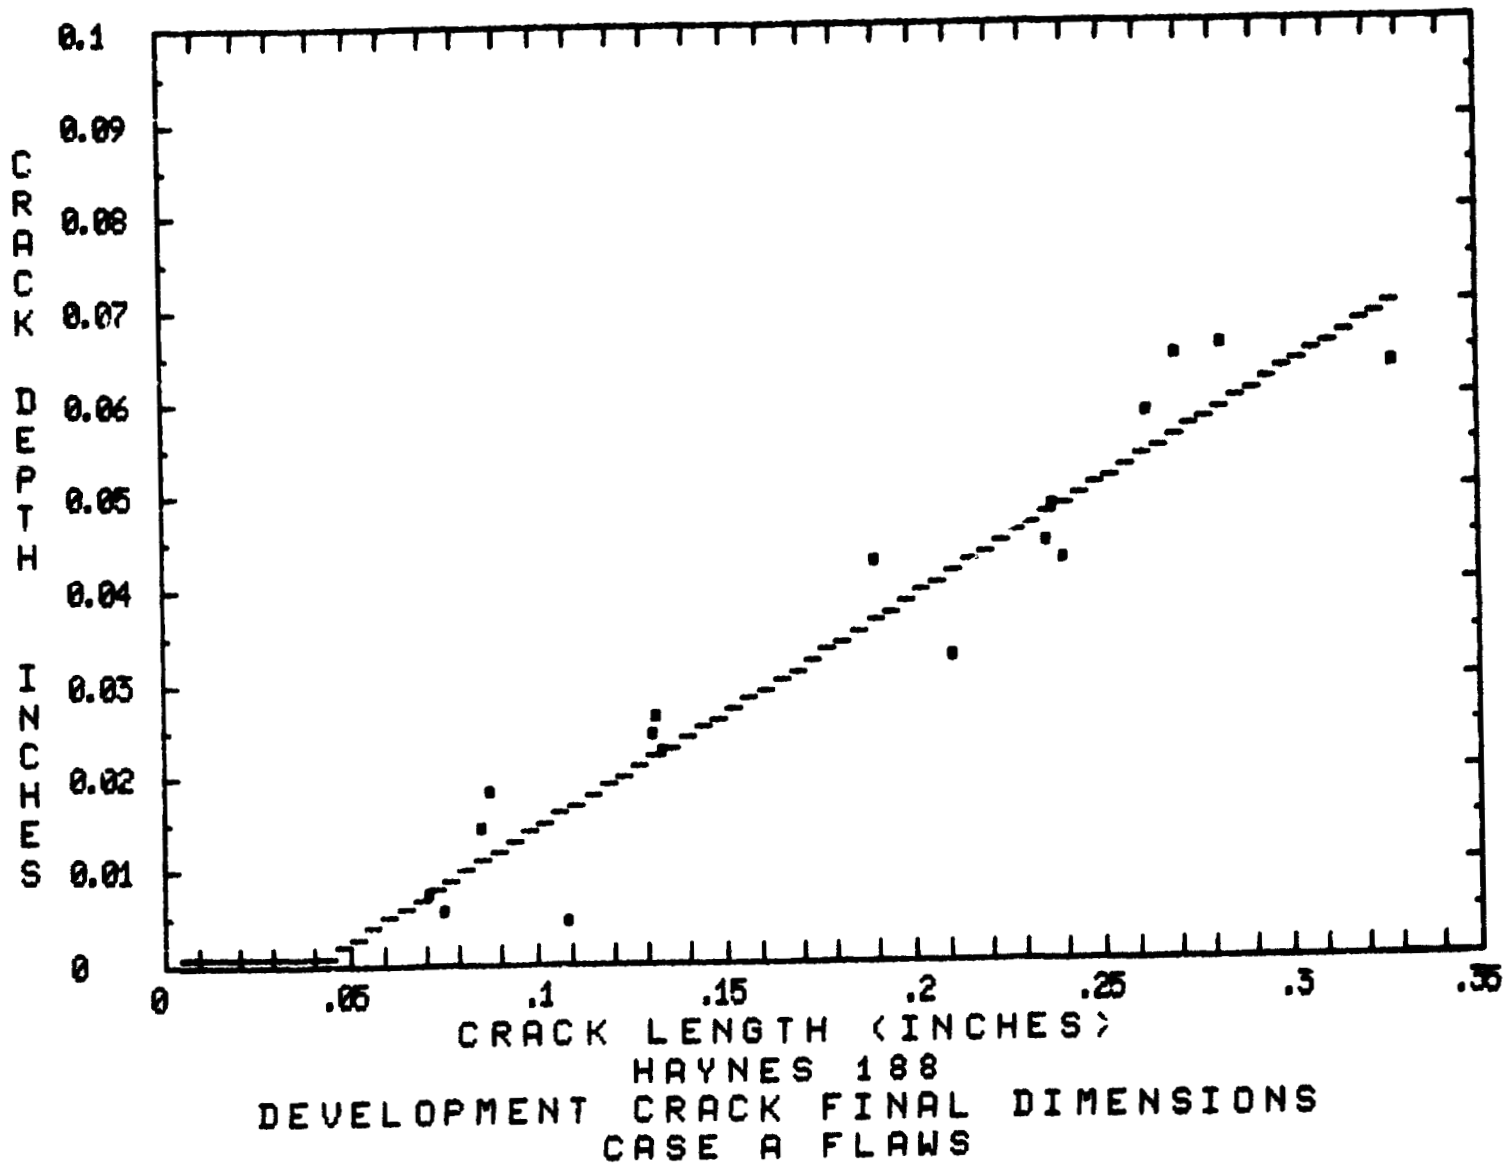
Figure 6 - Final Dimensions (After Machining) of Haynes 188  
Case A Development Flaws

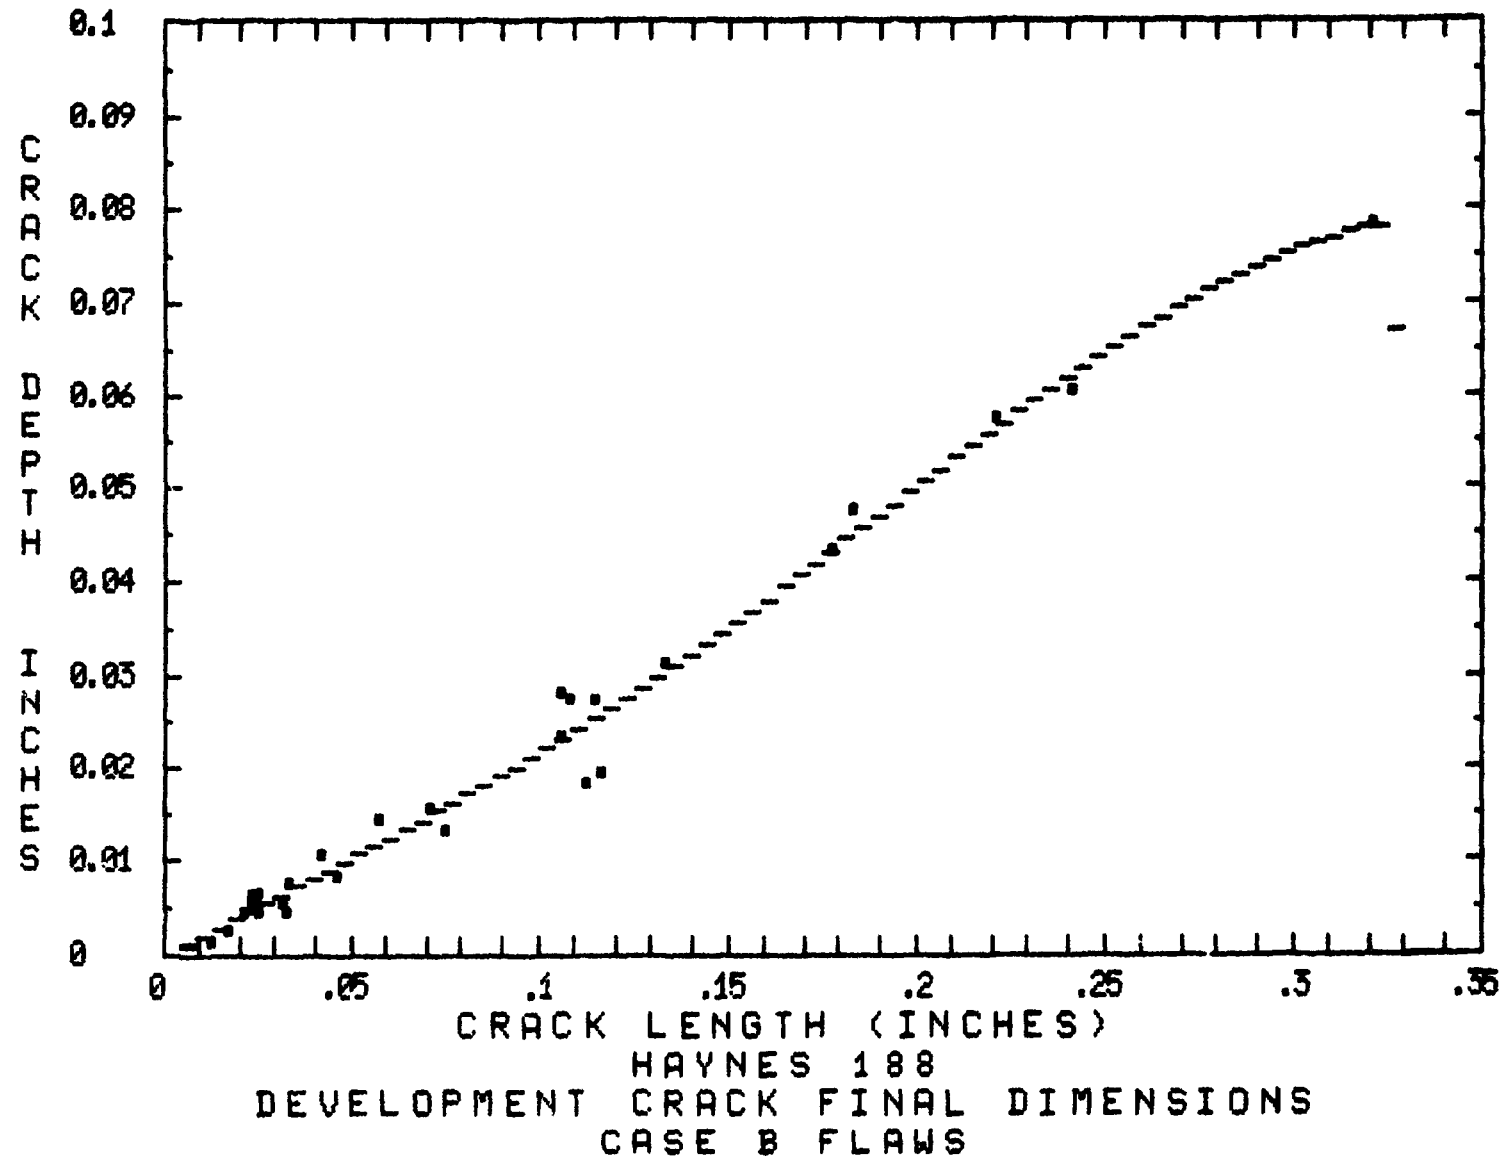
Figure 7 - Final Dimensions (After Machining) of Haynes 188  
Case B Development Flaws

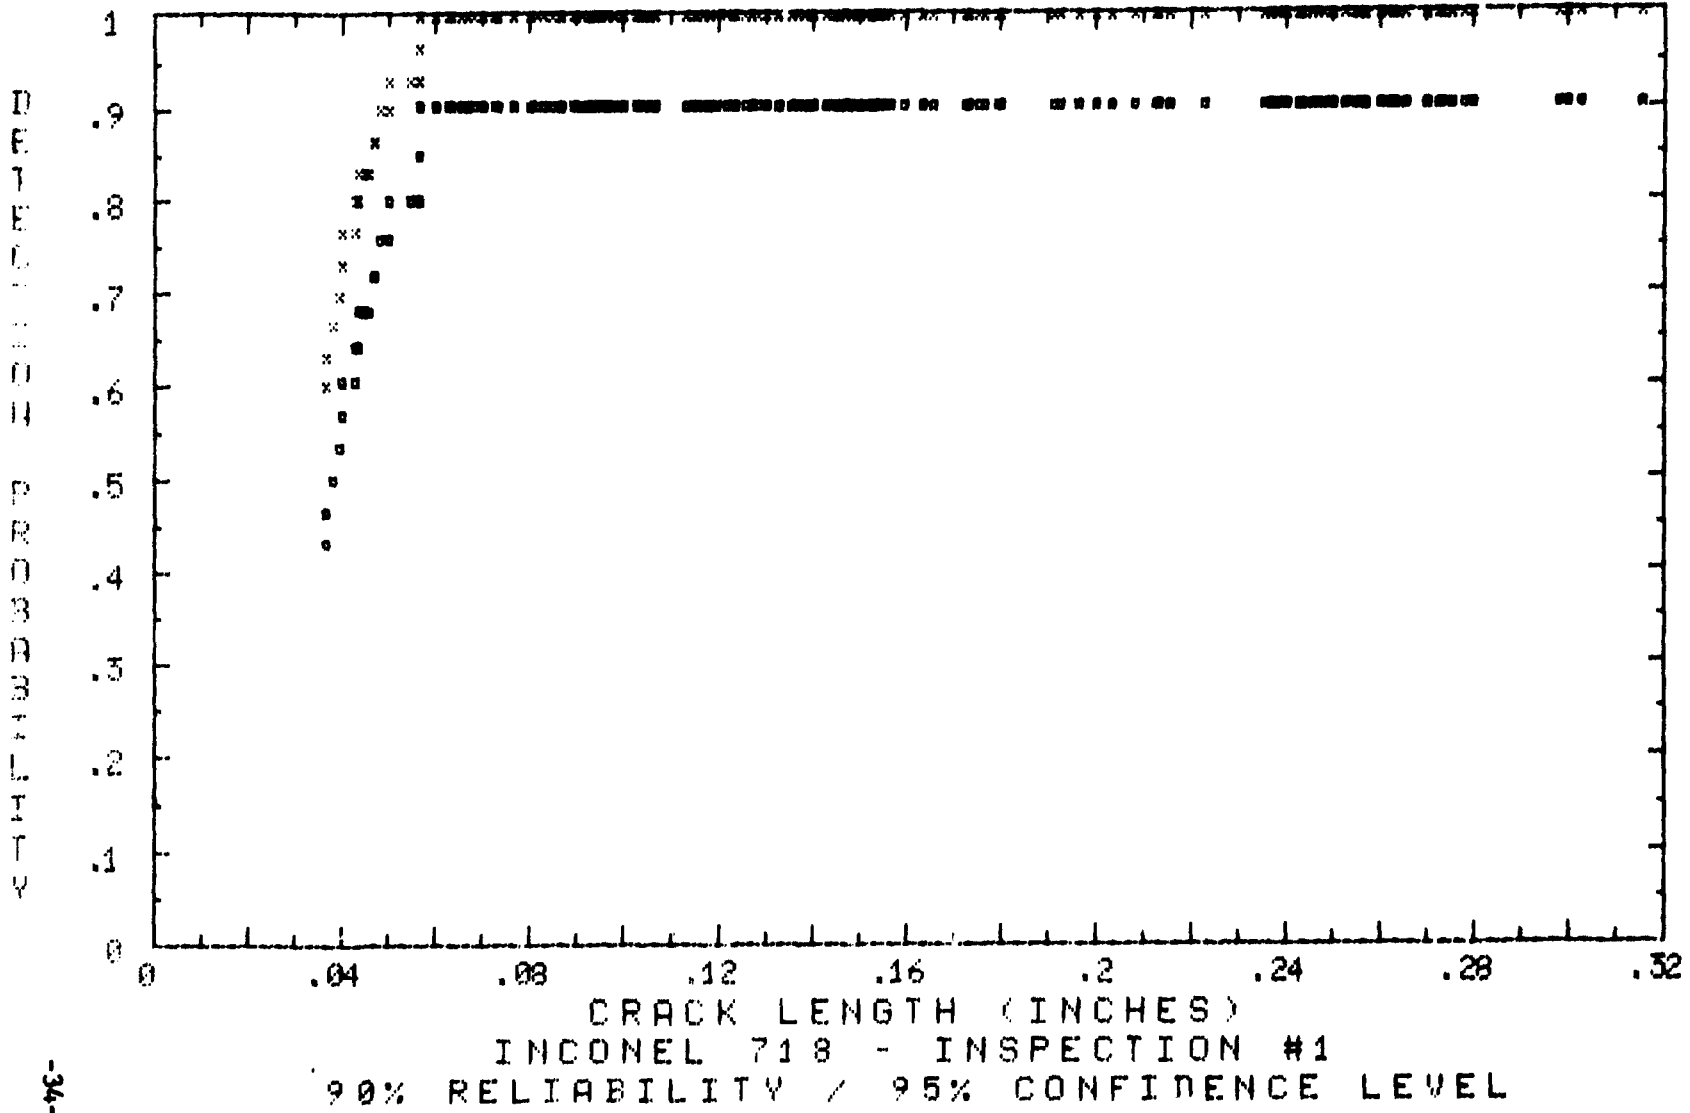
Figure 10 - Crack Detection Probability of Inconel 718 Penetrant Inspection #1.

Plots of detection probabilities for the three Inconel 718 panel inspections and the three Haynes 188 inspections are shown in Figures 10-21. The data has been plotted by both crack length and by estimated crack depth for each inspection.

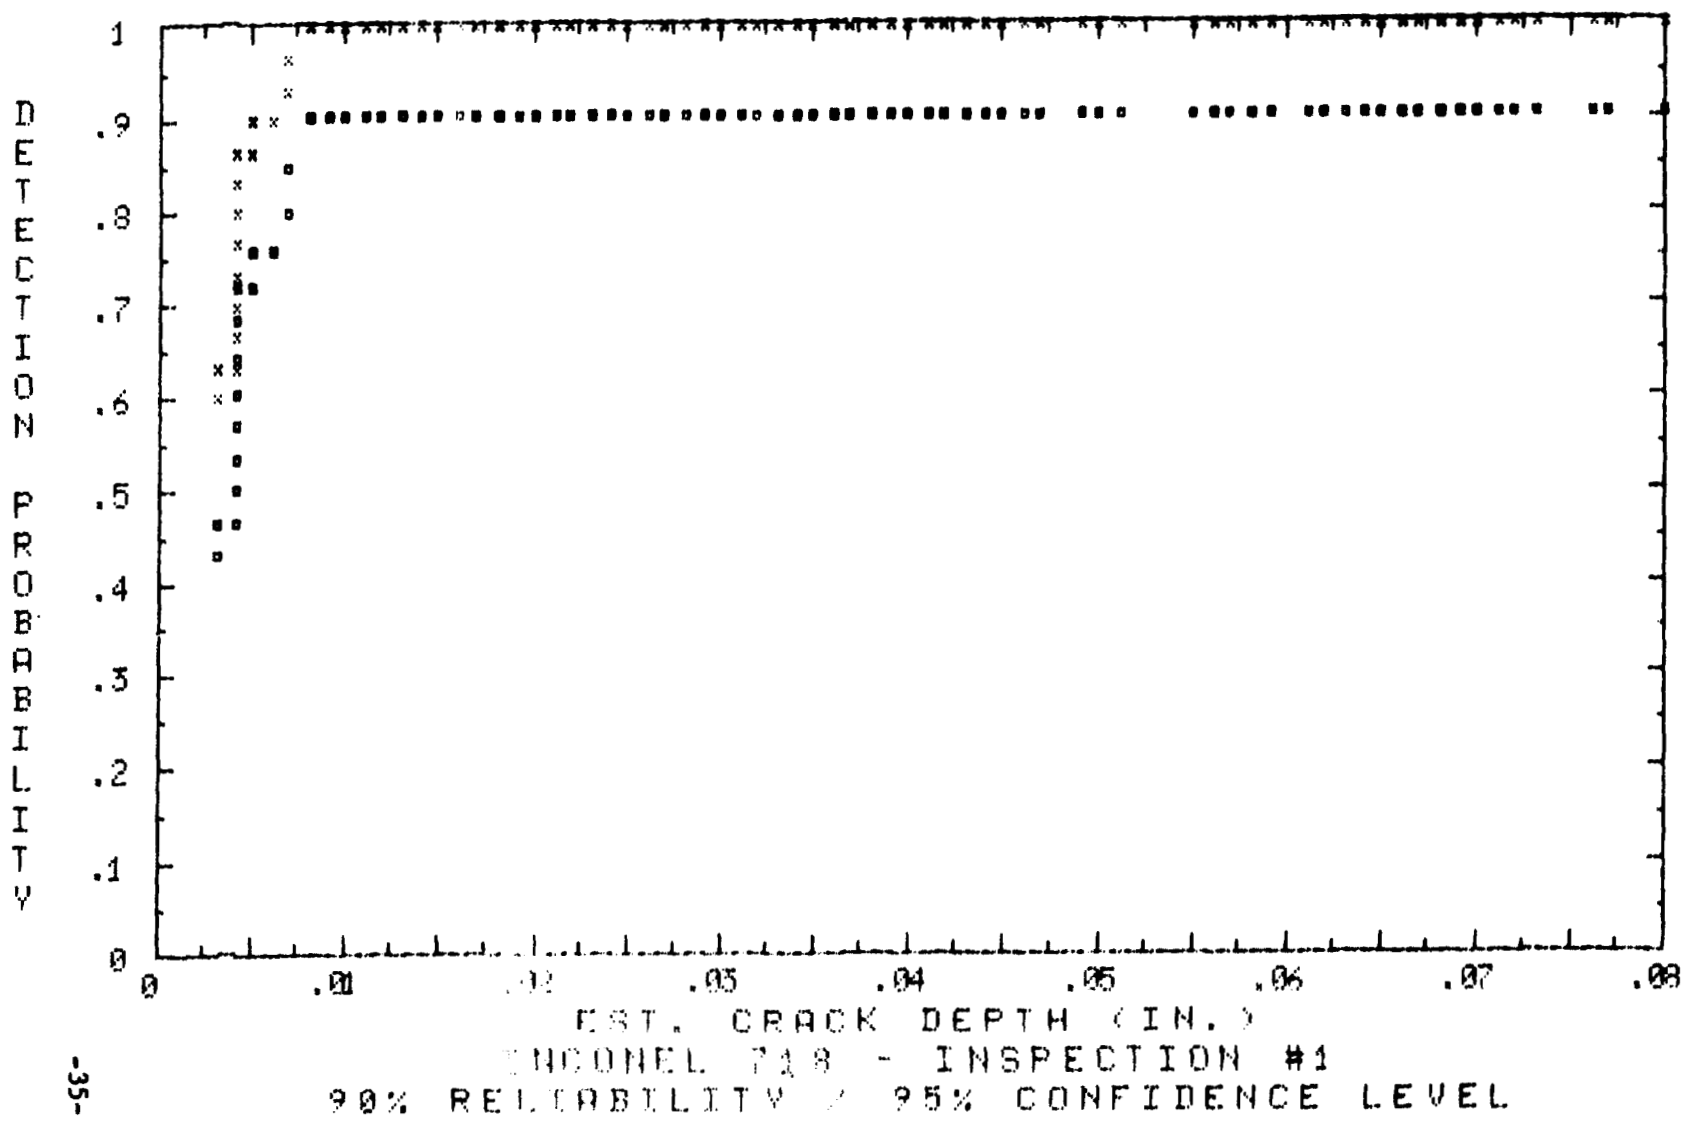
Figure 11 - Crack Detection Probability of Inconel 718 Penetrant Inspection #1.

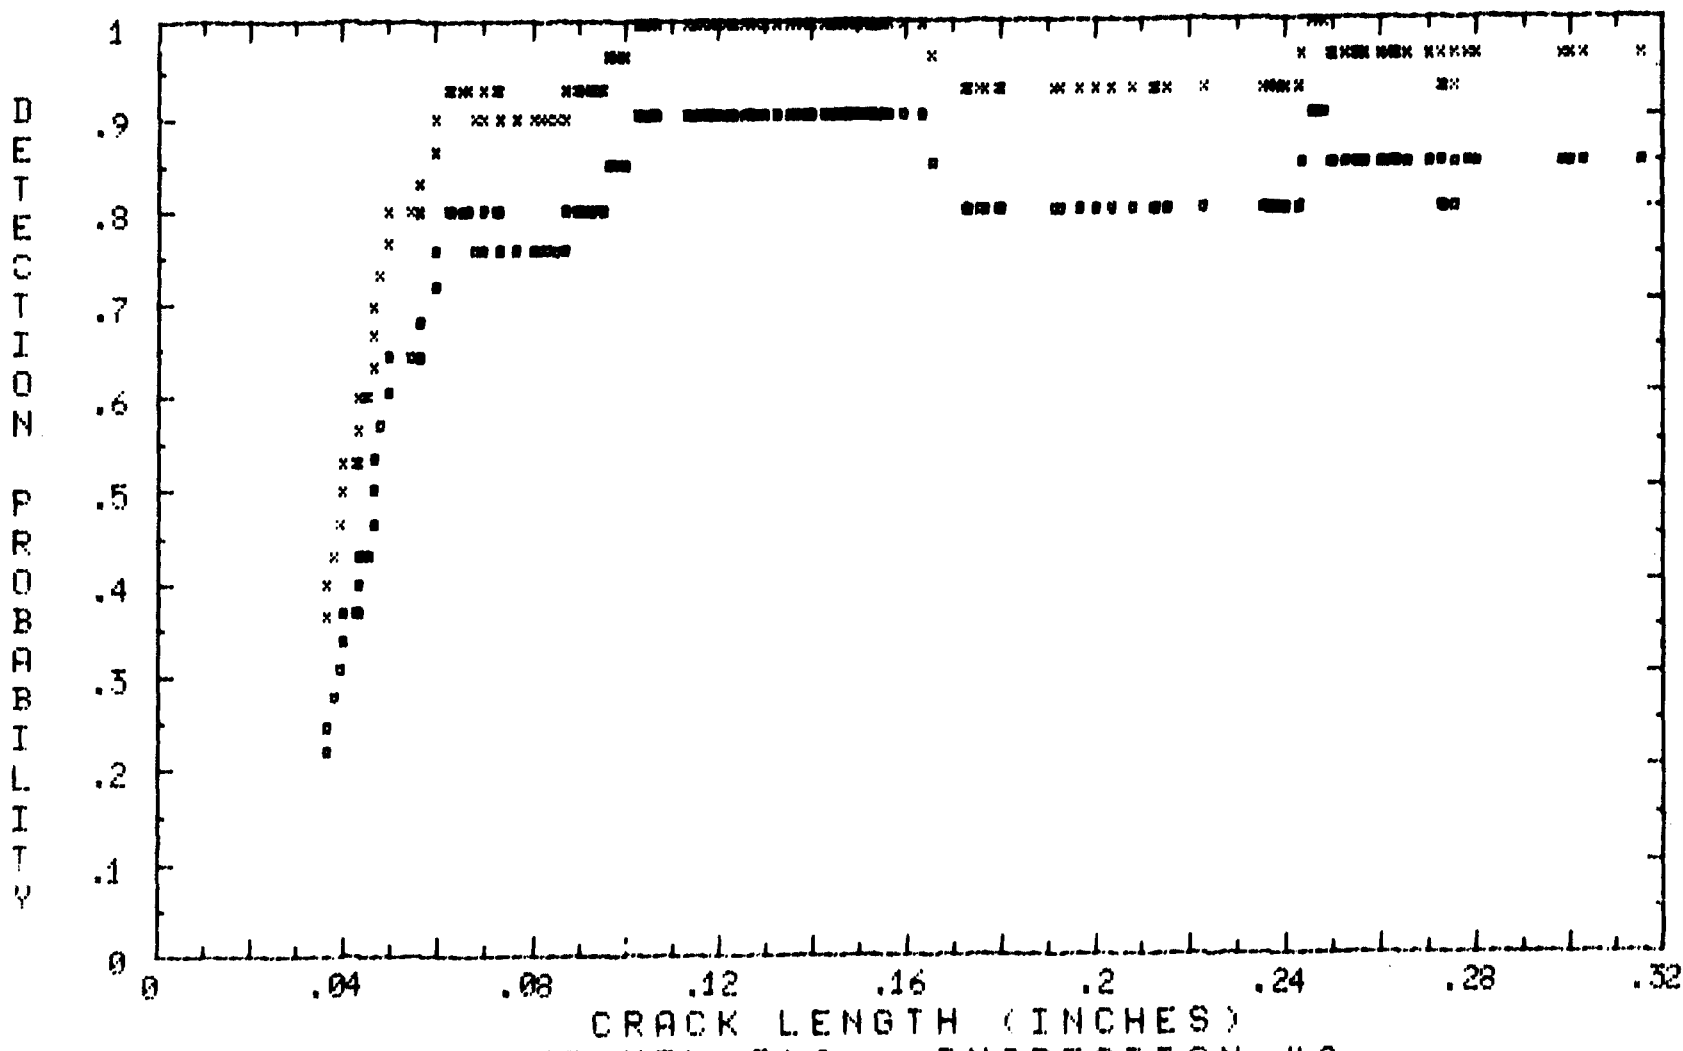
INCONEL 718 - INSPECTION #2  
90% RELIABILITY / 95% CONFIDENCE LEVEL

Figure 12 - Crack Detection Probability of Inconel 718 Penetrant Inspection #2.

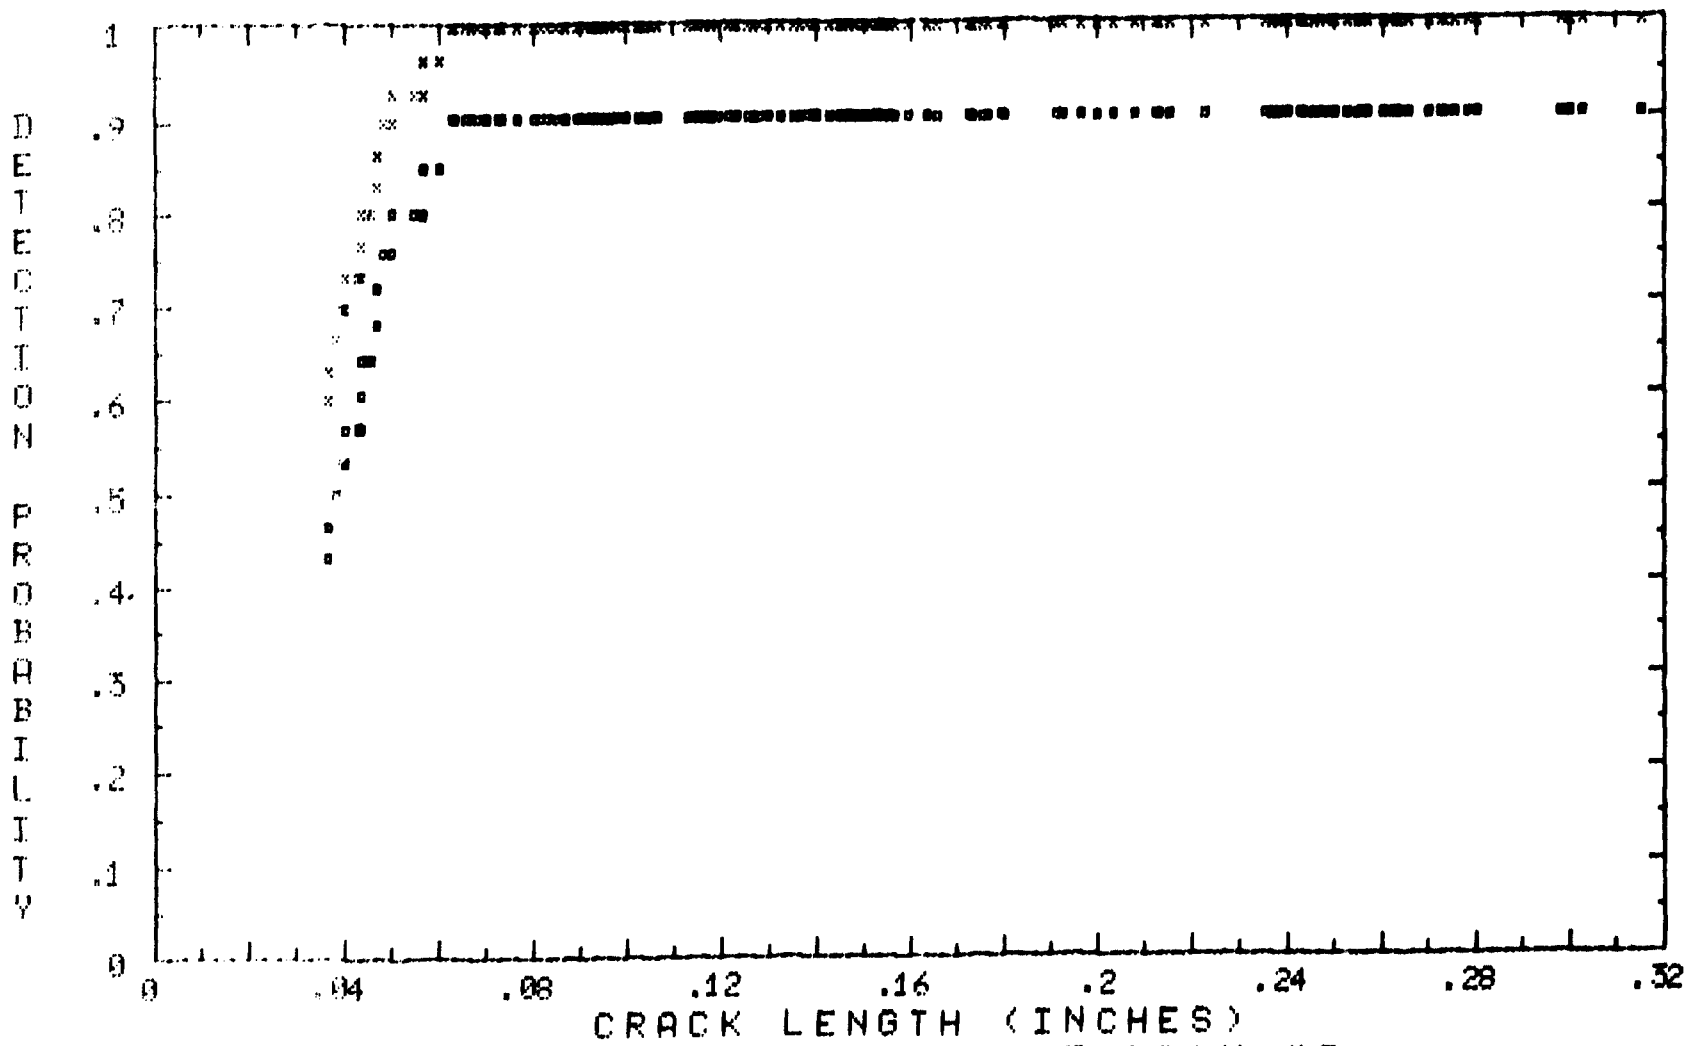
INCONEL 718 - INSPECTION #3

90% RELIABILITY / 95% CONFIDENCE LEVEL

Figure 14 - Crack Detection Probability of Inconel 718 Penetrant Inspection #3.

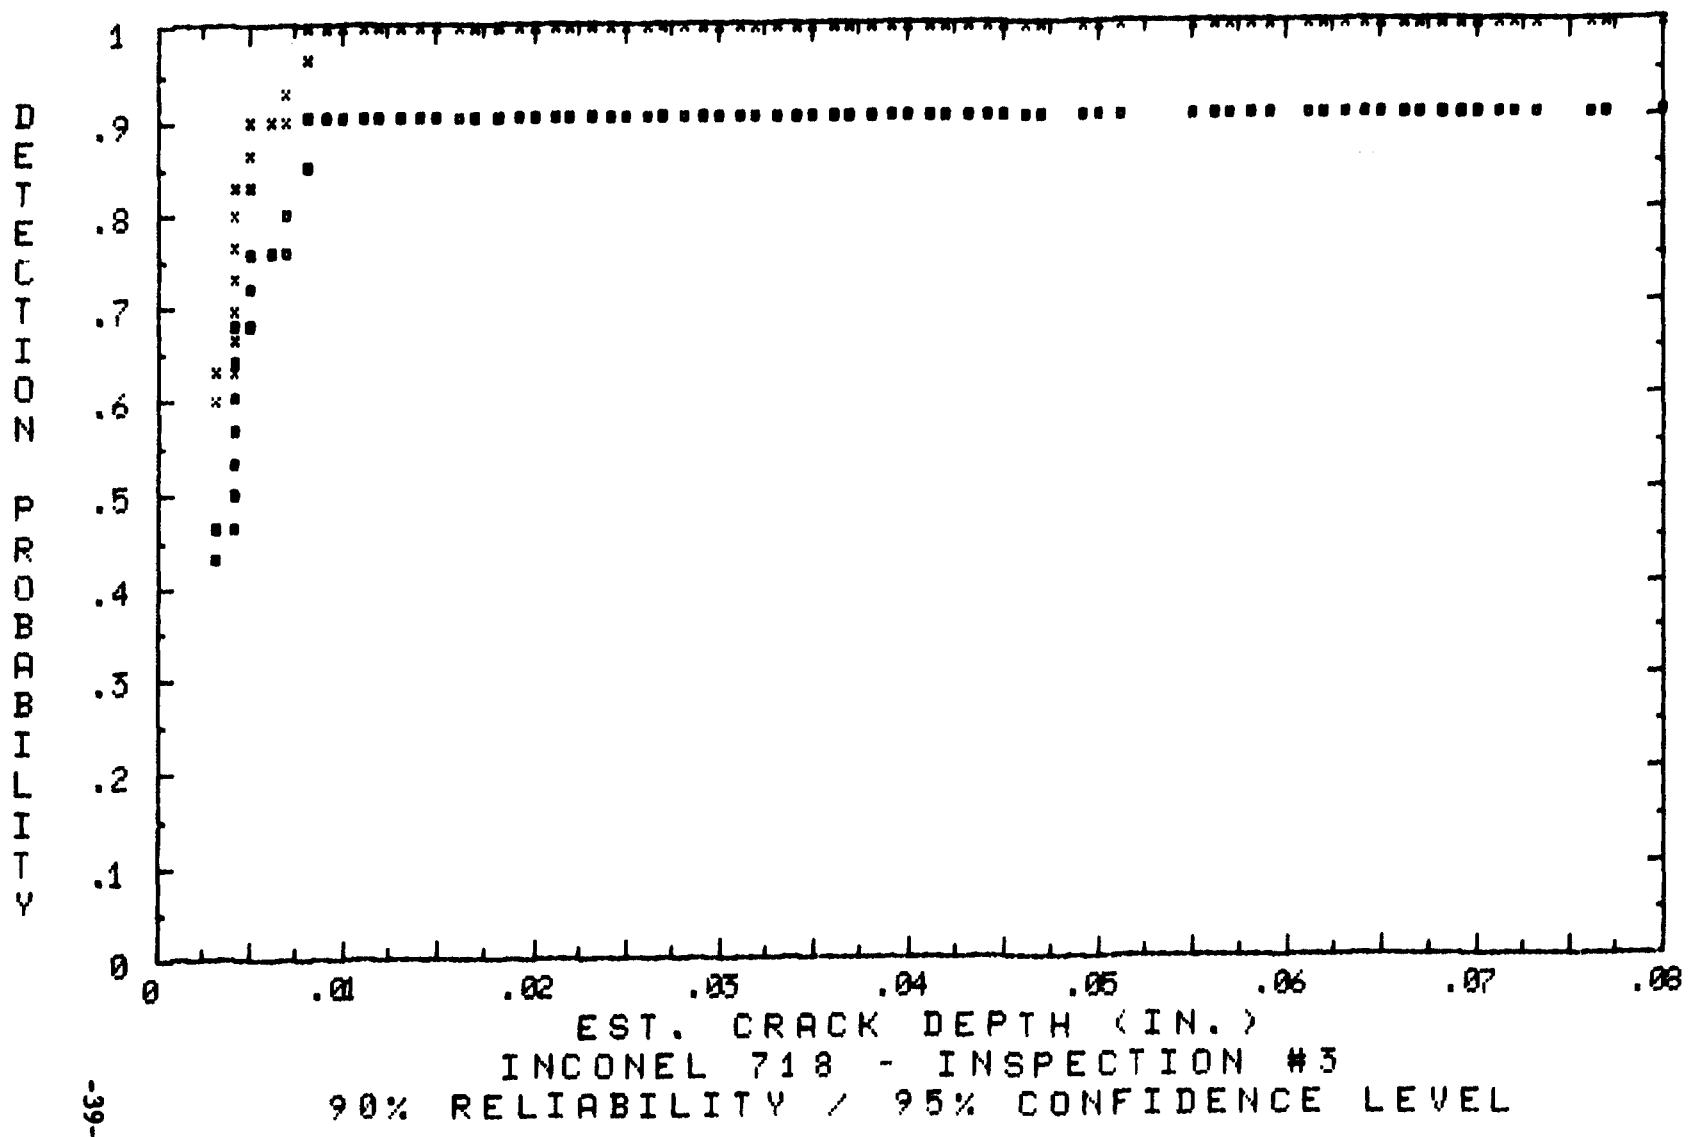
Figure 15 - Crack Detection Probability of Inconel 718 Penetrant Inspection #3.

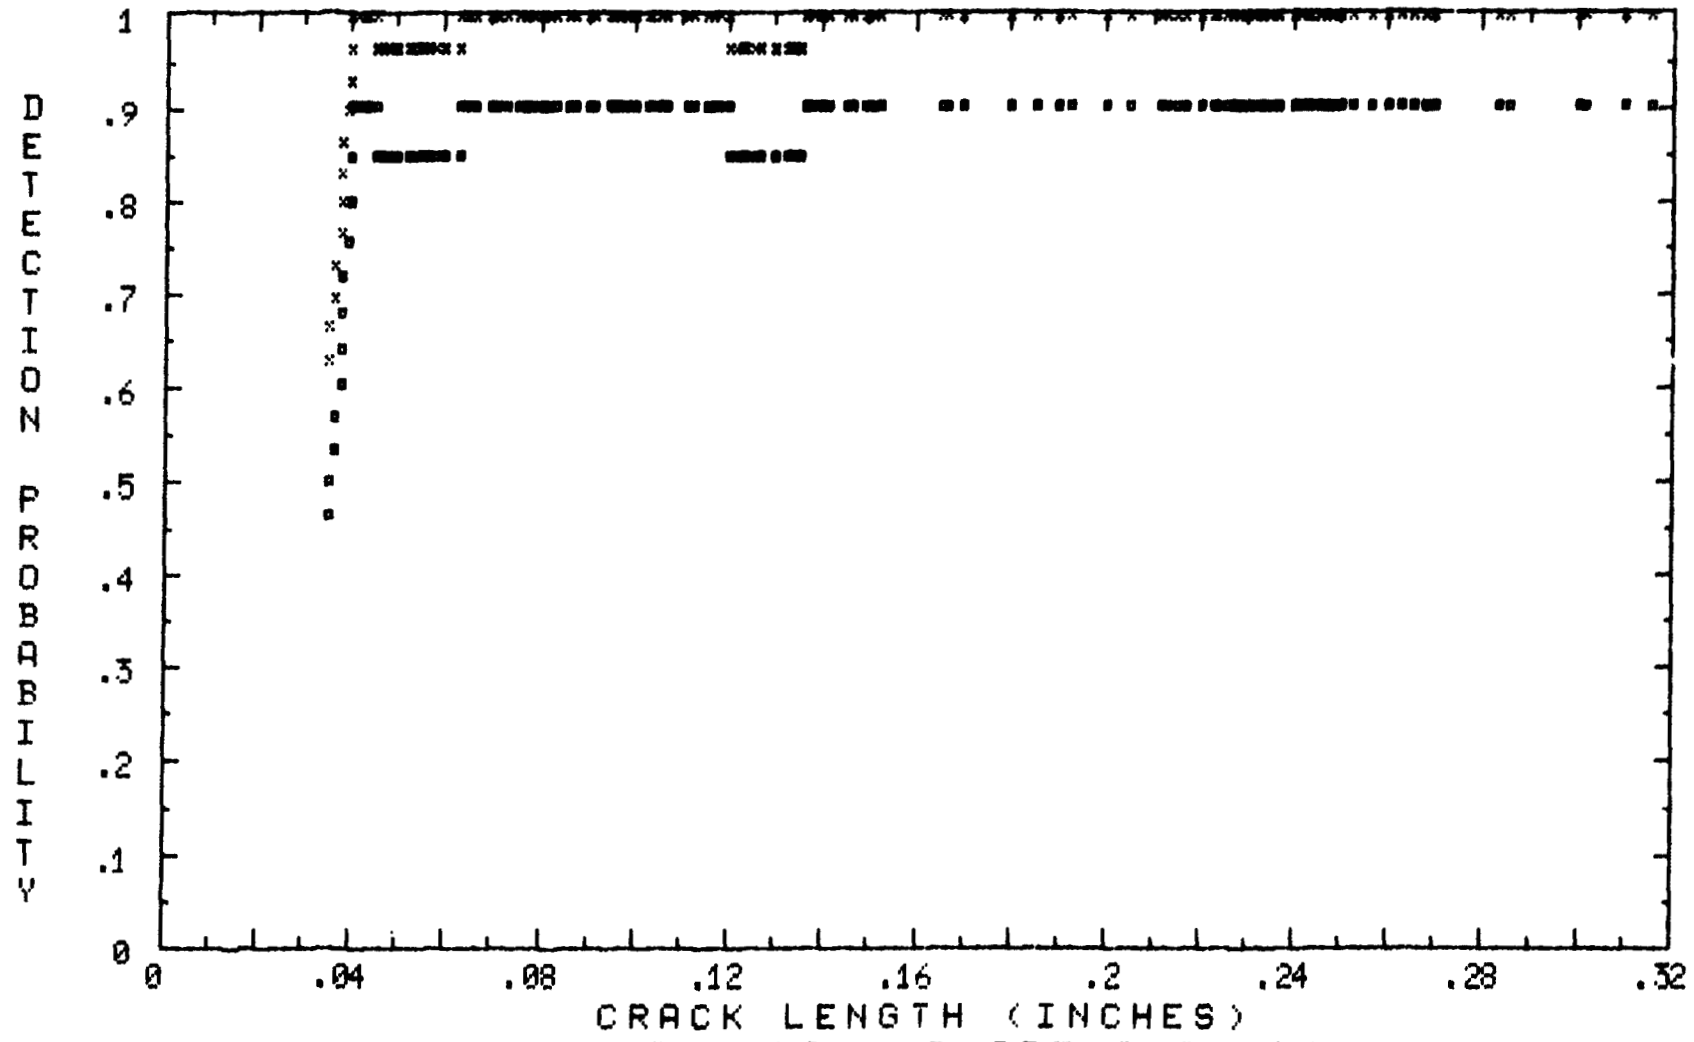
HAYNES 188 - INSPECTION #1  
URESOC F-149, E-153 AND D-499C PENETRANT SYSTEM  
90% RELIABILITY / 95% CONFIDENCE LEVEL

Figure 16 - Crack Detection Probability of Haynes 188 Penetrant Inspection #1.
