**Final Report**

# **NDE Detectability of Fatigue Type Cracks in High-Strength Alloys**

6. Performing Organization Code 3	
7. Author(s) Brent K. Christner, Ward D. Rummel				8. Performing Organization Report No. MCR-83-568	
9. Performing Organization Name and Address Martin Marietta Corporation Denver Aerospace, P.O. Box 179 Denver, Colorado 80201				10. Work Unit No. NASA-MSFC

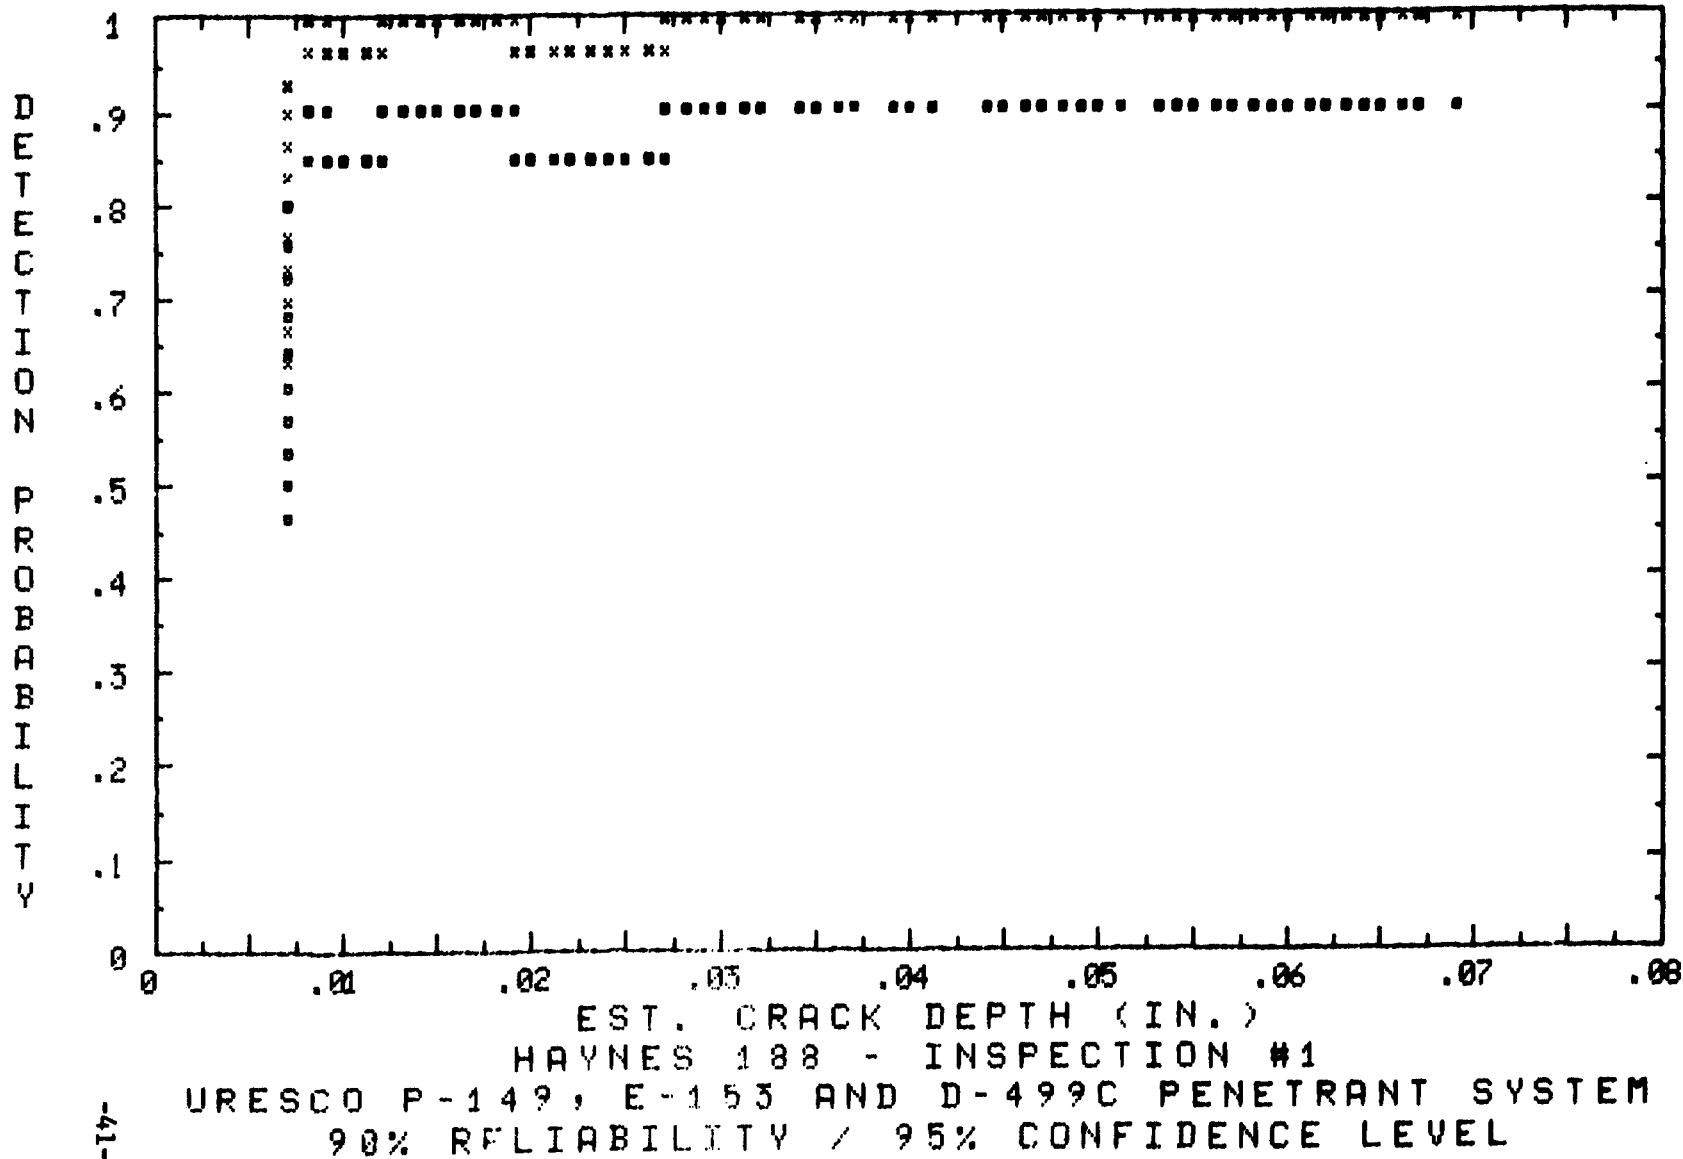
Figure 17 - Crack Detection Probability of Haynes 188 Penetrant Inspection #1.

Plots of detection probabilities for the three Inconel 718 panel inspections and the three Haynes 188 inspections are shown in Figures 10-21. The data has been plotted by both crack length and by estimated crack depth for each inspection.

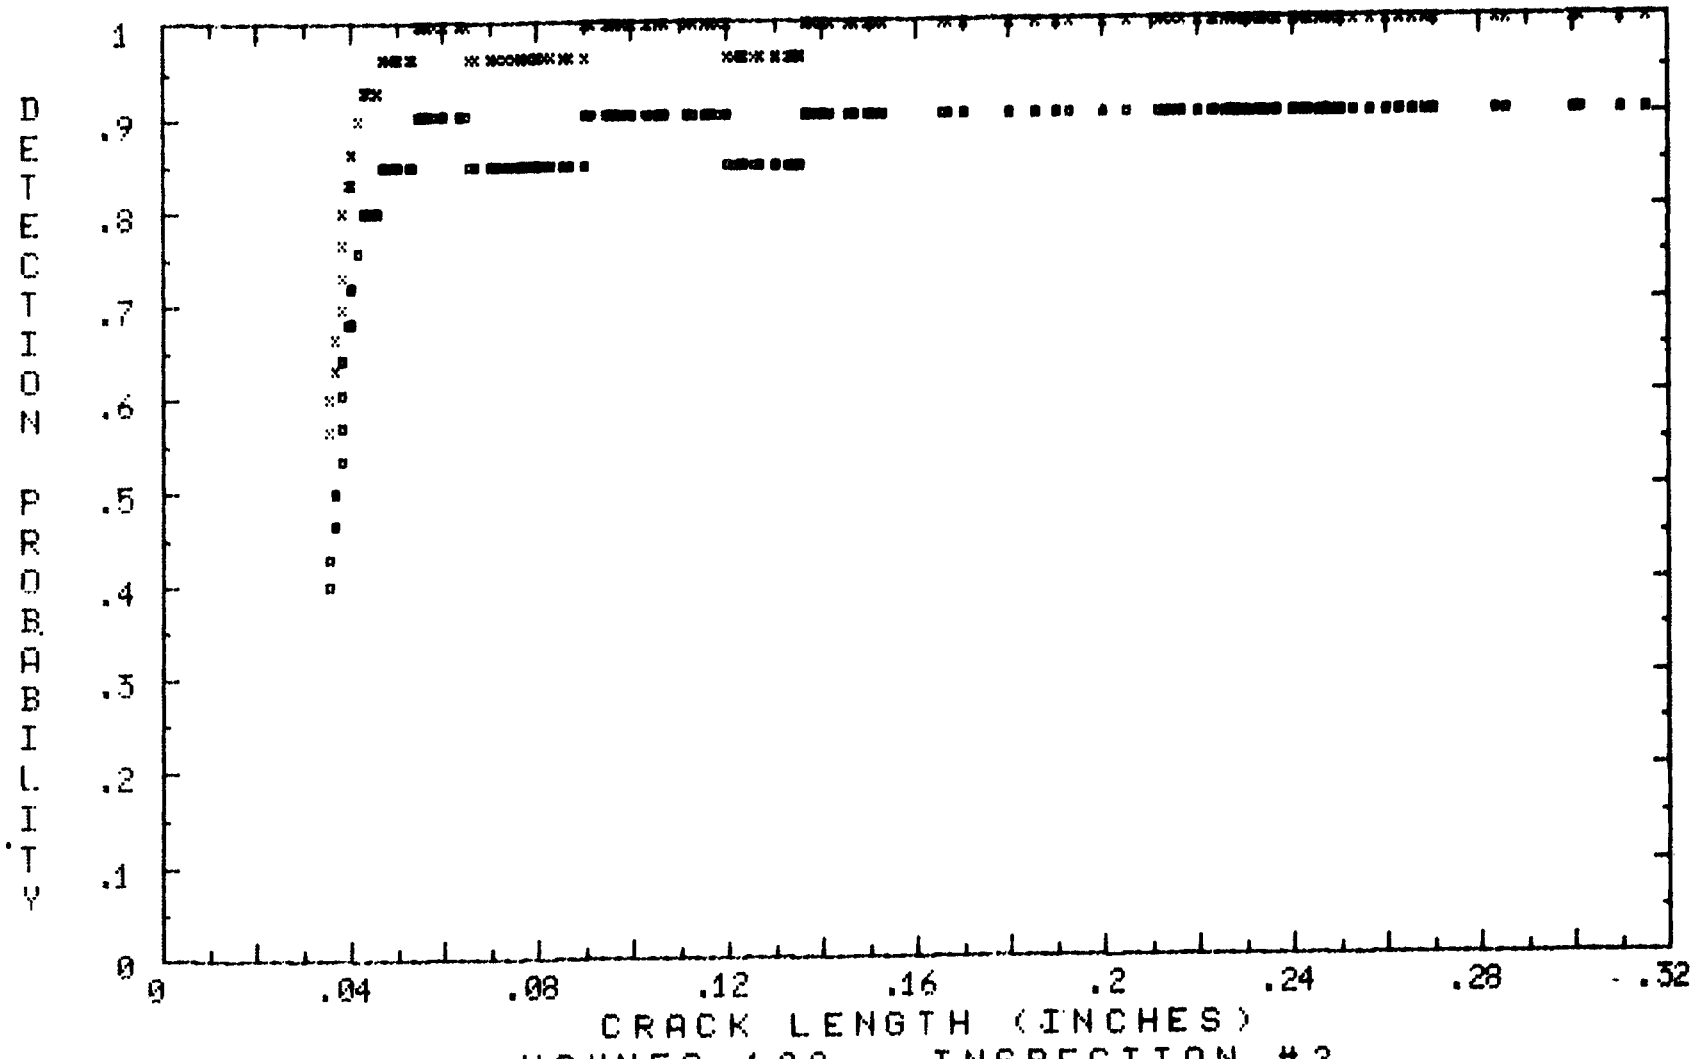
HAYNES 188 - INSPECTION #2  
MAGNAFLUX ZL37, ZR10A AND ZP9B PENETRANT SYSTEM  
90% RELIABILITY / 95% CONFIDENCE LEVEL

Figure 18 - Crack Detection Probability of Haynes 188 Penetrant Inspection #2.

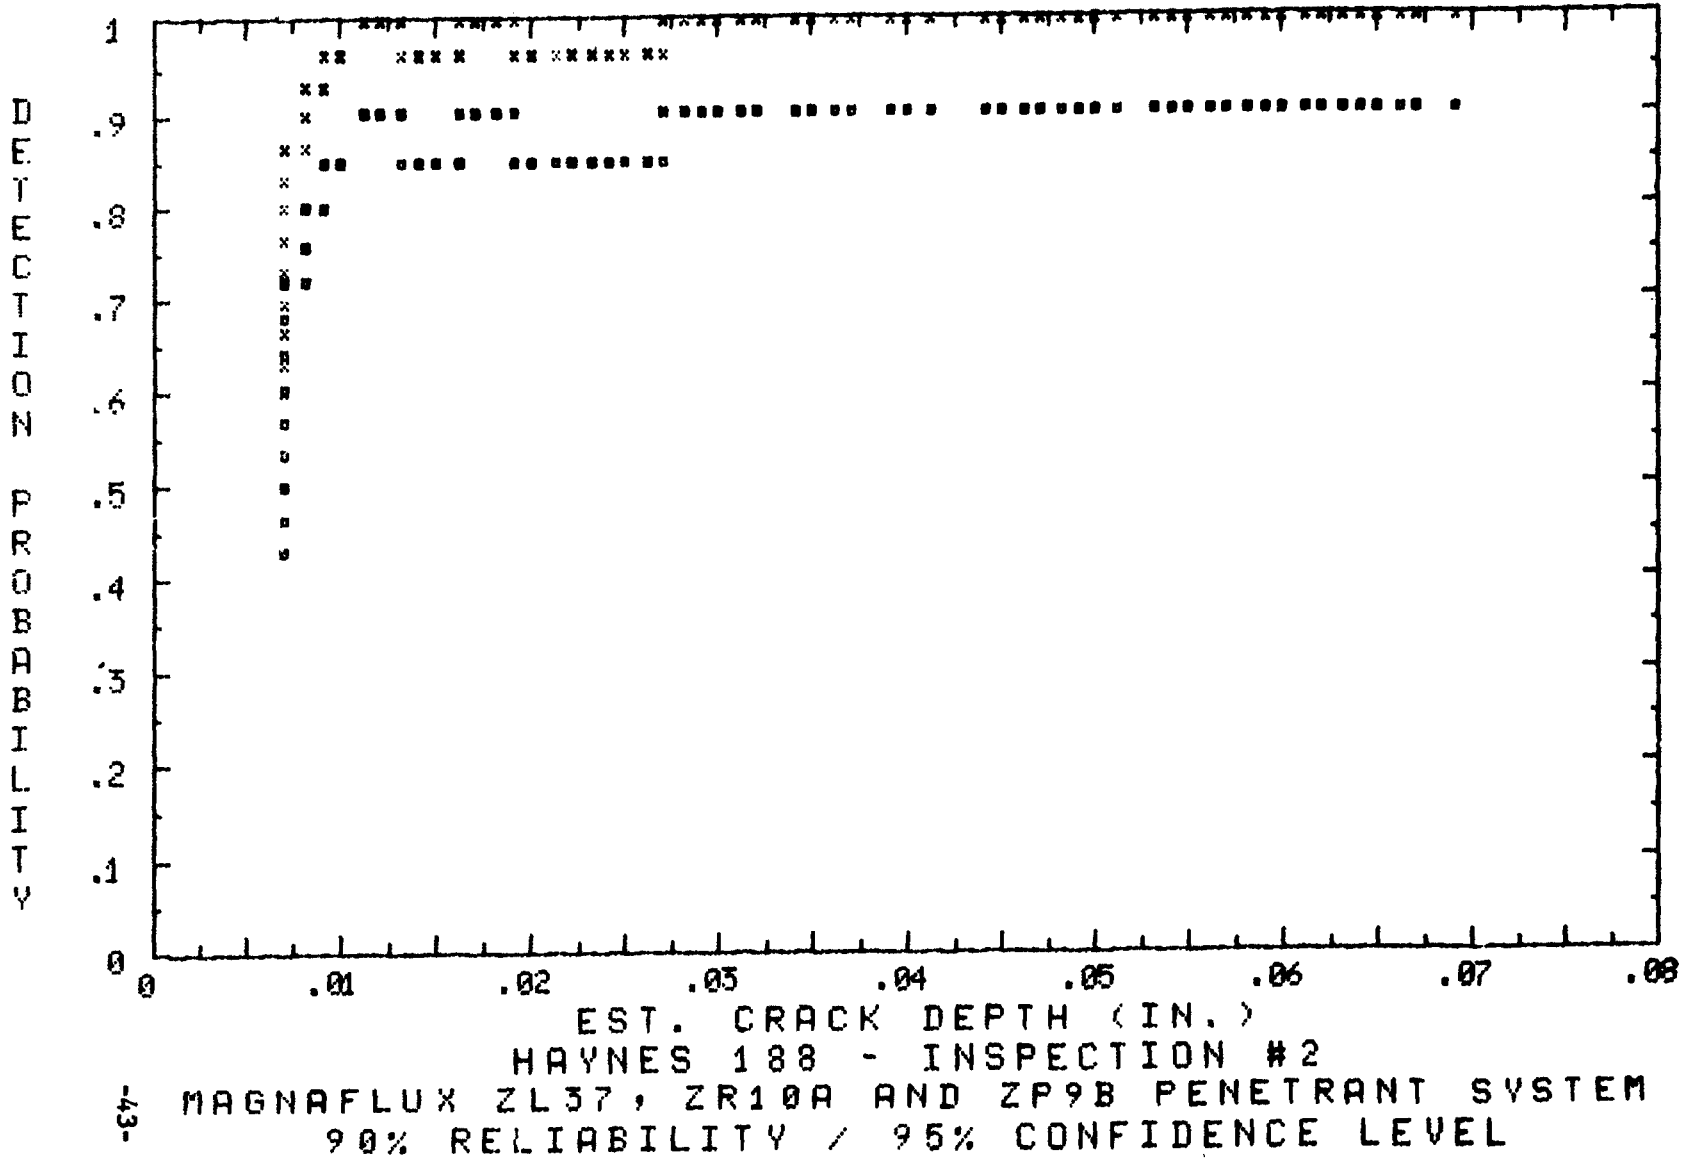
Figure 19 - Crack Detection Probability of Haynes 188 Penetrant Inspection #2.

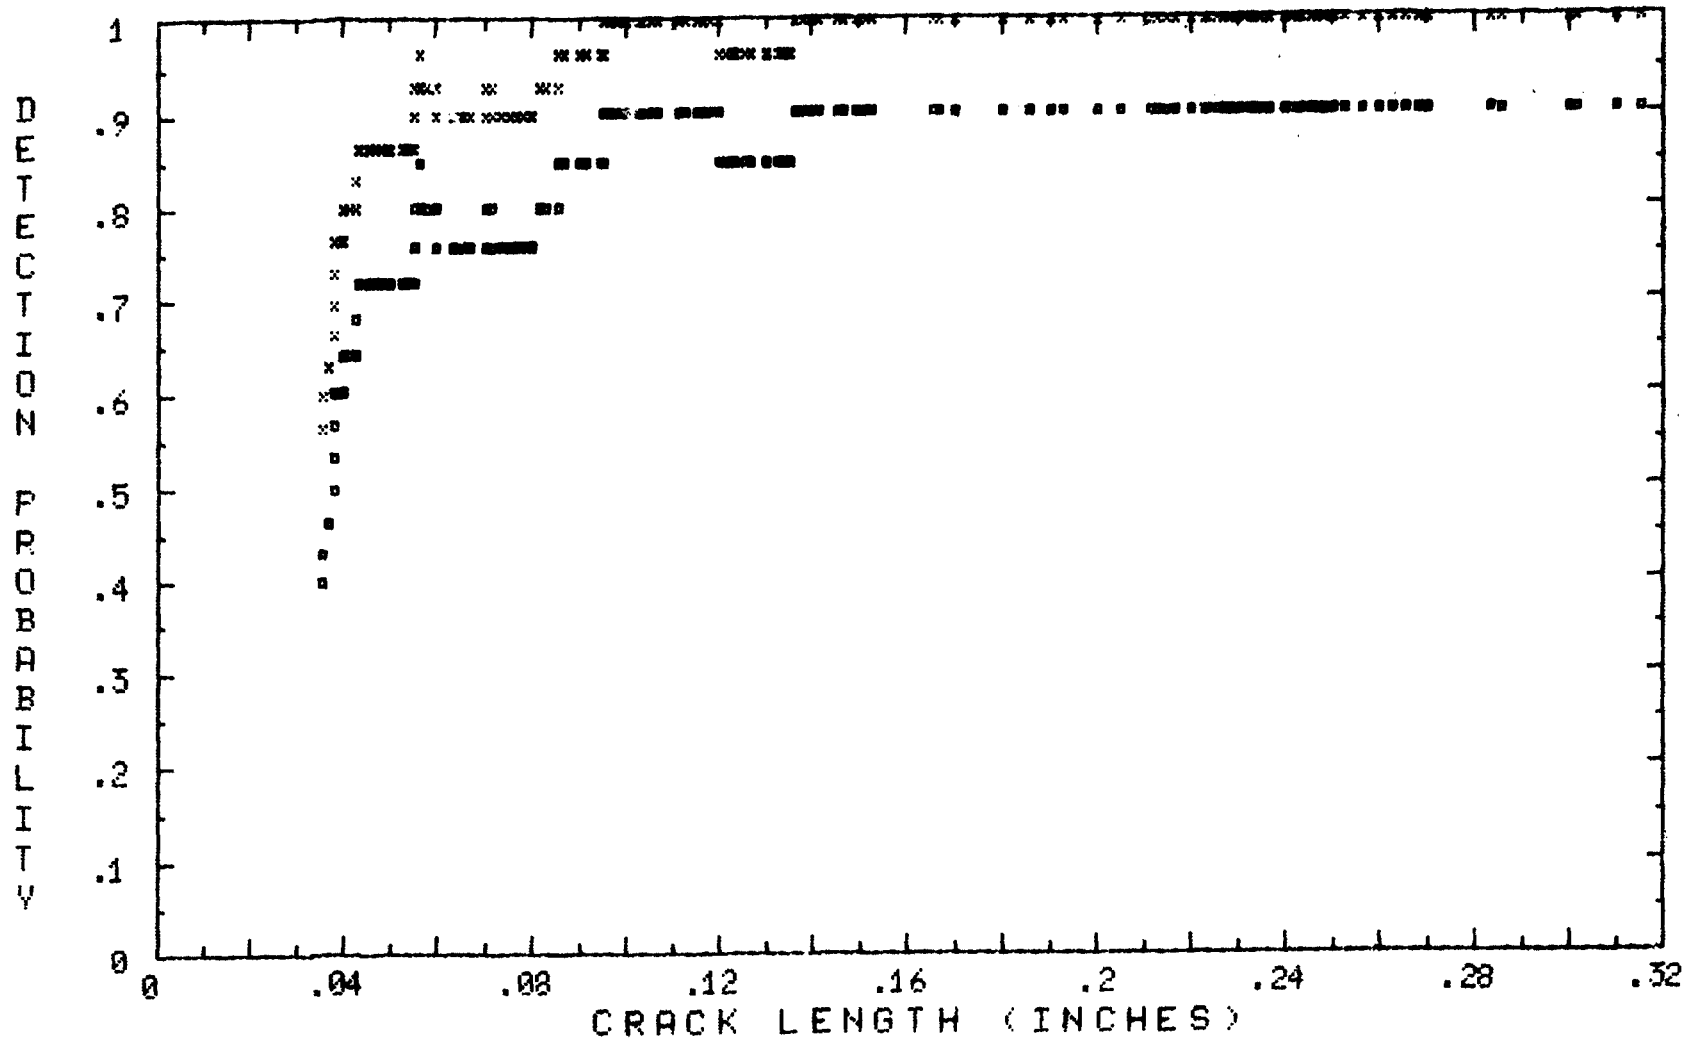
HAYNES 188 - INSPECTION #3  
SHERWIN I-319 AND D-100 PENETRANT SYSTEM  
90% RELIABILITY / 95% CONFIDENCE LEVEL

Figure 20 - Crack Detection Probability of Haynes 188 Penetrant Inspection #3.

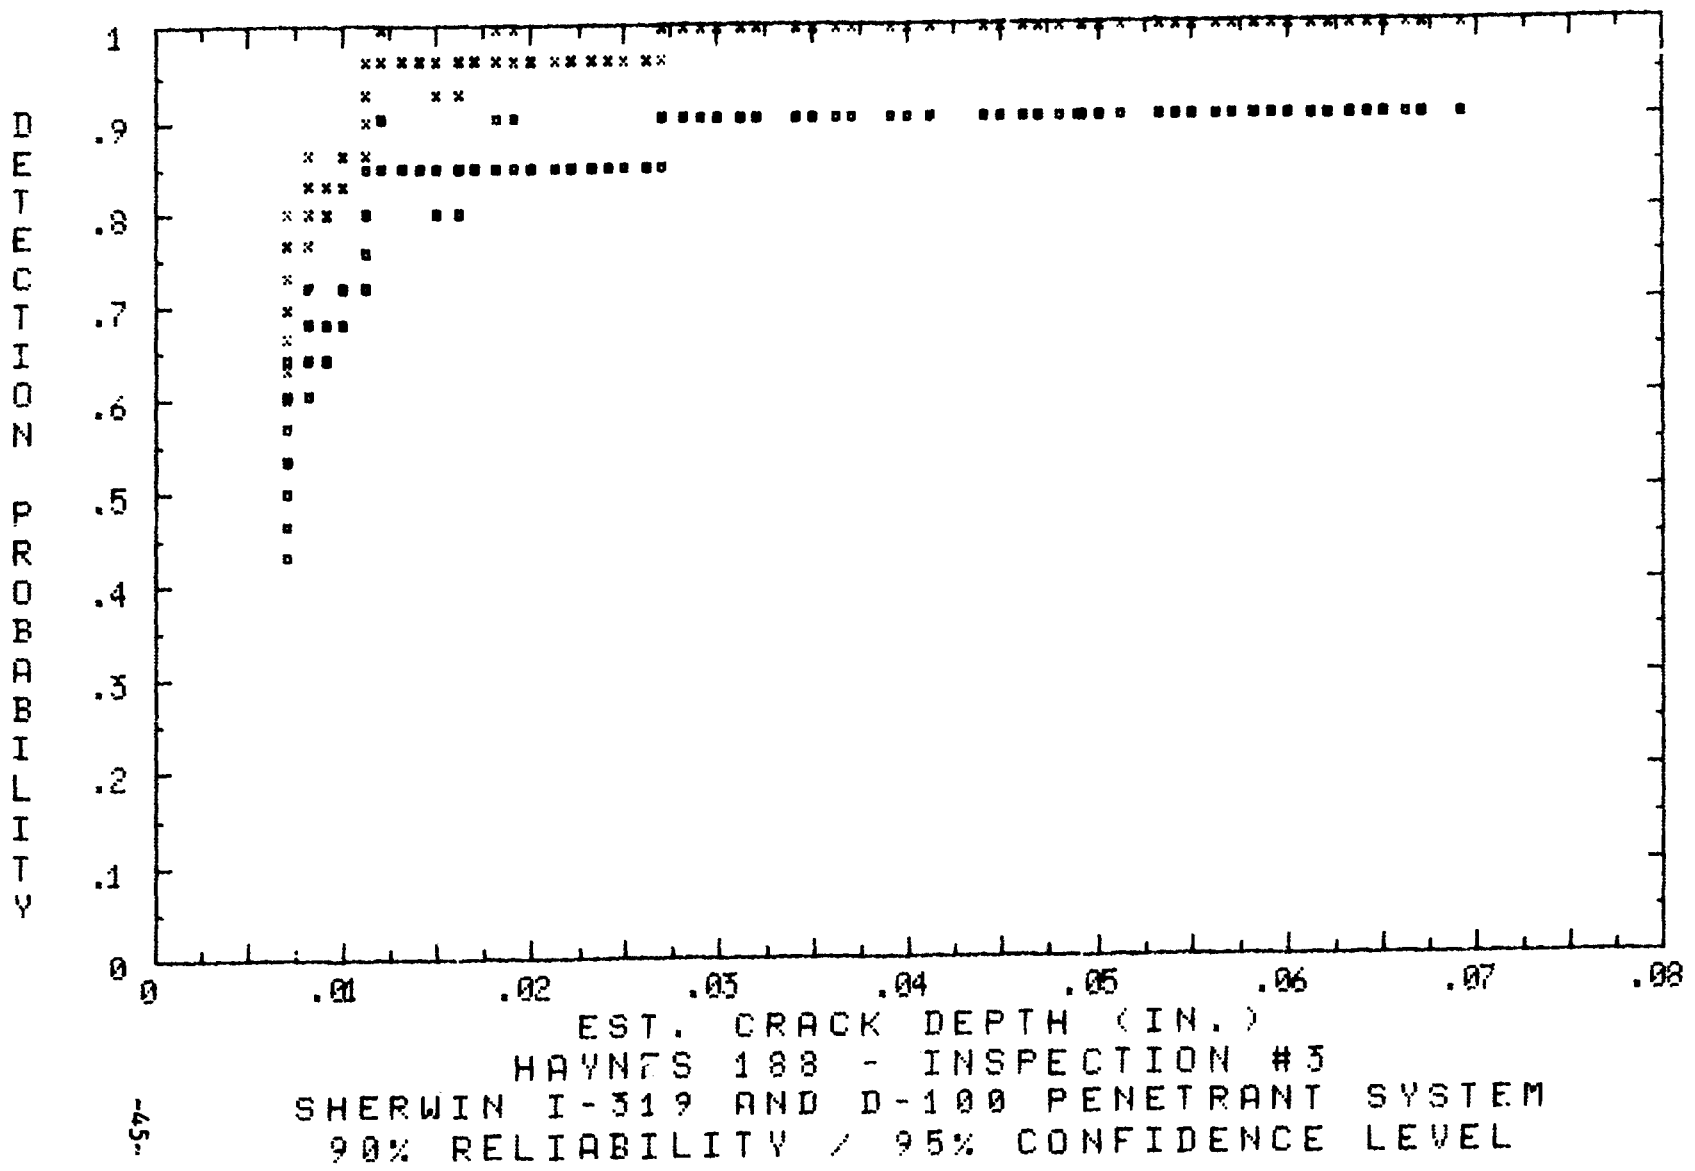
Figure 21 - Crack Detection Probability of Haynes 188 Penetrant Inspection #3.
