COLUMBIA

ACCIDENT INVESTIGATION BOARD

REPORT VOLUME I
AUGUST 2003

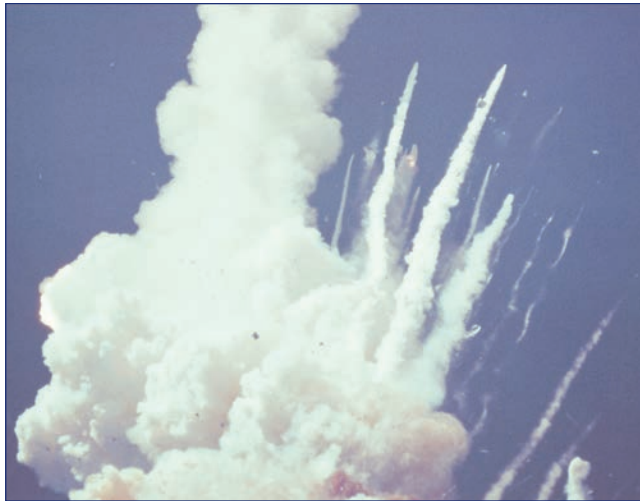
Figure 1.5-1. the Space Shuttle Challenger was lost during ascent on January 28, 1986, when an O-ring and seal in the right Solid Rocket Booster failed.

The Rogers Commission report, issued on June 6, 1986, recommended a redesign and recertification of the Solid Rocket Motor joint and seal and urged that an independent body oversee its qualification and testing. The report concluded that the drive to declare the Shuttle operational had put enormous pressures on the system and stretched its resources to the limit. Faulting NASA safety practices, the Commission also called for the creation of an independent NASA Office of Safety, Reliability, and Quality Assurance, reporting directly to the NASA Administrator, as well as structural changes in program management.²⁰ (The Rogers Commission findings and recommendations are discussed in more detail in Chapter 5.) It would take NASA 32 months before the next Space Shuttle mission was launched. During this time, NASA initiated a series of longer-term vehicle upgrades, began the construction of the Orbiter *Endeavour* to replace *Challenger*, made significant organizational changes, and revised the Shuttle manifest to reflect a more realistic flight rate.

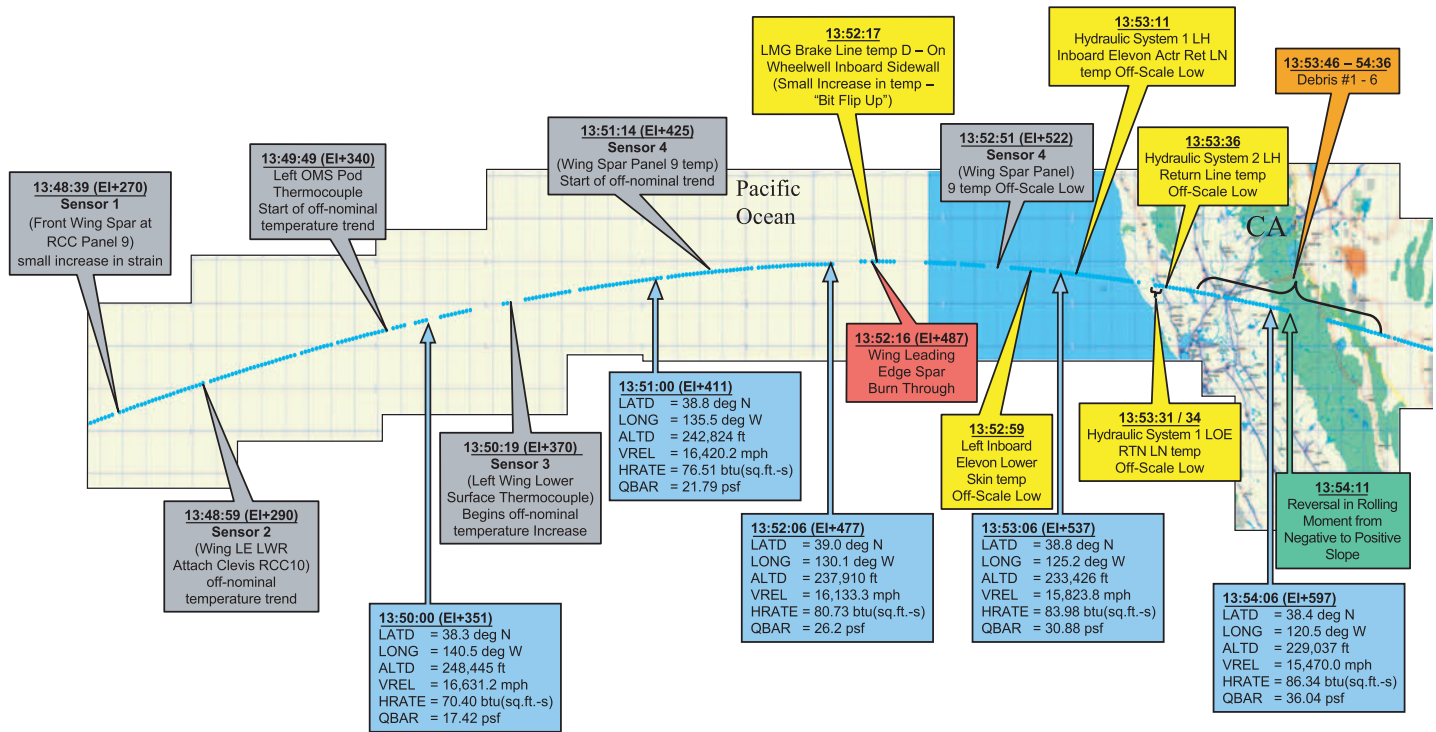
At 8:48:39 a.m. (EI+270), a sensor on the left wing leading edge spar showed strains higher than those seen on previous *Columbia* re-entries. This was recorded only on the Modular Auxiliary Data System, and was not telemetered to ground controllers or displayed to the crew (see Figure 2.6-1).

Figure 2.6-1. This simplified timeline shows the re-entry path of Columbia on February 1, 2003. The information presented here is a composite of sensor data telemetered to the ground combined with data from the Modular Auxiliary Data System recorder recovered after the accident. Note that the first off-nominal reading was a small increase in a strain gauge at the front wing spar behind RCC panel 9-left. The chart is color-coded: blue boxes contain position, attitude, and velocity information; orange boxes indicate when debris was shed from the Orbiter; green boxes are significant aerodynamic control events; gray boxes contain sensor information from the Modular Auxiliary Data System; and yellow boxes contain telemetered sensor information. The red boxes indicate other significant events.

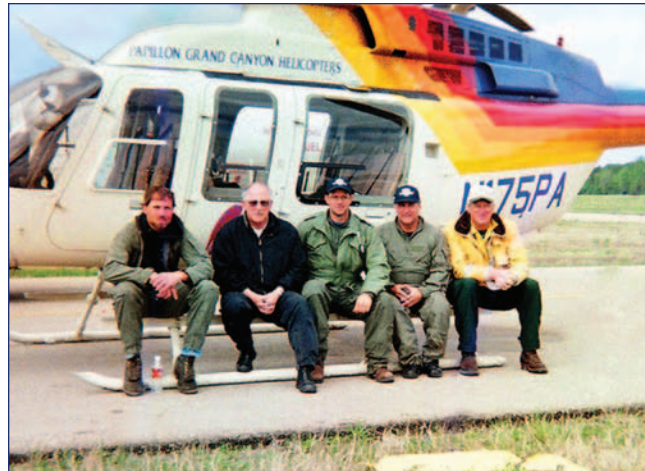
Figure 2.7-3. Tragically, a helicopter crash during the debris search claimed the lives of Jules "Buzz" Mier (in black coat) and Charles Krenek (yellow coat).

ty of the East Texas vegetation, the small sizes of the debris, and the inability of sensors to differentiate Orbiter material from other objects, these devices proved of little value. As a result, the detection work fell to spotter teams who visually scanned the terrain. Air search coordinators apportioned grids to allow a 50 percent probability of detection for a one-foot-square object. Civil Air Patrol volunteers and others in powered parachutes, a type of ultralight aircraft, also participated in the search, but were less successful than helicopter and fixed-wing air crews in retrieving debris. During the air search, a Bell 407 helicopter crashed in Angelina National Forest in San Augustine County after a mechanical failure. The accident took the lives of Jules F. "Buzz" Mier Jr., a contract pilot, and Charles Krenek, a Texas Forest Service employee, and injured three others (see Figure 2.7-3).

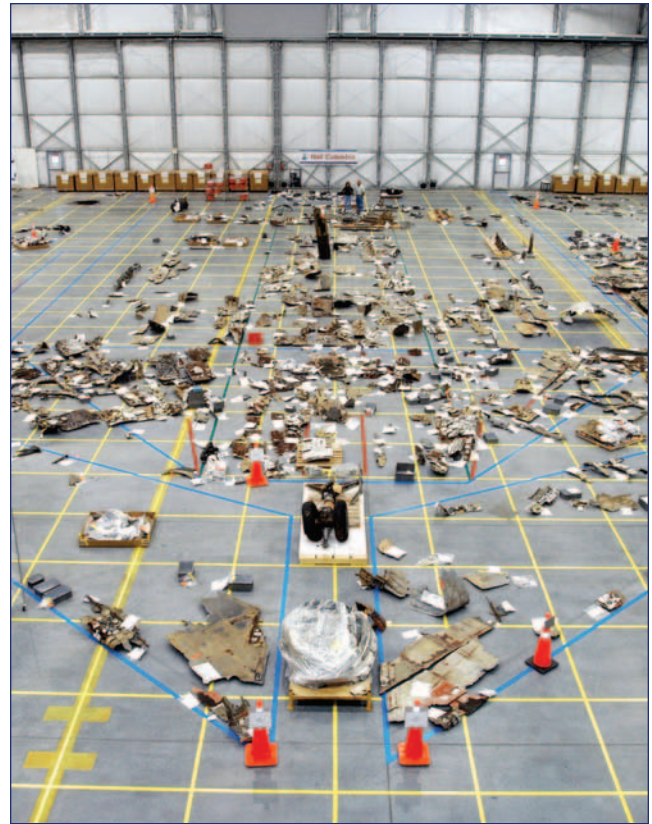
Figure 2.7-4. Recovered debris was returned to the Kennedy Space Center where it was laid out in a large hangar. The tape on the floor helped workers place each piece near where it had been on the Orbiter.

The debris collected (see Figure 2.7-4) by searchers aided the investigation in significant ways. Among the most important finds was the Modular Auxiliary Data System recorder that captured data from hundreds of sensors that was not telemetered to Mission Control. Data from these 800 sensors, recorded on 9,400 feet of magnetic tape, provided investigators with millions of data points, including temperature sensor readings from *Columbia's* left wing leading edge. The data also helped fill a 30-second gap in telemetered data and provided an additional 14 seconds of data after the telemetry loss of signal.

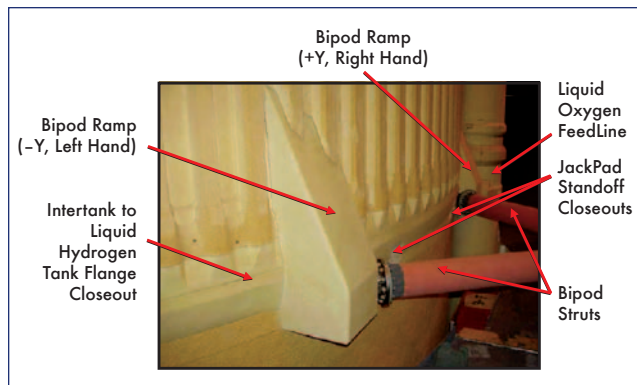
Figure 3.2-2. The exterior of the left bipod attachment area showing the foam ramp that came off during the ascent of STS-107.

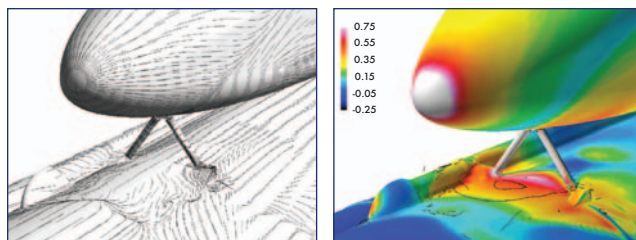
Figure 3.2-5. Computational Fluid Dynamics was used to understand the complex flow fields and pressure coefficients around bipod strut. The flight conditions shown here approximate those present when the left bipod foam ramp was lost from External Tank 93 at Mach 2.46 at a 2.08-degree angle of attack.

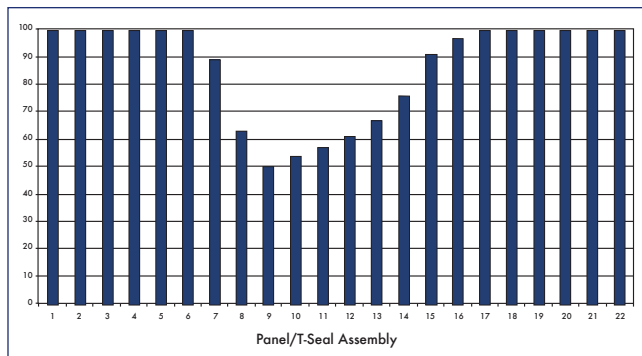
For the first five missions of *Columbia*, the RCC components were not coated with Type A sealant, and had shorter mission service lives than the RCC components on the other Orbiters. (*Columbia*'s panel 9 has the shortest mission service life of 50 flights as shown in Figure 3.3-4.) The predicted life for panel/T-seals 7 through 16 range from 54 to 97 flights.⁷

Figure 3.3-4. The expected mission life for each of the wing leading edge RCC panels on Columbia. Note that panel 9 has the shortest life expectancy.

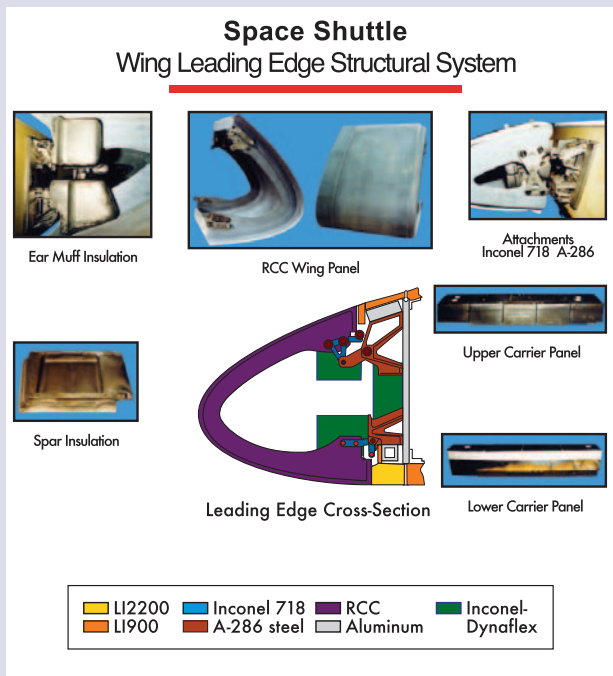
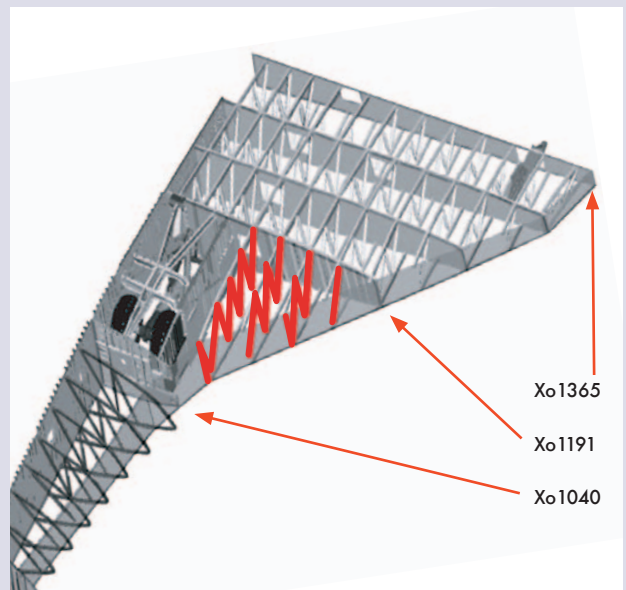
The Wing Leading Edge Structural System on Columbia.

The mid-wing area on the left wing, behind where the breach occurred, is supported by a series of trusses, as shown in red in the figure below. The mid-wing area is bounded in the front and back by the Xo1040 and Xo1191 cross spars, respectively. The numerical designation of each spar comes from its location along the Orbiter's X-axis; for example, the Xo1040 spar is 1,040 inches from the zero point on the X-axis. The cross spars provide the wing's structural integrity. Three major cross spars behind the Xo1191 spar provide the primary structural strength for the aft portion of the wing. The inboard portion of the mid-wing is the outer wall of the left wheel-well, and the outboard portion of the mid-wing is the wing leading edge spar, where the RCC panels attach.

The major internal support structures in the mid-wing are constructed from aluminum alloy. Since aluminum melts at 1,200 degrees Fahrenheit, it is likely these truss tubes in the mid-wing were destroyed and wing structural integrity was lost.

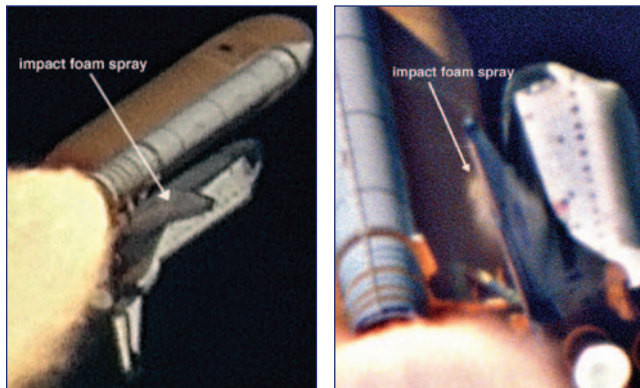
Figure 3.4-1 (color enhanced and "de-blurred" by Lockheed Martin Gaithersburg) and Figure 3.4-2 (processed by the National Imagery and Mapping Agency) are samples of the type of visual data used to establish the time of the impact (81.9 seconds), the altitude at which it occurred (65,860 feet), and the object's relative velocity at impact (about 545 mph relative to the Orbiter).

A 35-mm film camera, E212, which recorded the foam strike from 17 miles away, and video camera E208, which recorded it from 26 miles away, provided the best of the available evidence. Analysis of this visual evidence (see Figures 3.4-1 and 3.4-2) along with computer-aided design analysis, refined the potential impact area to less than 20 square feet in RCC panels 6 through 9 (see Figure 3.4-3), including a portion of the corresponding carrier panels and adjacent tiles. The investigation image analysis team found no conclusive visual evidence of post-impact debris flowing over the top of the wing.

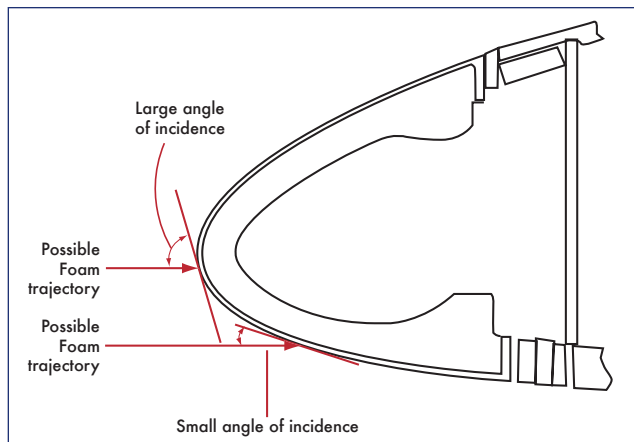
Image analysis determined that the foam was moving almost parallel to the Orbiter's fuselage at impact, with about a five-degree angle upward toward the bottom of the wing and slight motion in the outboard direction. If the foam had hit the tiles adjacent to the leading edge, the angle of incidence would have been about five degrees (the angle of incidence is the angle between the relative velocity of the projectile and the plane of the impacted surface). Because the wing leading edge curves, the angle of incidence increases as the point of impact approaches the apex of an RCC panel. Image and transport analyses estimated that for impact on RCC panel 8, the angle of incidence was between 10 and 20 degrees (see Figure 3.4-4).⁹ Because the total force delivered by the impact depends on the angle of incidence, a foam strike near the apex of an RCC panel could have delivered about twice the force as an impact close to the base of the panel.

Figure 3.4-4. This drawing shows the curve of the wing leading edge and illustrates the difference the angle of incidence has on the effect of the foam strike.

The precise impact location of the foam determined the impact angle because the debris was moving almost parallel to the Orbiter's fuselage at impact. Tile areas would have been hit at very small angles (approximately five degrees), but the curvature of the leading edge created angles closer to 20 degrees (see Figure 3.4-4).

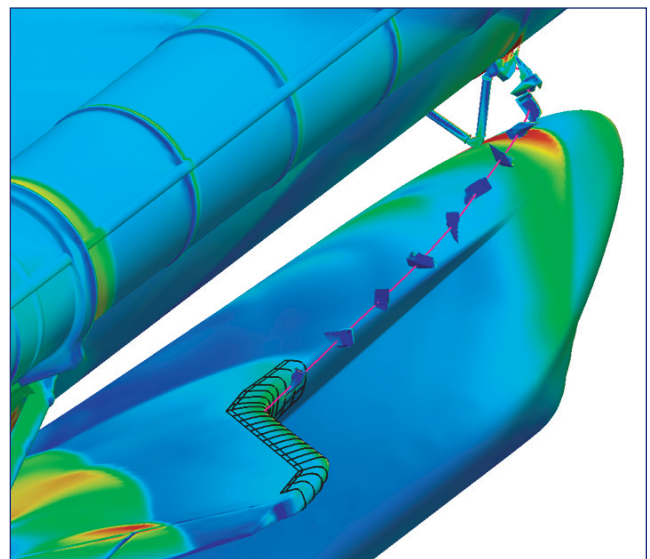
Figure 3.4-6. These are the results of a trajectory analysis that used a computational fluid dynamics approach in a program called CART-3D, a comprehensive (six-degree-of-freedom) computer simulation based on the laws of physics. This analysis used the aerodynamic and mass properties of bipod ramp foam, coupled with the complex flow field during ascent, to determine the likely position and velocity histories of the foam.

The undetermined and yet certainly irregular shape of the foam introduced substantial uncertainty about its estimated aerodynamic characteristics. Appendix D.8 contains an independent analysis conducted by the Board to confirm that the estimated range of ballistic coefficients of the foam in Figure 3.4-6 was credible, given the foam dimension results from the image analyses and the expected range of the foam density. Based on the results in Figure 3.4-7, the physical dimensions of the bipod ramp, and the sizes and shapes of the available barrels for the compressed-gas gun used in the impact test program described later in this chapter, the Board and the NASA Accident Investigation Team decided that a foam projectile 19 inches by 11.5 inches by 5.5 inches, weighing 1.67 pounds, and with a weight density of 2.4 pounds per cubic foot, would best represent the piece of foam that separated from the External Tank bipod ramp and was hit by the Orbiter’s left wing. See Section 3.8 for a full discussion of the foam impact testing.

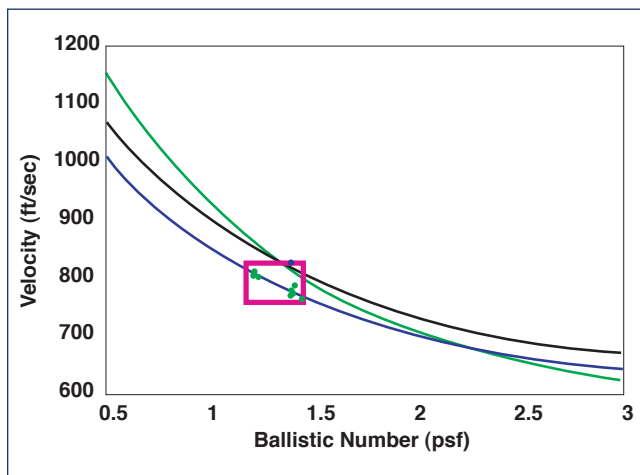
Figure 3.4-7. The results of numerous possible trajectories based on various assumed sizes, shapes, and densities of the foam. Either the foam had a slightly higher ballistic coefficient and the Orbiter struck the foam at a lower speed relative to the Orbiter, or the foam was more compact and the wing struck the foam at a higher speed. The “best fit” box represents the overlay of the data from the image analysis with the transport analysis computations. This data enabled a final selection of projectile characteristics for impact testing.

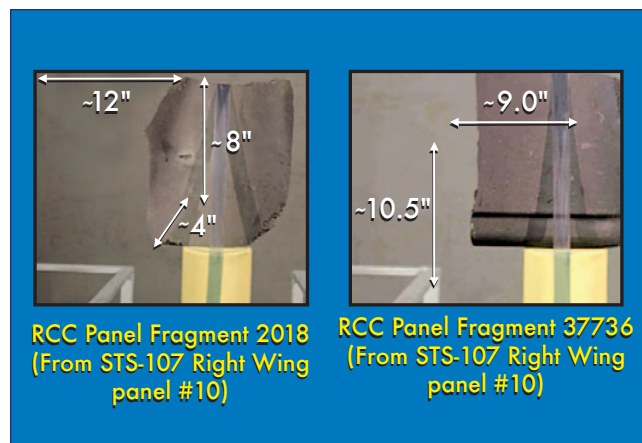
Figure 3.5-1. These representative RCC acreage pieces matched the radar cross-section of the Flight Day 2 object.

In the Advanced Compact Range at the Air Force Research Laboratory in Dayton, Ohio, analysts tested 31 materials from the Orbiter's exterior and payload bay. Additional supercomputer radar cross-section predictions were made for Reinforced Carbon-Carbon T-seals. After exhaustive radar cross-section analysis and testing, coupled with ballistic analysis of the object's orbital decay, only a fragment of RCC panel would match the UHF radar cross-section and ballistic coefficients observed by the Space Surveillance network. Such an RCC panel fragment must be approximately 140 square inches or greater in area to meet the observed radar cross-section characteristics. Figure 3.5-1 shows RCC panel fragments from *Columbia*'s right wing that represent those meeting the observed characteristics of object 2003-003B.¹⁰

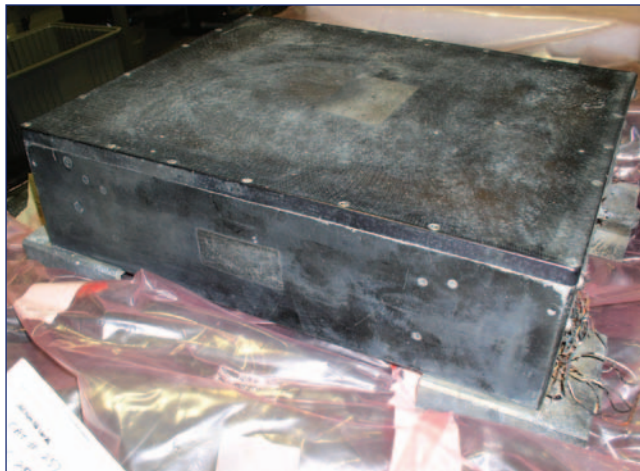
The Modular Auxiliary Data System is a supplemental instrumentation system that gathers Orbiter data for processing after the mission is completed. Inputs are almost exclusively physical sensor readings of temperatures, pressures, mechanical strains, accelerations, and vibrations. The Modular Auxiliary Data System usually records only the mission's first and last two hours (see Figure 3.6-1).

Figure 3.6-1. The Modular Auxiliary Data System recorder, found near Hemphill, Texas. While not designed to withstand impact damage, the recorder was in near-perfect condition when recovered on March 19, 2003.

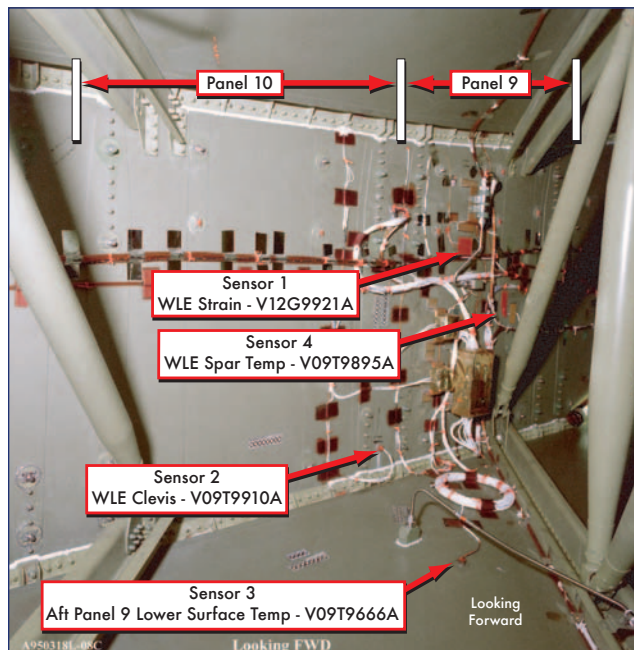
Figure 3.6-2. Location of sensors on the back of the left wing leading edge spar (vertical aluminum structure in picture). Also shown are the round truss tubes and ribs that provided the structural support for the mid-wing in this area.

or outside the wing leading edge spar near Reinforced Carbon-Carbon (RCC) panel 9-left, helped tell the story of what happened on the left wing of the Orbiter early in the re-entry. These four sensors were: strain gauge V12G9921A (Sensor 1), resistance temperature detector V09T9910A on the RCC clevis between panel 9 and 10 (Sensor 2), thermocouple V07T9666A, within a Thermal Protection System tile (Sensor 3), and resistance temperature detector V09T9895A (Sensor 4), located on the back side of the wing leading edge spar behind RCC panels 8 and 9 (see Figure 3.6-2).

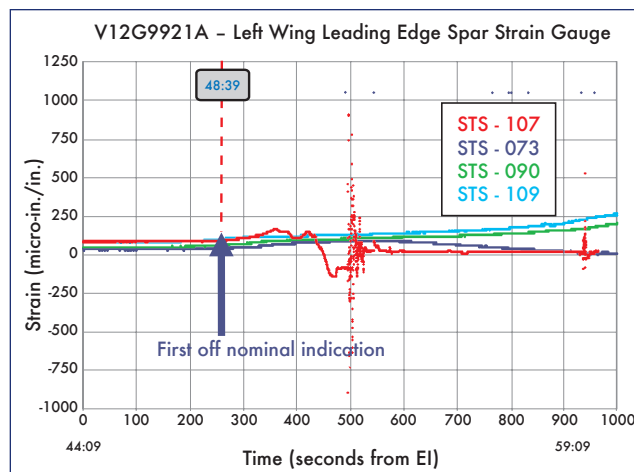
Figure 3.6-3. The strain gauge (Sensor 1) on the back of the left wing leading edge spar was the first sensor to show an anomalous reading. In this chart, and the others that follow, the red line indicates data from STS-107. Data from other Columbia re-entries, similar to the STS-107 re-entry profile, are shown in the other colors.

Sensor 1 provided the first anomalous reading (see Figure 3.6-3). From EI+270 to EI+360, the strain is higher than that on previous *Columbia* flights. At EI+450, the strain reverses, and then peaks again in a negative direction at EI+475. The strain then drops slightly, and remains constant and negative until EI+495, when the sensor pattern becomes unreliable, probably due to a propagating soft short, or “burn-through” of the insulation between cable conductors caused by heating or combustion. This strain likely indicates significant damage to the aluminum honeycomb spar. In particular, strain reversals, which are unusual, likely mean there was significant high-temperature damage to the spar during this time.

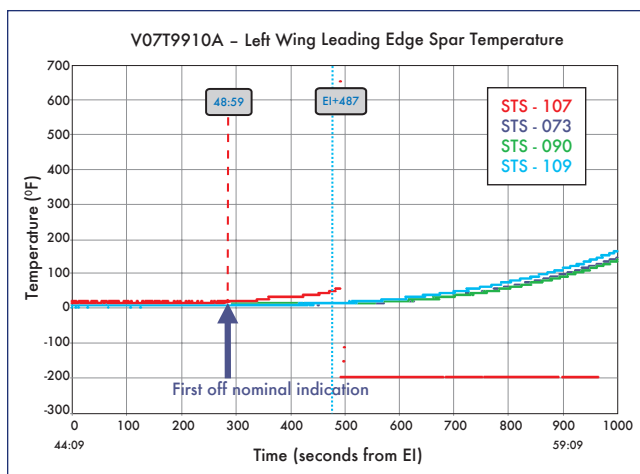
Figure 3.6-4. This temperature thermocouple (Sensor 2) was mounted on the outside of the wing leading edge spar behind the insulation that protects the spar from radiated heat from the RCC panels. It clearly showed an off-nominal trend early in the re-entry sequence and began to show an increase in temperature much earlier than the temperature sensor behind the spar.

left wing leading edge spar, recorded the beginning of a gradual and abnormal rise in temperature from an expected 30 degrees Fahrenheit to 65 degrees at EI+493, when it then dropped to “off-scale low,” a reading that drops off the scale at the low end of the sensor’s range (see Figure 3.6-4). Sensor 2, one of the first to fail, did so abruptly. It had indicated only a mild warming of the RCC attachment clevis before the signal was lost.

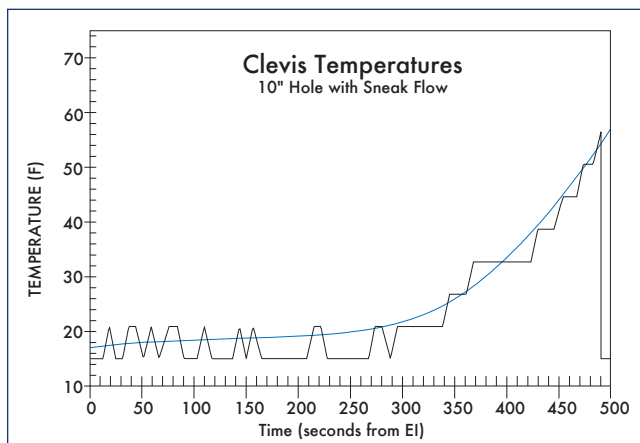
Figure 3.6-5. The analysis of the effect of a 10-inch hole in RCC panel 8 on Sensor 2 from EI to EI+500 seconds. The jagged line shows the actual flight data readings and the smooth line the calculated result for a 10-inch hole with some sneak flow of superheated air behind the spar insulation.

A series of thermal analyses were performed for different sized holes in RCC panel 8 to compute the time required to heat Sensor 2 to the temperature recorded by the Modular Auxiliary Data System. To heat the clevis, various insulators would have to be bypassed with a small amount of leakage, or “sneak flow.” Figure 3.6-5 shows the results of these calculations for, as an example, a 10-inch hole, and demonstrates that with sneak flow around the insulation, the temperature profile of the clevis sensor was closely matched by the engineering calculations. This is consistent with the same sneak flow required to match a similar but abnormal ascent temperature rise of the same sensor, which further supports the premise that the breach in the leading edge of the wing occurred during ascent. While the exact size of the breach will never be known, and may have been smaller or larger than 10 inches, these analyses do provide a plausible explanation for the observed rises in temperature sensor data during re-entry.

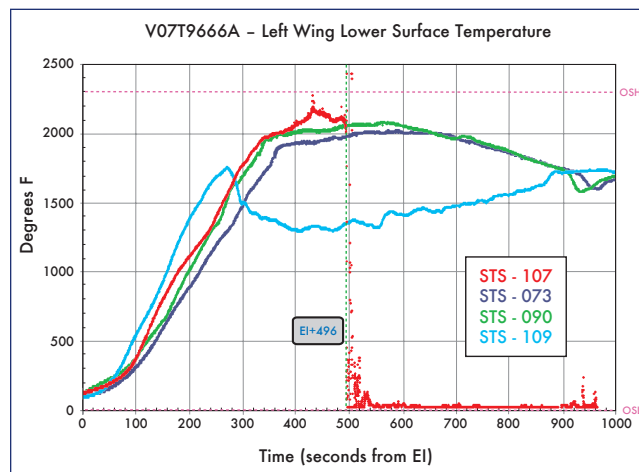
Figure 3.6-6. As early as EI+370, Sensor 3 began reading significantly higher than on previous flights. Since this sensor was located in a thermal tile on the lower surface of the left wing, its temperatures are much higher than those for the other sensors.

The readings of Sensor 3, which was in a thermal tile, began rising abnormally high and somewhat erratically as early as EI+370, with several brief spikes to 2,500 degrees Fahrenheit, significantly higher than the 2,000-degree peak temperature on a normal re-entry (Figure 3.6-6). At EI+496, this reading became unreliable, indicating a failure of the wire or the sensor. Because this thermocouple was on the wing lower surface, directly behind the junction of RCC panel 9 and 10, the high temperatures it initially recorded were almost certainly a result of air jetting through the damaged area of RCC panel 8, or of the normal airflow being disturbed by the damage. Note that Sensor 3 provided an external temperature measurement, while Sensors 2 and 4 provided internal temperature measurements.

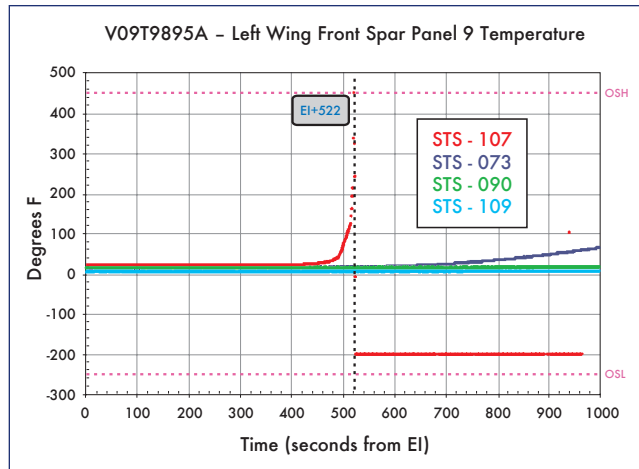
Sensor 4 also recorded a rise in temperature that ended in an abrupt fall to off-scale low. Figure 3.6-7 shows that an abnormal temperature rise began at EI+425 and abruptly fell at EI+525. Unlike Sensor 2, this temperature rise was extreme, from an expected 20 degrees Fahrenheit at EI+425 to 40 degrees at EI+485, and then rising much faster to 120 degrees at EI+515, then to an off-scale high (a reading that climbs off the scale at the high end of the range) of 450 degrees at EI+522. The failure pattern of this sensor likely indicates destruction by extreme heat.

Figure 3.6-7. Sensor 4 also began reading significantly higher than previous flights before it fell off-scale low. The relatively late reaction of this sensor compared to Sensor 2, clearly indicated that superheated air started on the outside of the wing leading edge spar and then moved into the mid-wing after the spar was burned through. Note that immediately before the sensor (or the wire) fails, the temperature is at 450 degrees Fahrenheit and climbing rapidly. It was the only temperature sensor that showed this pattern.

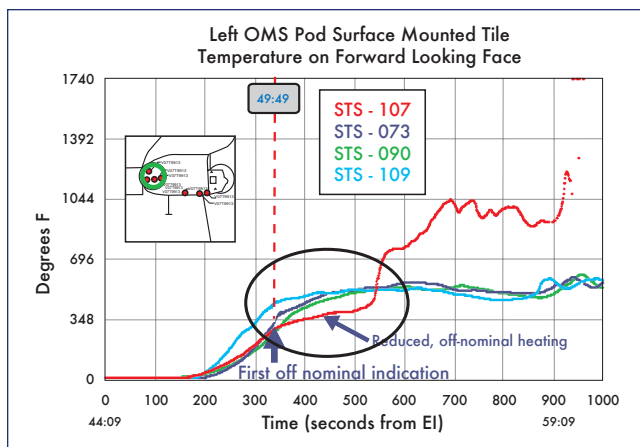
Figure 3.6-9. Orbital Maneuvering System (OMS) pod heating was initially significantly lower than that seen on previous Columbia missions. As wing leading edge damage later increased, the OMS pod heating increased dramatically. Debris recovered from this area of the OMS pod showed substantial pre-breakup heat damage and imbedded drops of once-molten metal from the wing leading edge in the OMS pod thermal tiles.

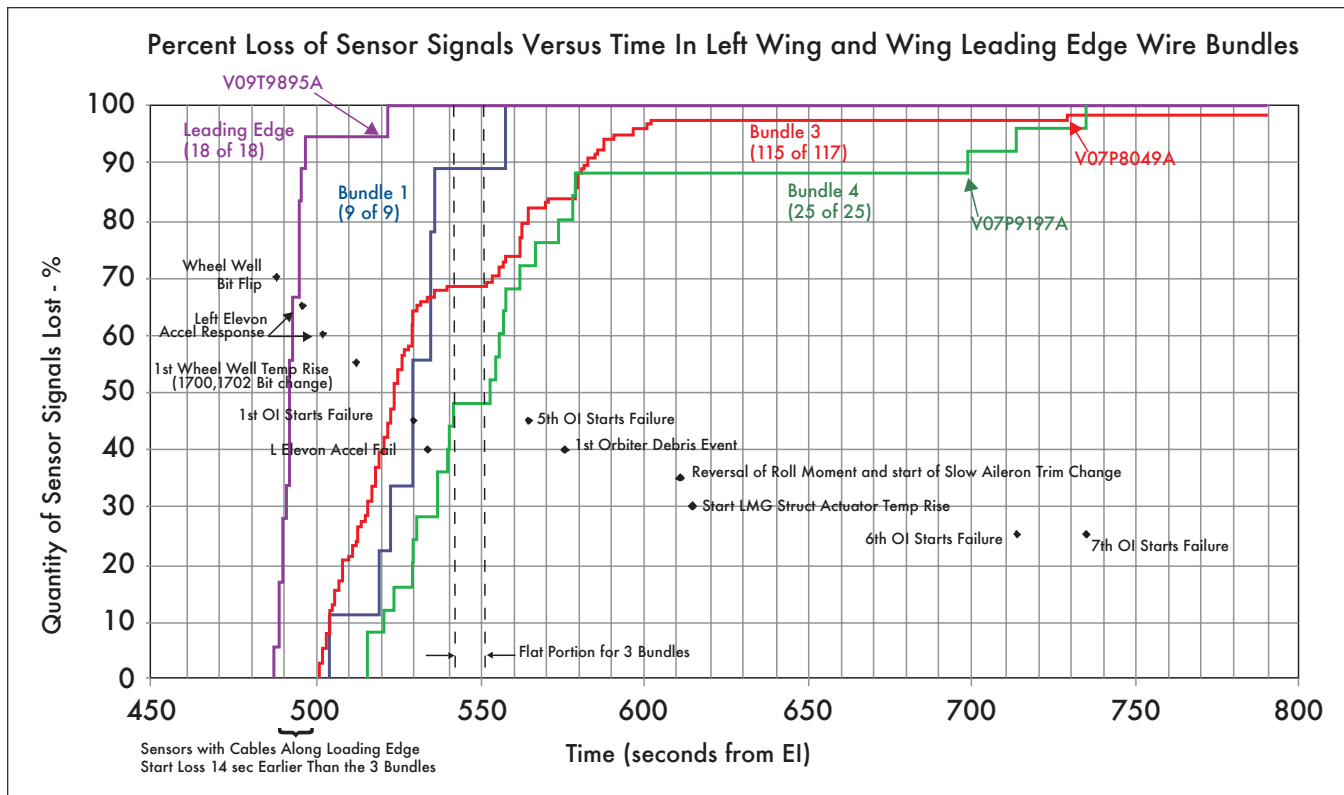
Fourteen seconds after the loss of the first sensor wire on the wing leading edge spar at EI+487, a sensor wire in a bundle of some 150 wires that ran along the upper outside corner of the left wheel well showed a burn-through. In the next 50 seconds, more than 70 percent of the sensor wires in three cables in this area also burned through (see Figure 3.6-10). Investigators plotted the wiring run for every left-wing sensor, looking for a relationship between their location and time of failure.

Figure 3.6-10. This chart shows how rapidly the wire bundles in the left wing were destroyed. Over 70 percent of the sensor wires in the wiring bundles burned through in under a minute. The black diamonds show the times of significant timeline sensor events.

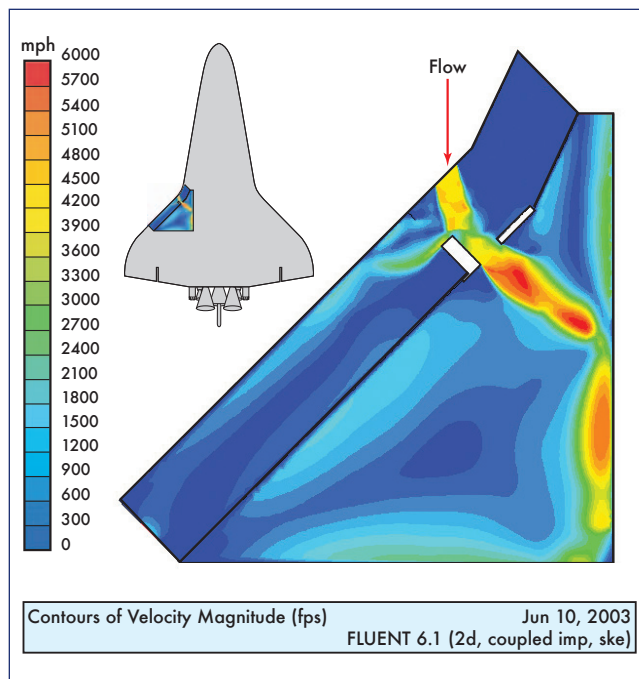
Later computational fluid dynamics analysis of the mid-wing area behind the spar showed that superheated air flowing into a breached RCC panel 8 and then interacting with the internal structure behind the RCC cavity (RCC ribs and spar insulation) would have continued through the wing leading edge spar as a jet, and would have easily allowed superheated air to traverse the 56.5 inches from the spar to the outside of the wheel well and destroy the cables (Figure 3.6-11). Controllers on the ground saw these first anomalies in the telemetry data at EI+613, when four hydraulic sensor cables that ran from the aft part of the left wing through the wiring bundles outside the wheel well failed.

Figure 3.6-11. The computational fluid dynamics analysis of the speed of the superheated air as it entered the breach in RCC panel 8 and then traveled through the wing leading edge spar. The darkest red color indicates speeds of over 4,000 miles per hour. Temperatures in this area likely exceeded 5,000 degrees Fahrenheit. The area of detail is looking down at the top of the left wing.

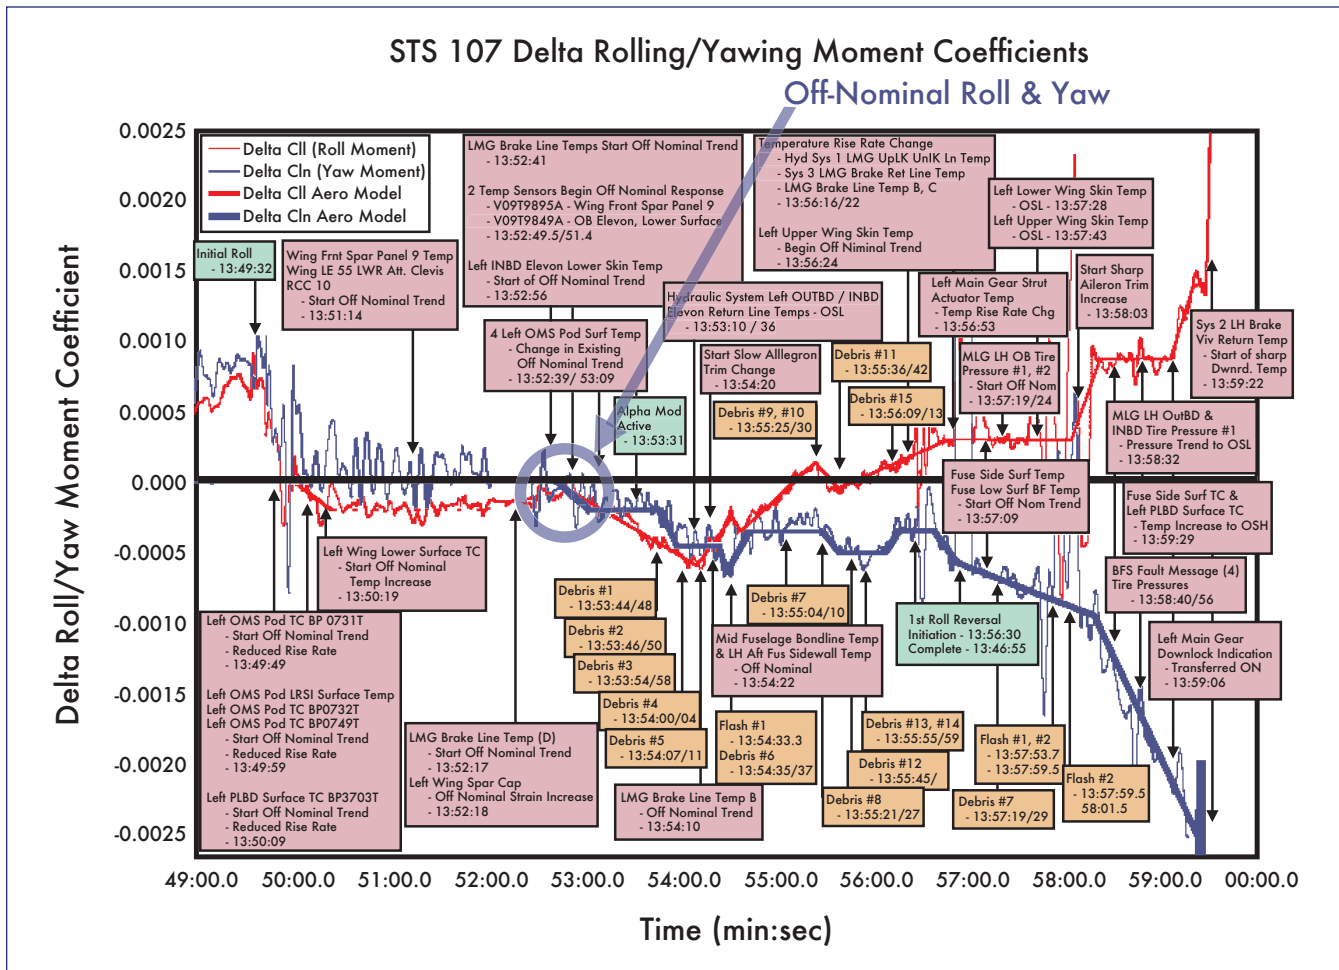
Figure 3.6-12. At approximately EI+500 seconds, the aerodynamic roll and yaw forces began to diverge from those observed on previous flights. The blue line shows the Orbiter's tendency to yaw while the red line shows its tendency to roll. Nominal values would parallel the solid black line. Above the black line, the direction of the force is to the right, while below the black line, the force is to the left.

and to the forces predicted for STS-107. In the early phase of flight, these abnormal aerodynamic forces indicated that *Columbia's* flight control system was reacting to a change in the external shape of the wing, which was caused by progressive RCC damage that caused a continuing decrease in lift and a continuing increase in drag on the left wing.

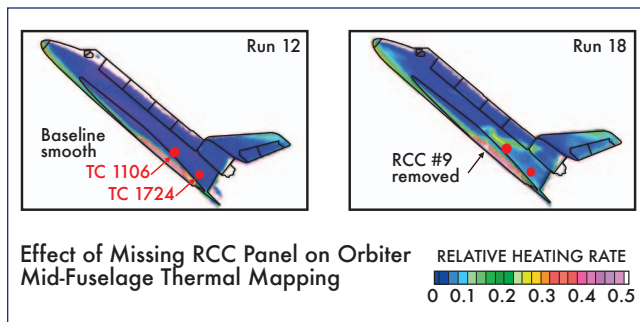
Figure 3.6-13 shows the comparison of surface temperature distribution with an undamaged Orbiter and one with an entire panel 9 removed. With panel 9 removed, a strong vortex flow structure is positioned to increase the temperature on the leading edge of the Orbital Maneuvering System pod. The aim is not to demonstrate that all of panel 9 was missing at this point, but rather to indicate that major damage to panels near panel 9 can shift the strong vortex flow pattern and change the Orbiter's temperature distribution to match the Modular Auxiliary Data System information. Wind tunnel tests also demonstrated that increasing damage to leading edge RCC panels would result in increasing drag and decreasing lift on the left wing.

Figure 3.6-13. The effects of removing RCC panel 9 are shown in this figure. Note the brighter colors on the front of the OMS pod show increased heating, a phenomenon supported by both the OMS pod temperature sensors and the debris analysis.

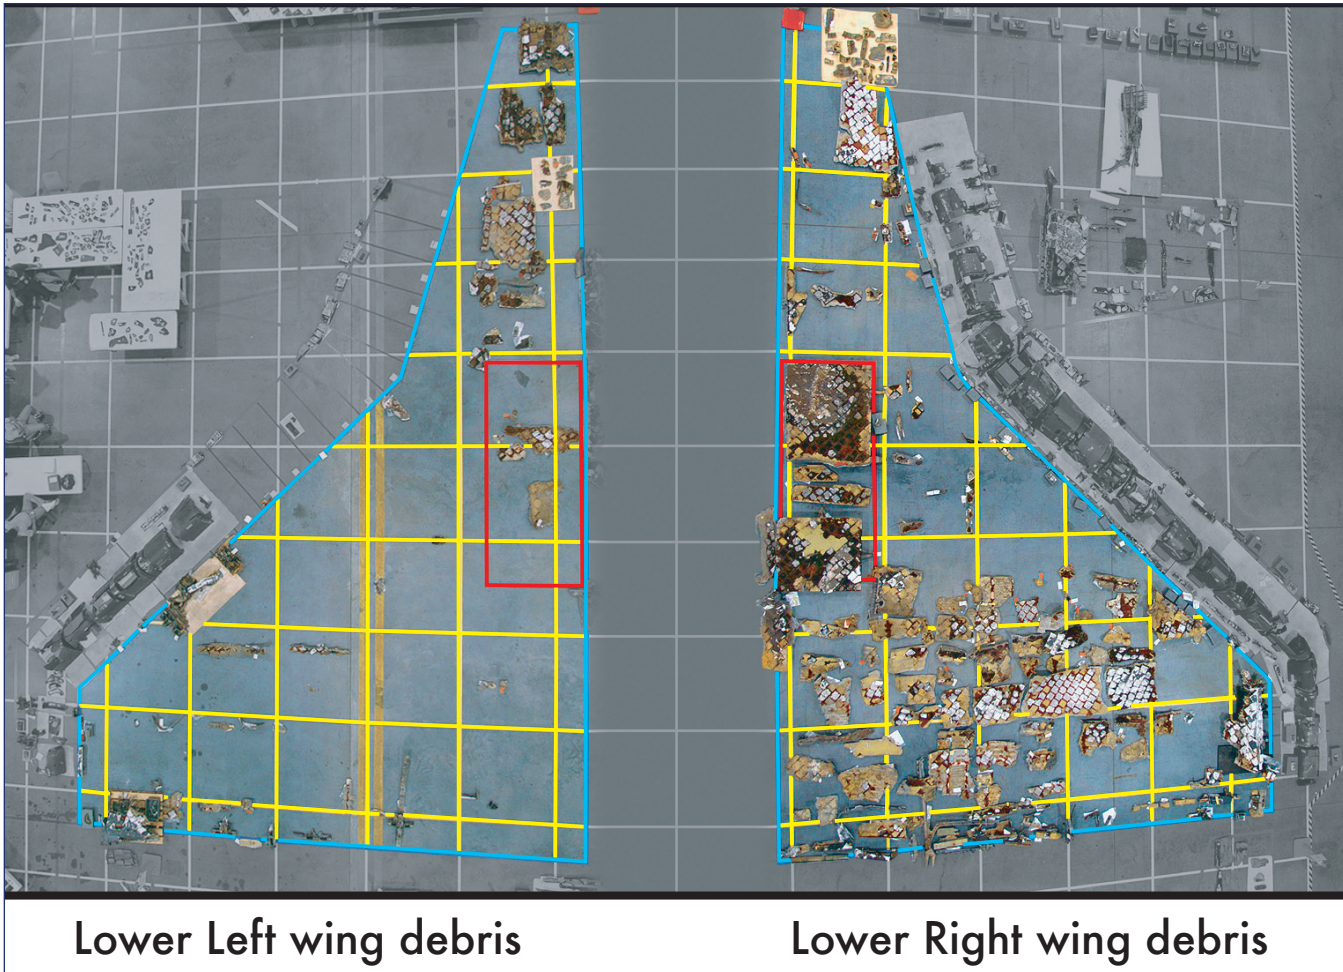
Figure 3.7-1. Comparison of amount of debris recovered from the left and right wings of Columbia. Note the amount of debris recovered from areas in front of the wheel well (the red boxes on each wing) were similar, but there were dramatic differences in the amount of debris recovered aft of each wheel well.

Detailed analysis of the debris revealed unique features and convincing evidence that the damage to the left wing differed significantly from damage to the right, and that significant differences existed in pieces from various areas of the left wing. While a substantial amount of upper and lower right wing structure was recovered, comparatively little of the upper and lower left wing structure was recovered (see Figure 3.7-1).

The difference in recovered debris from the Orbiter's wings clearly indicates that after the breakup, most of the left wing succumbed to both high heat and aerodynamic forces, while the right wing succumbed to aerodynamic forces only. Because the left wing was already compromised, it was the first area of the Orbiter to fail structurally. Pieces were exposed to higher heating for a longer period, resulting in more heat damage and ablation of left wing structural material. The left wing was also subjected to superheated air that penetrated directly into the mid-body of the wing for a substantial period. This pre-heating likely rendered those components unable to absorb much, if any, of the post-breakup heating. Those internal and external structures were likely vaporized during post-breakup re-entry. Finally, the left wing likely lost significant amounts of the Thermal Protection System prior to breakup due to the effect of internal wing heating on the Thermal Protection System bonding materials, and this further degraded the left wing's ability to resist the high heat of re-entry after it broke up.

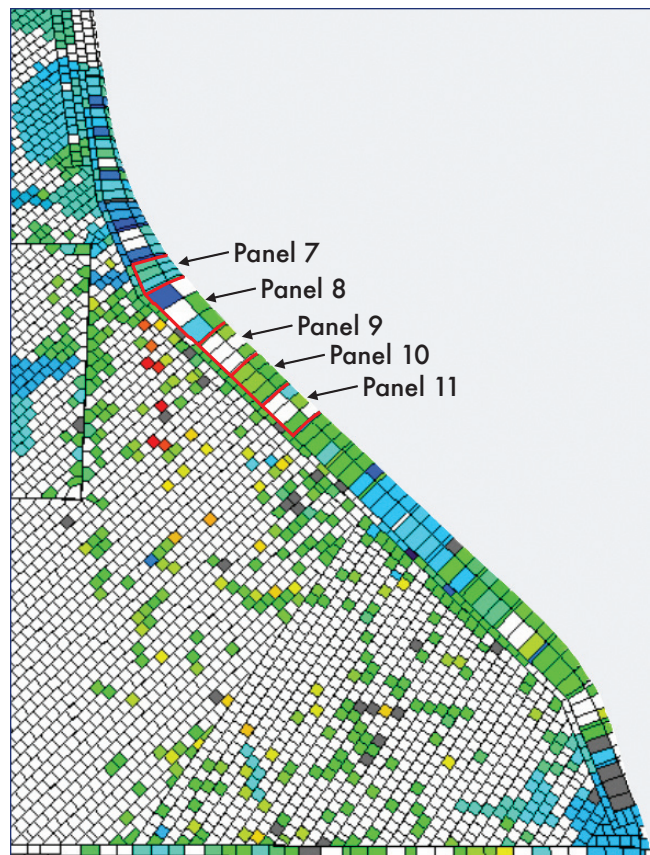
Figure 3.7-6. The tiles recovered farthest west all came from the area immediately behind left wing RCC panels 8 and 9. In the figure, each small box represents an individual tile on the lower surface of the left wing. The more red an individual tile appears, the farther west it was found.

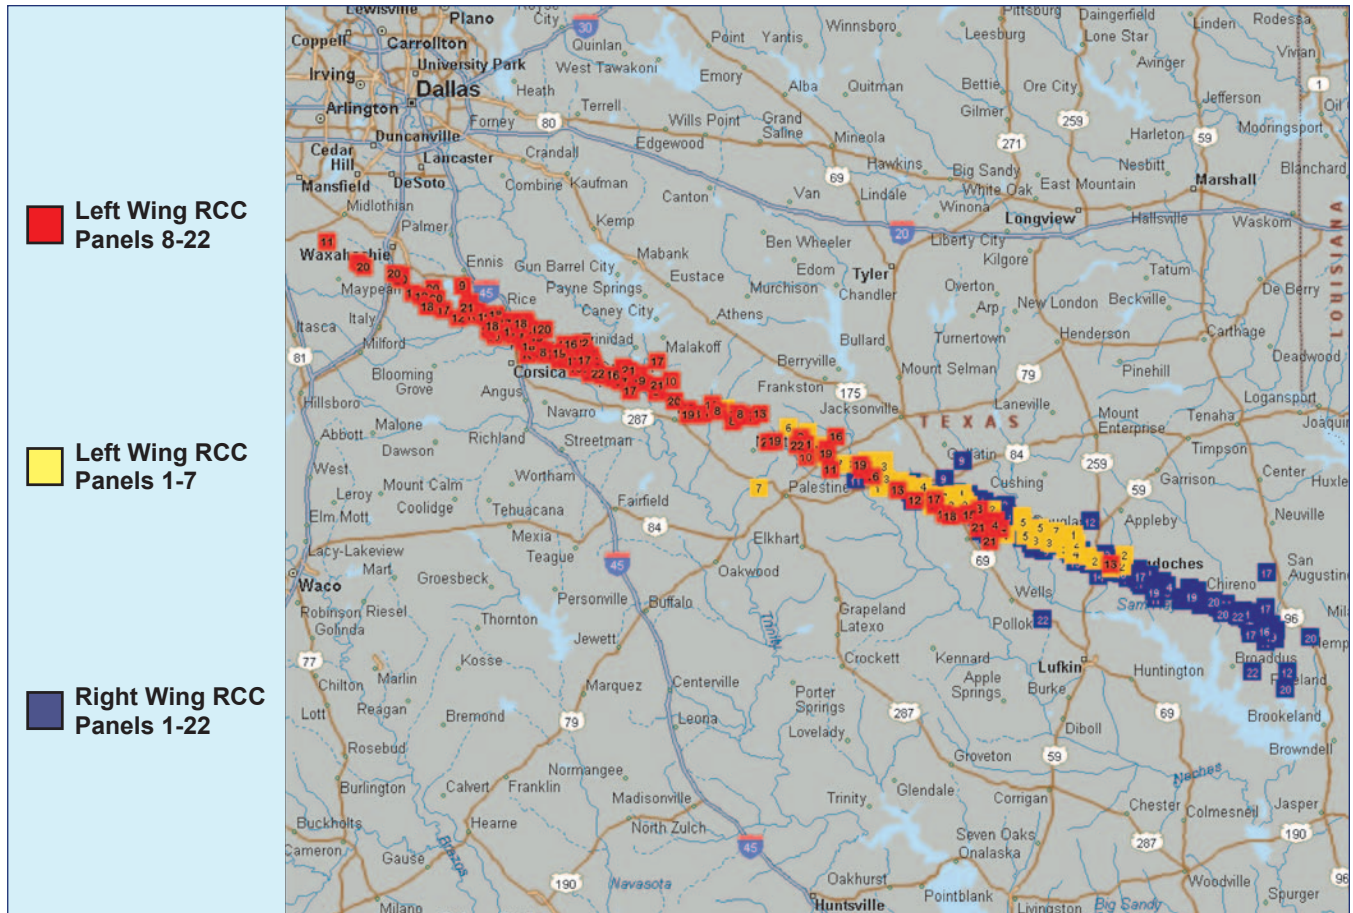
The location of debris on the ground also provided evidence of where the initial breach occurred. The location of every piece of recovered RCC was plotted on a map and labeled according to the panel the piece originally came from. Two distinct patterns were immediately evident. First, it was clear that pieces from left wing RCC panels 9 through 22 had fallen the farthest west, and that RCC from left wing panels 1 through 7 had fallen considerably farther east (see Figure 3.7-5). Second, pieces from left wing panel 8 were

Figure 3.7-5. The location of RCC panel debris from the left and right wings, shown where it was recovered from in East Texas. The debris pattern suggested that the left wing failed before the right wing, most likely near left RCC panels 8 and 9.

found throughout the debris field, which suggested that the left wing likely failed in the vicinity of RCC panel 8. The early loss of the left wing from RCC panel 9 and outboard caused the RCC from that area to be deposited well west of the RCC from the inboard part of the wing. Since panels 1 through 7 were so much farther to the east, investigators concluded that RCC panels 1 through 7 had stayed with the Orbiter longer than had panels 8 through 22.

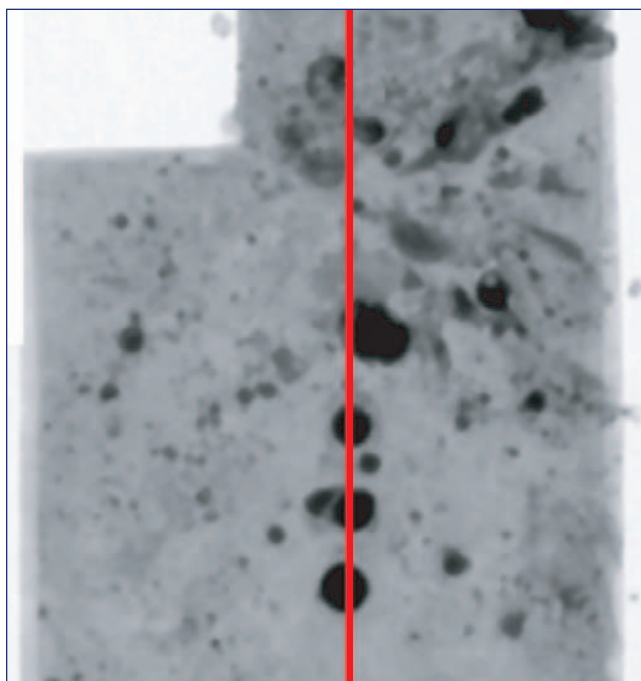
The X-ray analysis of left wing RCC panel 8 (see Figure 3.7-7) showed a bottom-to-top pattern of slag deposits. In some areas, small spheroids of heavy metal were aligned vertically on the recovered pieces, which indicated a superheated airflow from the bottom of the panel toward the top in the area of RCC panel 8-left. These deposits were later determined by chemical analysis to be Inconel 718, probably from the wing leading edge attachment fittings on the spanner beams on RCC panels 8 and 9. Computational fluid dynamics modeling of the flow behind panel 8 indicated that the molten deposits would be laid down in this manner.

Figure 3.7-7. X-ray analysis of RCC panel 8-left showed a bottom-to-top pattern of slag deposits.

The layered deposits on panel 8 were also markedly different from those on all other left- and right-wing panels. There was much more material deposited on RCC panel 8-left. These deposits had a much rougher overall structure, including rivulets of Cerachrome slag deposited directly on the RCC. This indicated that Cerachrome, the insulation that protects the wing leading edge spar, was one of the first materials to succumb to the superheated air entering through the breach in RCC panel 8-left. Because the melting temperature of Cerachrome is greater than 3,200 degrees Fahrenheit, analysis indicated that materials in this area were exposed to extremely

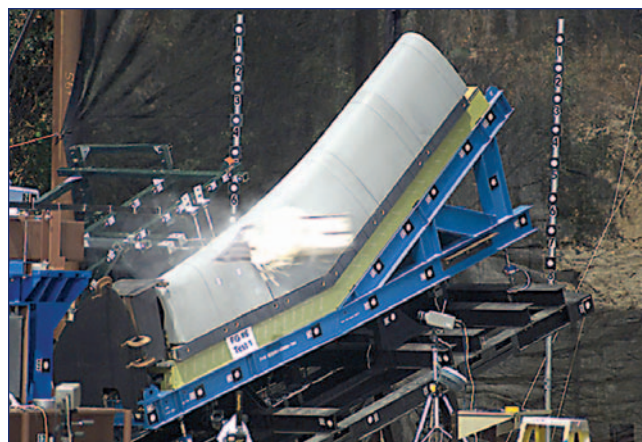
Figure 3.8-5. A typical foam strike leaves impact streaks, and the foam projectile breaks into shards and larger pieces. Here the foam is striking Panel 6 on a fiberglass test article.

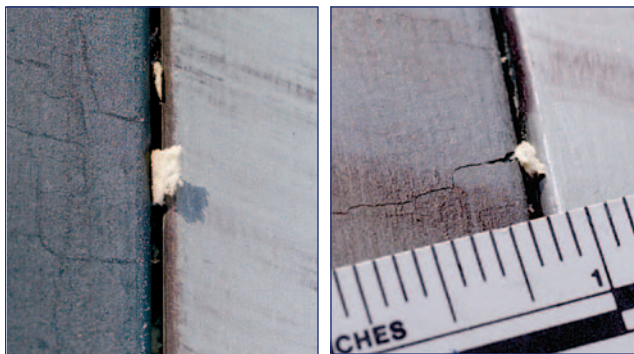
Figure 3.8-8. Two views of foam lodged into the slit during tests.
