COLUMBIA

ACCIDENT INVESTIGATION BOARD

REPORT VOLUME I
AUGUST 2003

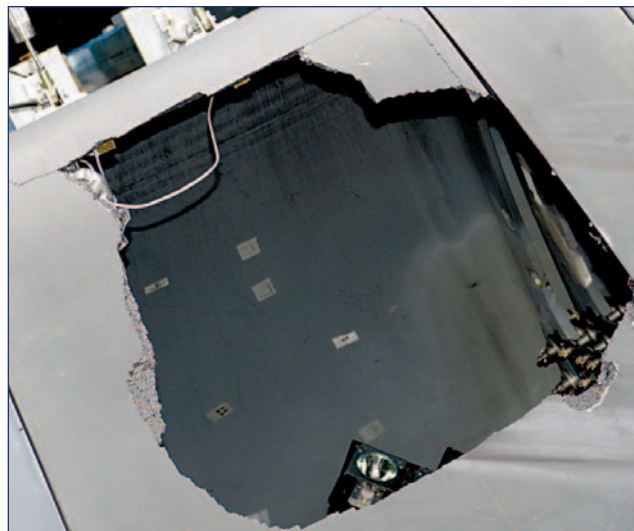
Figure 3.8-9. The large impact hole in Panel 8 from the final test.

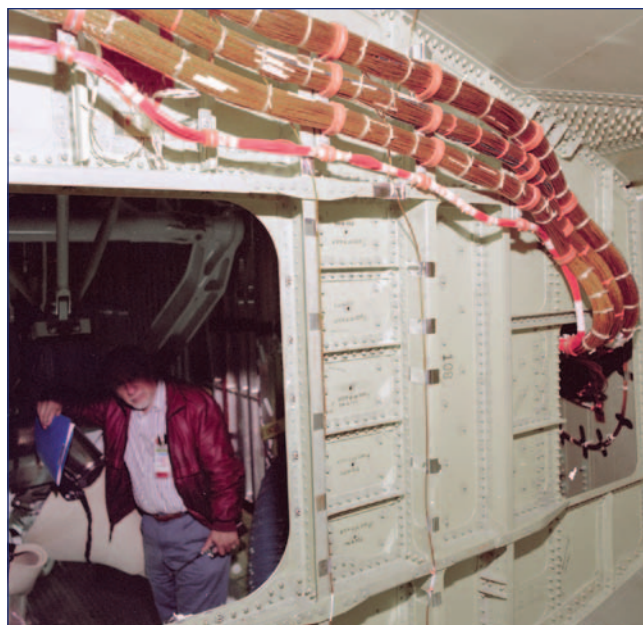
Figure 4.2-3. Typical wiring bundle inside Orbiter wing.

A typical wiring bundle is shown in Figure 4.2-3. Wiring nonconformances are corrected by rerouting, reclamping, or installing additional insulation such as convoluted tubing, insulating tape, insulating sheets, heat shrink sleeving, and abrasion pads (see Figure 4.2-4). Testing has shown that wiring bundles usually stop arc tracking when wires are physically separated from one another. Further testing under conditions simulating the Shuttle's wiring environment demonstrated that arc tracking does not progress beyond six inches. Based on these results, Boeing recommended that NASA separate all critical paths from larger wire bundles and individually protect them for a minimum of six inches beyond their separation points.⁴ This recommendation is being adopted through modifications performed during scheduled Orbiter Major Modifications. For example, analysis of telemetered data from 14 of *Columbia's* left wing sensors (hydraulic line/wing skin/wheel temperatures, tire pressures, and landing gear downlock position indication) provided failure signatures supporting the scenario of left-wing thermal intrusion, as opposed to a catastrophic failure (extensive arc tracking) of Kapton wiring. Actual NASA testing in the months following the accident, during which wiring bundles were subjected to intense heat (ovens, blowtorch, and arc jet), verified the failure signature analyses. Finally, extensive testing and analysis in years prior to STS-107 showed that, with the low currents and low voltages associated with the Orbiter's instrumentation system (such as those in the left wing), the probability of arc tracking is commensurately low.

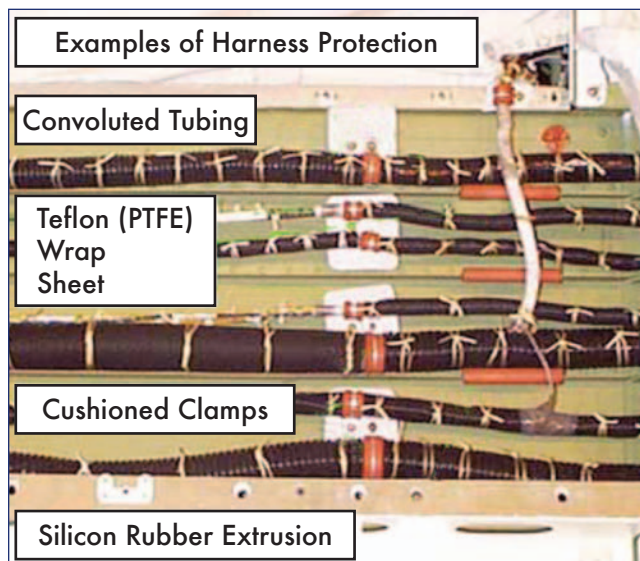
Figure 4.2-4. Typical wiring harness protection methods.

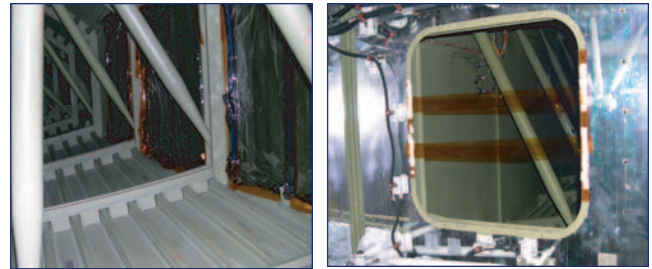
Figure 4.2-5. At left, a wing section open for inspection; at right, wing access closed off after inspection.
