**COMMITTEE FOR THE RE-INVESTIGATION OF
THE SMOLENSK AIR CRASH**

TECHNICAL REPORT

**This report contains facts regarding the crash of the TU-154M
No. 101 (Fight PLF101) that took place near
SMOLENSK NORTH airport, Russia on April 10th, 2010.**

WARSAW 2018

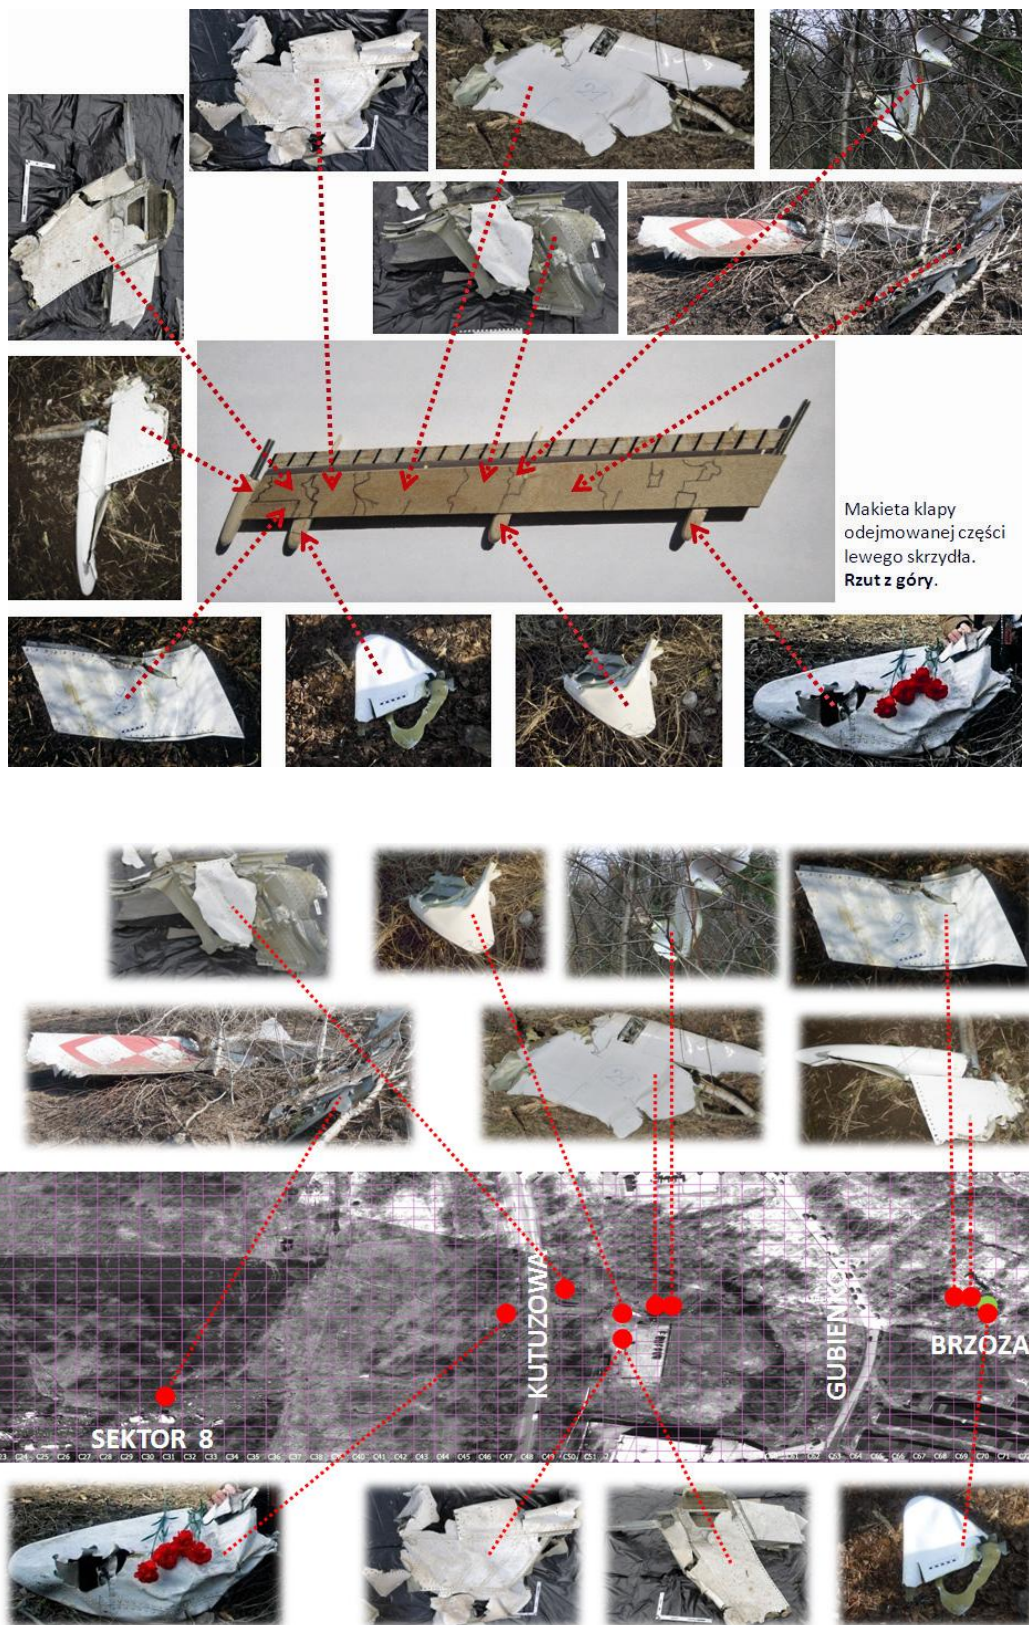
The majority of elements from the flaps of the detachable wing part were scattered from the 'bb tree' in the direction of the main crash site in an area that spanned 15m-225m in the flight direction of the TU-154M. (Fig. 20).

Fig. 20. The locations on the ground of various parts from the left wing.

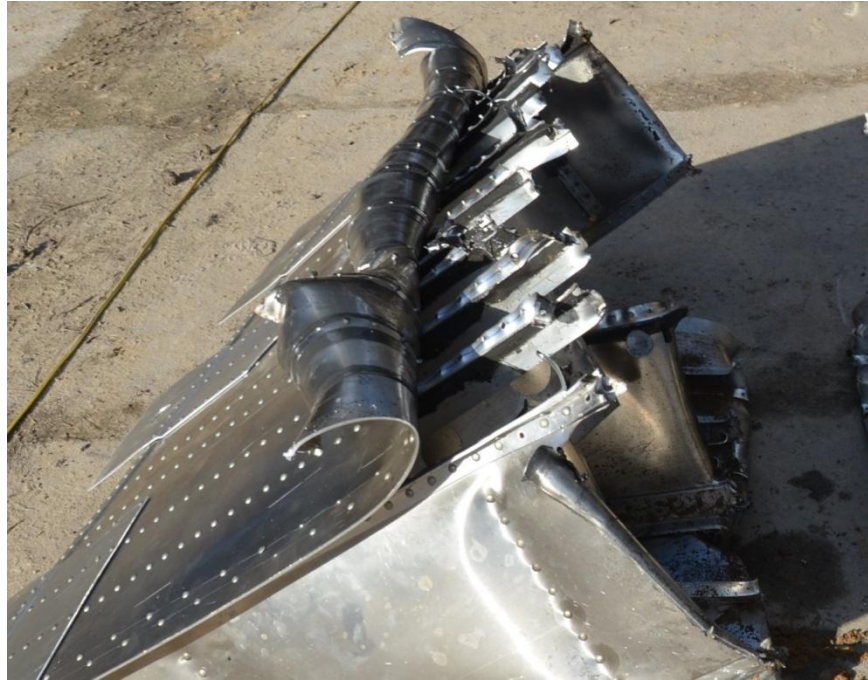
The experiments carried out by the KBWLLP Committee in March 2018 on the wing fragment model (Scale 1: 4 and 1: 1) show that a wing with fuel and fuel vapors can be destroyed by explosive charges without a major fuel explosion and with many observed features similar to the destruction of the wing tip of the TU-154M that crashed in Smolensk. (Fig. 23 and Fig. 24)

Fig. 23. Separation by explosive material of the wing box containing fuel (Scale 1:1). The experiment demonstrated the wing could be cut (destroyed?-) without a secondary, major fuel explosion.

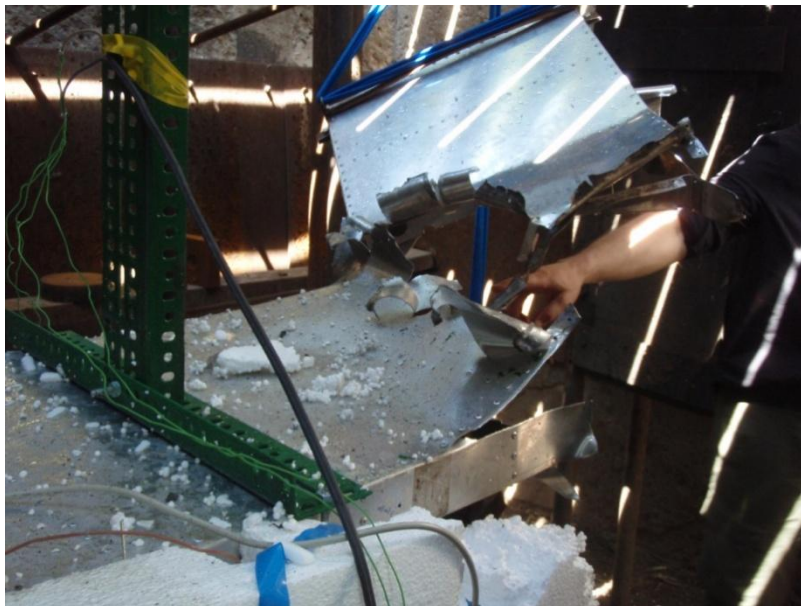
Fig.24. Experiment (model on a 1:4 scale) of cutting a wing with fuel with the use of 6g/m PETN Cord Note in the direction of curls away from the area of high internal pressure. The experiment demonstrated the wing could be cut without a secondary, major fuel explosion.

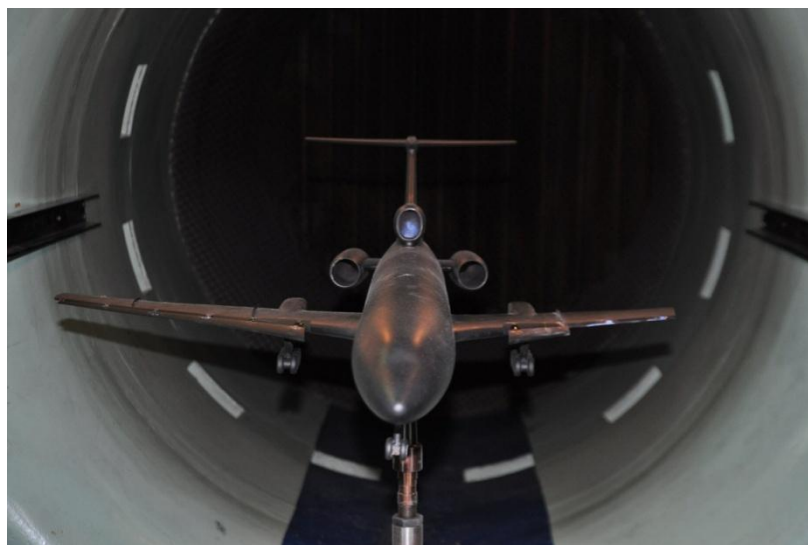
Experiments in an aerodynamic tunnel, conducted in IL, showed that the loss of lift between 4.8% and 8.7%, due to the loss of the left wingtip, does not necessarily result in a left roll. Those experiments show that the pilots, even with an angle of impact up to 11.5degrees, can fully balance the rolling moment by introducing a 7-degree side slip (i.e. they have to change the configuration of the plane in such a way that the left wing is moved forward). Further balancing is possible with the move of the right aileron. A side slip is an element of basic aviation training and instinctive for experienced pilots, who use this technique during situations with cross-wind. When losing 1/3 of the left wing, the decreased wind resistance on this side will result in a right-turn of the plane towards the sideslip resulting in the left wing facing towards the front. (Fig. 25).

Fig. 25. Airplane model in the wind tunnel of the Institute of Aviation. This version includes a cut left wing and is without slats and the outer flap.

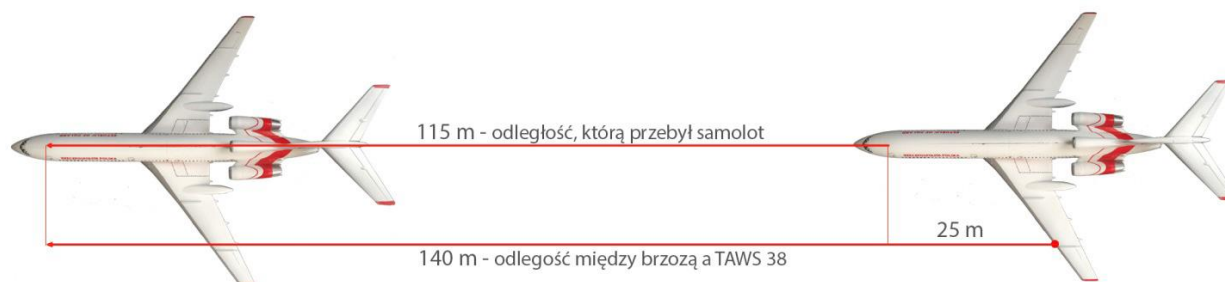
The distance between the Bodin tree ('bb') and TAWS38 is approx. 140m. The distance that the plane traveled between the location of supposed contact of the wing with the 'bb' tree, as assumed in the Miller and MAK reports, and TAWS 38 is 115m.

Fig. 26. The difference in distance from the tree claimed to have made wing contact to TAWS38 (140m) and the distance that the plane travelled (115m). The distances are different as the GPS antennas are located 25m in front of the hypothetical zone of contact.

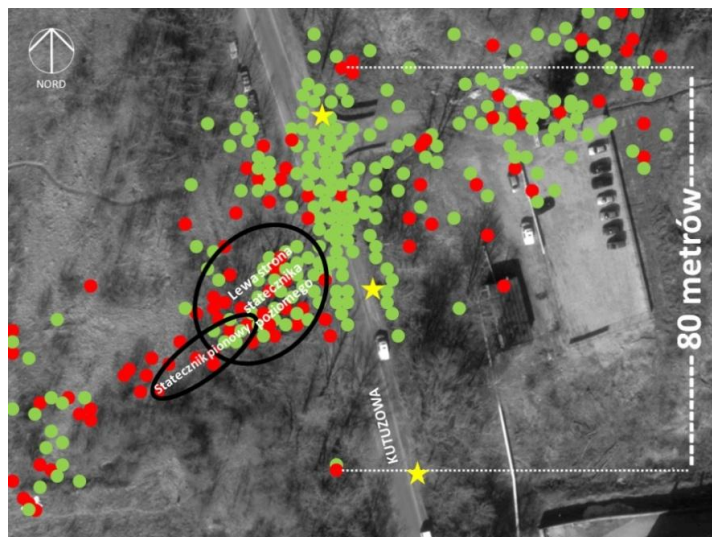
One line of debris from the left horizontal and vertical stabilizers (stemming from the area, where it was connected to the horizontal stabilizer) behind Kutuzov Street, shows that the roll of the plane was large, and the dispersion of parts falling off of the plane and destroyed branches, points to a sudden destruction of the plane in the air (Fig. 27).

Fig. 27. Placement of the horizontal stabilizer and the vertical stabilizer on the left side of the Kutuzov highway. The flight direction is from right to left. Red dots show debris from the Tu-154M, and green dots show debris from the associated tree damage.

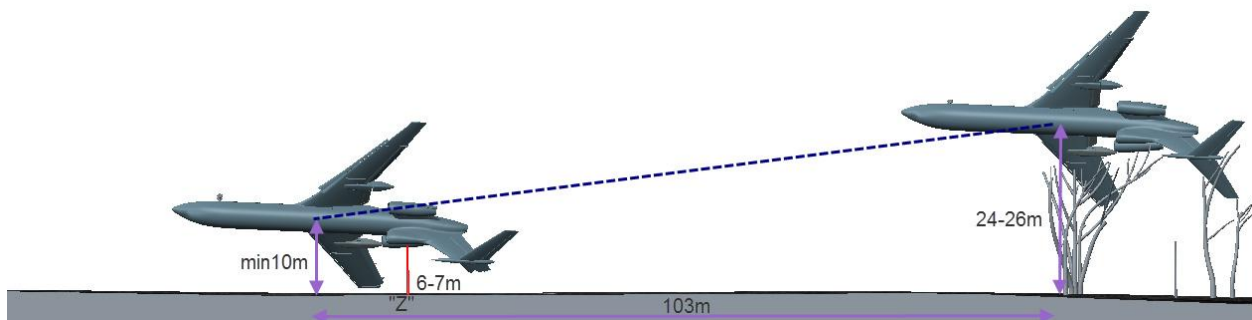
A tree of 6-7m in height is marked with the letter "Z" on fig 29 to fig. 31b and is directly above the trajectory of the flight. It was not damaged by the plane, which means that the altitude to the balance point in that moment, when the tail passes the "Z" tree, is at least 10m.

Fig. 29. A view to the north in the moment when the plane flies from Kutuzov street (right) to the crash site (left). The 6-7m tall tree is marked with the letter "Z".

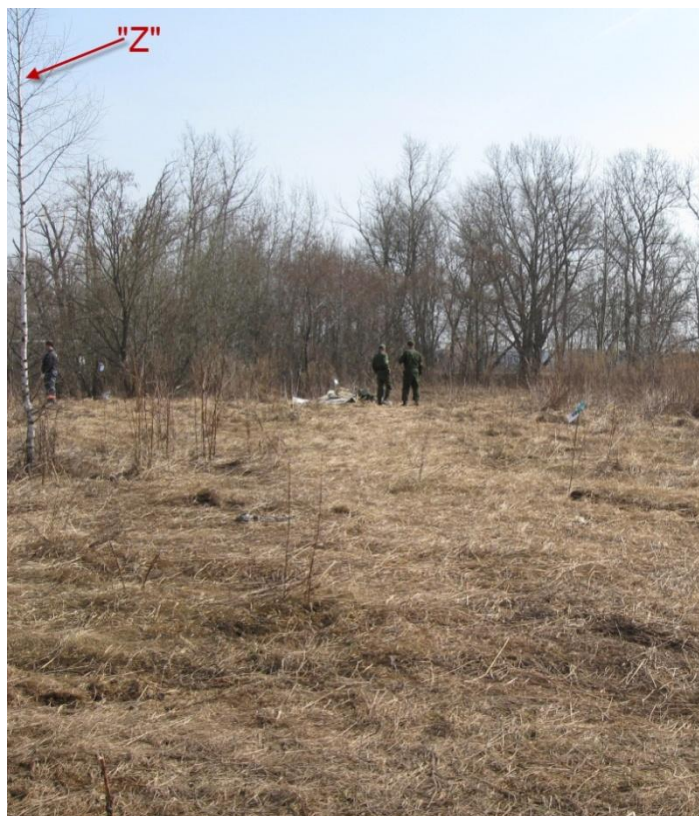
Fig. 30. The tree marked "Z" growing in the direct vicinity of the flight path, where the plane was flying from Kutuzov Street (in the background) to the place of the crash. On the right side, starting at the blue marker on a tall stem, there is a visible trace in the ground, where the left stabilizer ploughed through.

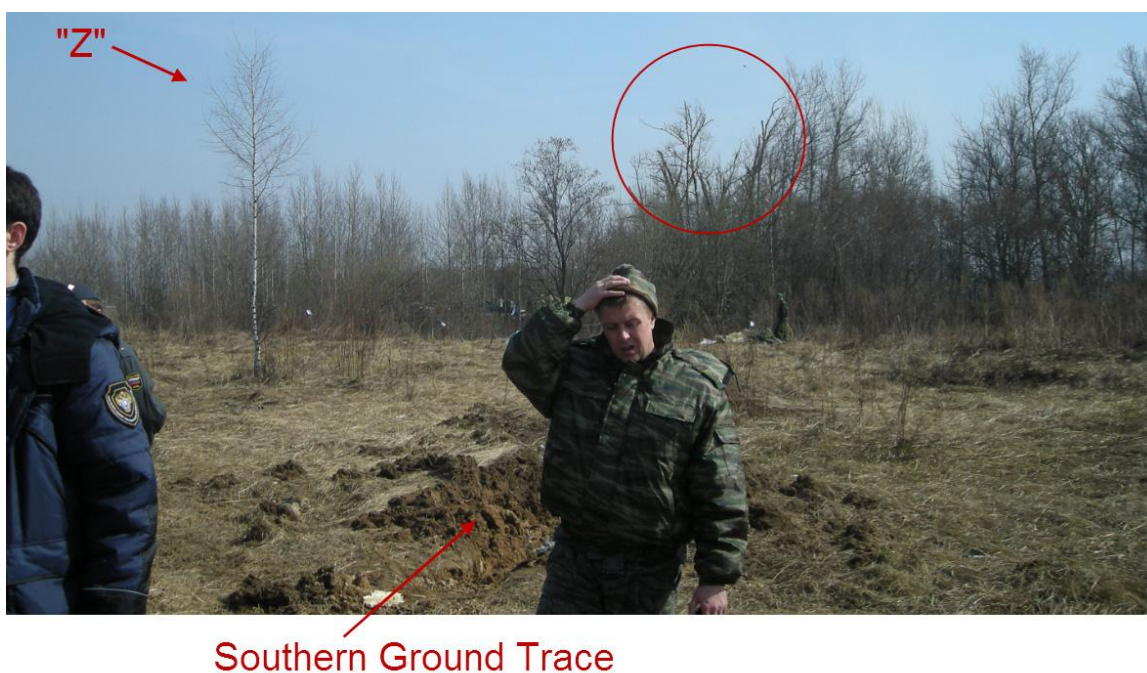
Fig. 31a. The tree marked "Z" growing in the direct vicinity of the flight path, where the plane flew from Kutuzov Street (red circle) to the place of crash. The ground trace from the tail is visible and marked here as "Southern Ground Trace".

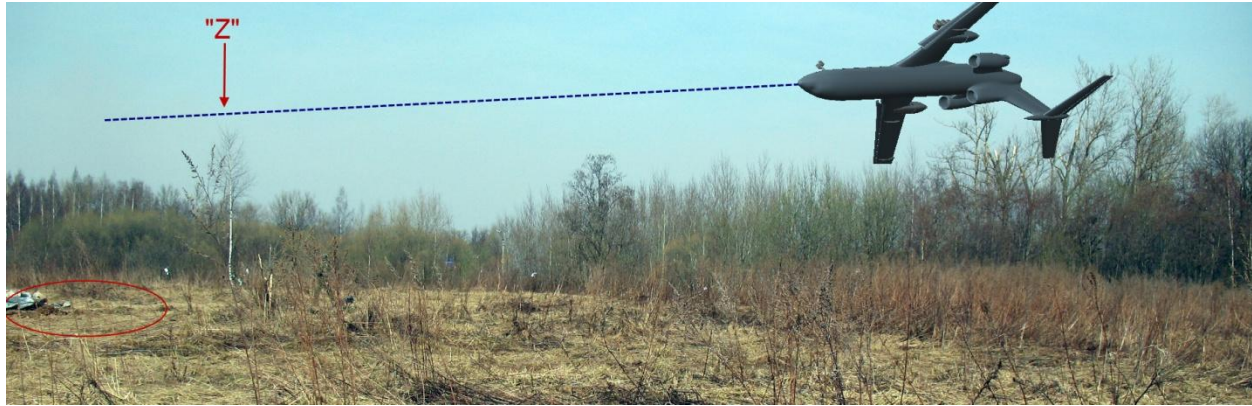
Fig. 31b. The tree marked "Z" growing in the direct vicinity of the flight path, where the plane was flying from Kutuzov Street (right side) to the place of crash (left side). The trace in the ground from the tail's collision is visible and marked with a red oval. The white part inside the oval shows the new position of the left horizontal stabilizer after the Russians moved it 35m closer to the crash site.

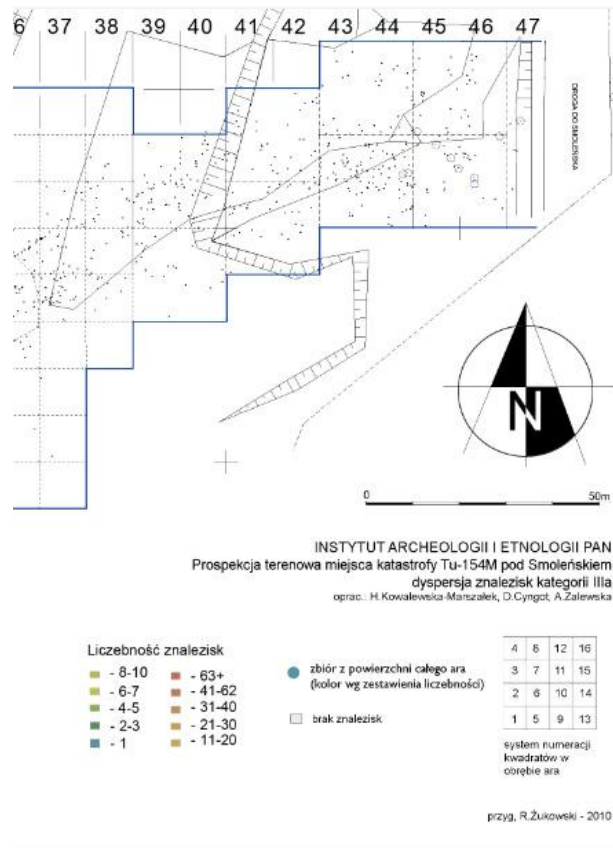
Numerous pieces of the plane were found during a terrain analysis, performed by Polish archeologists in Smolensk in October 2010, in sector 13, behind Kutuzov Street and before the main crash site (fig 32). These pieces, ranging in size from a couple to tens of square centimeters, had traces of thermal and mechanical effects (fig 33).

Fig. 32. A map from the archeological report showing where pieces were found behind Kutuzov street (marked "the road to Smolensk" at the right).

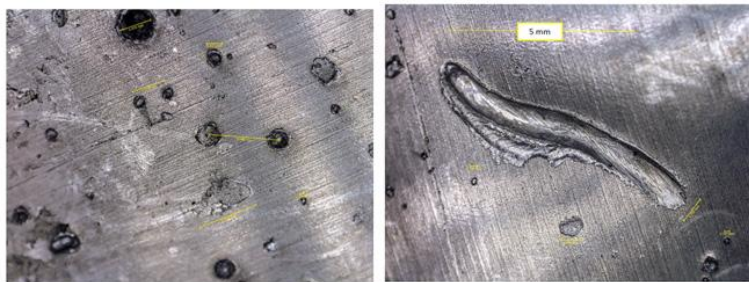
This feature is typical for explosive destruction.

Fig. 34. Comparison of micro craters on the surface of the debris found by archeologists and debris created after the pyrotechnical experiments.

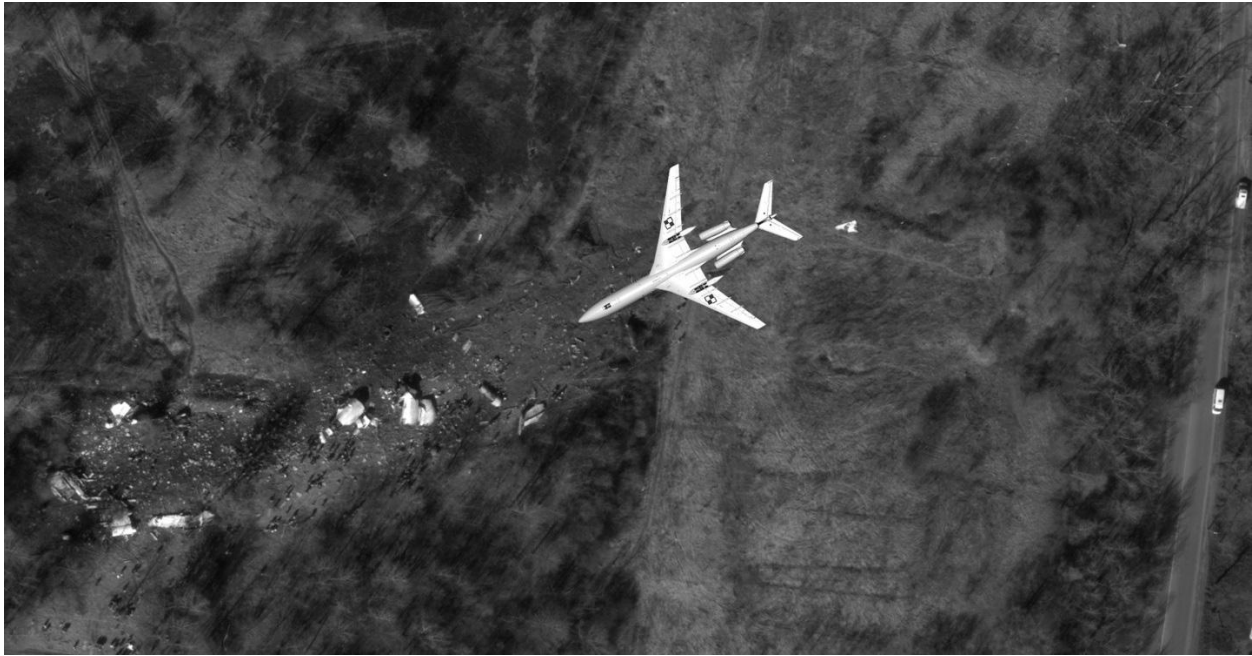
The view of the crash site, with very scattered debris, compared to the shape of TU-154M in a 1:1 proportion shows that the pieces of the plane fell as a result of an explosion in the air, and did not disintegrate during the sliding on the ground. There is no evidence of a ground collision, no visible crater or trace like the one from the stabilizer analyzed earlier. (Fig. 35).

Fig. 35. A view of the crash site compared to TU154M in reverse position in correct scale.

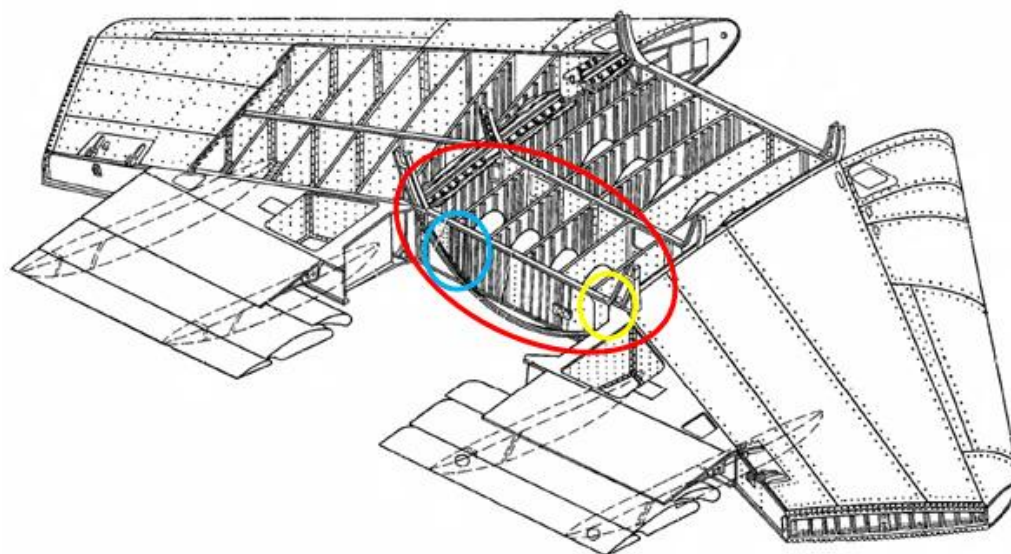
Fig. 39. The center wing box of TU-154M. Highlighted in red, the fuel box no.1.

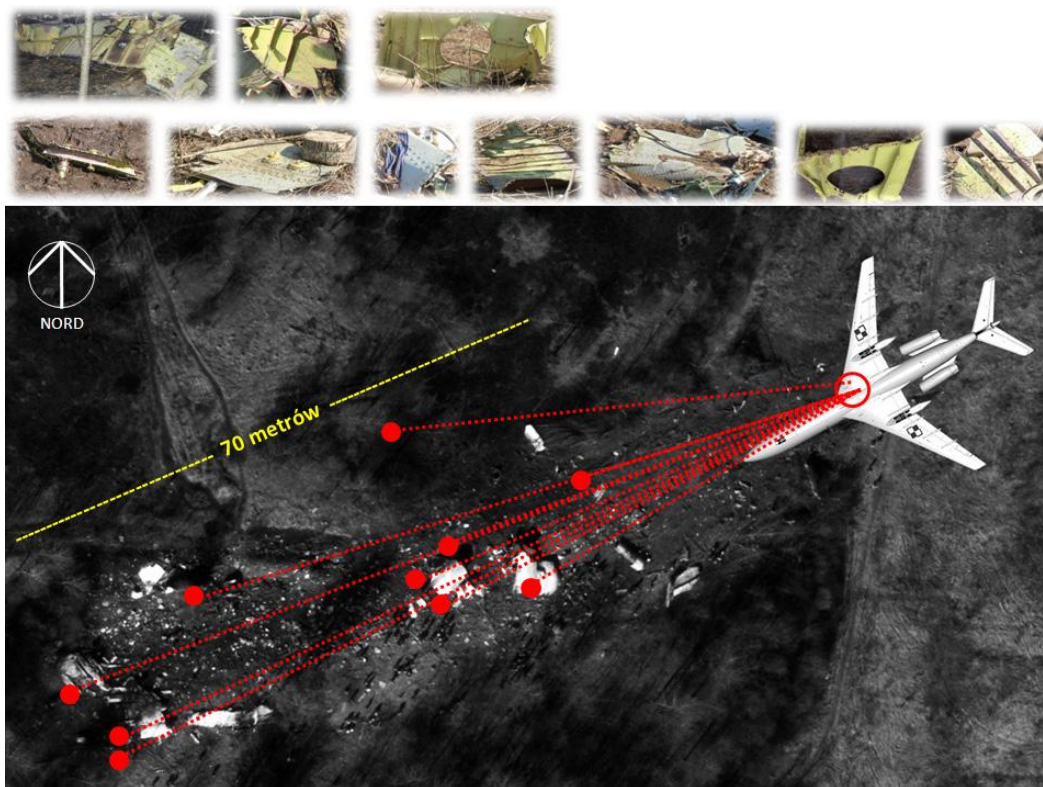
Fig. 41. The general dispersion of the pieces of the center wing on the crash site, with the distance and place where the most important pieces fell. The torn pieces of the rear spar No.3 of fuel box No.1 of the central part of the center wing.

The torn pieces of the rear spar no.3 of the fuel box no.1 of the central part of the center wing confirms the theory that its destruction was the result of an explosion and not a hydraulic impact to its front wall during the fall of TU154M to the ground.

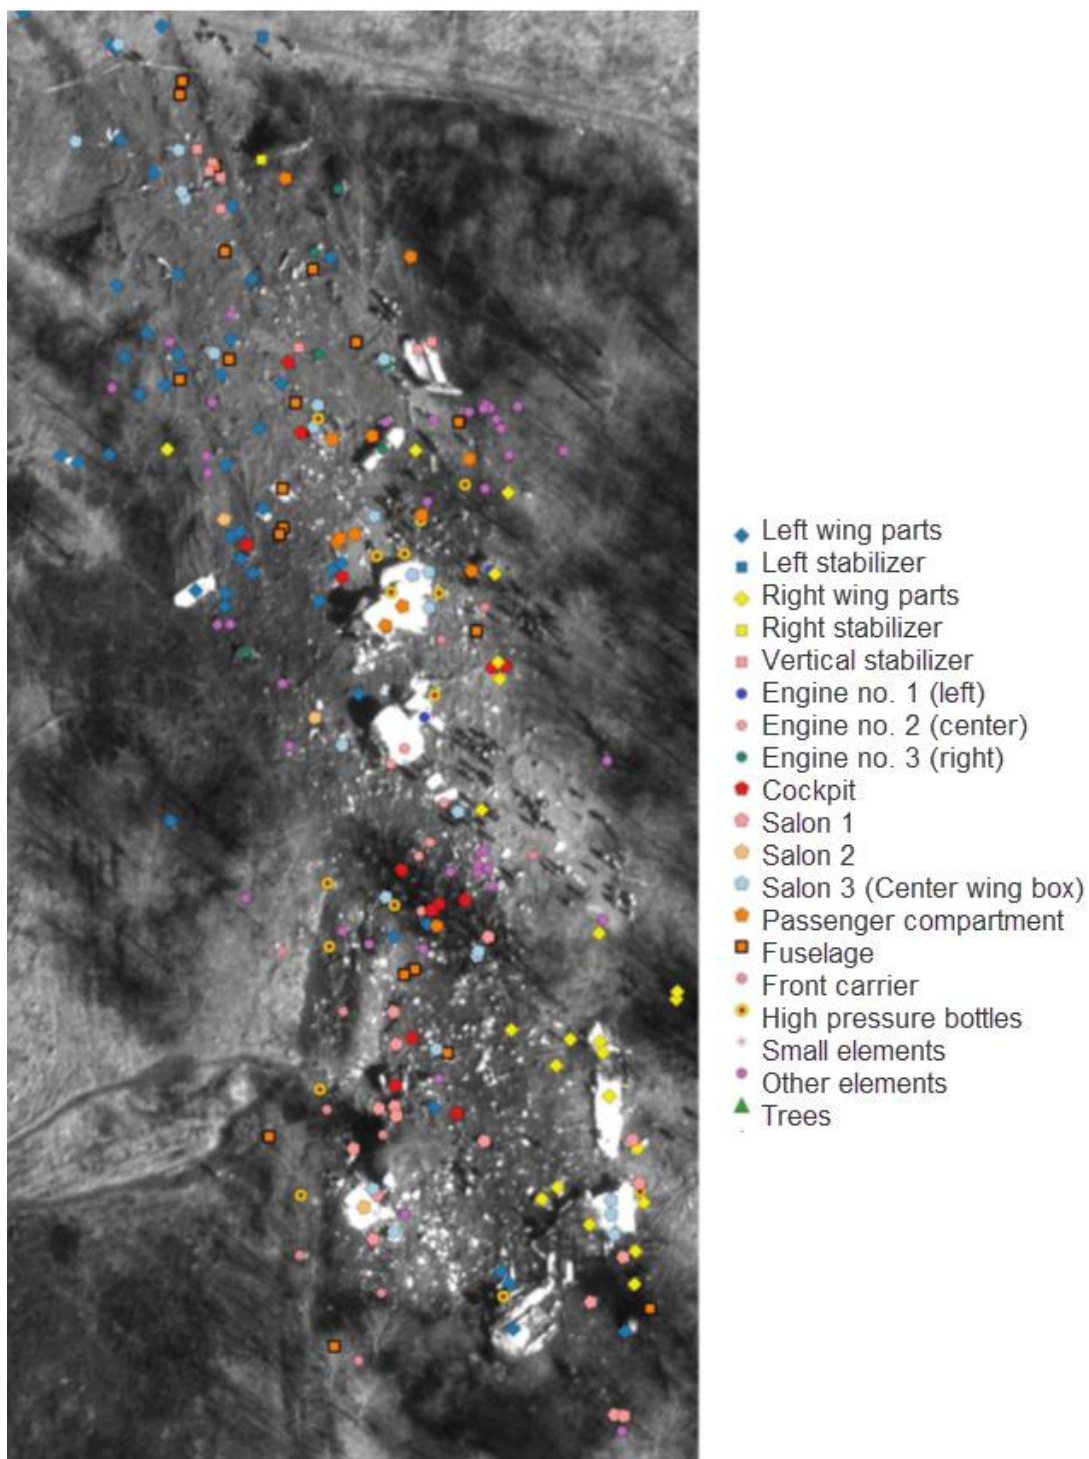
Fig. 43. Dispersion of the aircraft debris. Study of the Committee. The direction of the flight is from top left corner and down towards bottom right corner.

The TU154M aircraft disintegrated into more than 60,000 pieces. The majority of the elements were rammed into the ground, and though located, they were never extracted. 10,000 pieces were collected 6 months after the crash. To date, the number of elements of the debris that were not removed from the ground to be moved to storage has not been calculated.

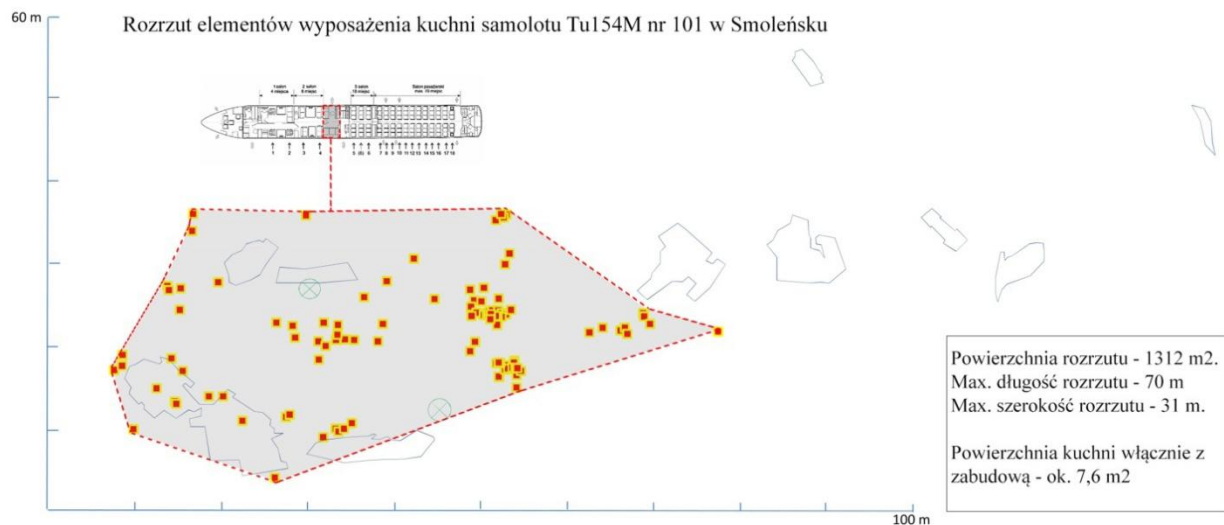
The less than 8m² galley area was found scattered over an area of more than 1300m² in small fragments.

Fig.45. Parts of the galley being before the third salon were distributed in the shown region on an area of 1312m².

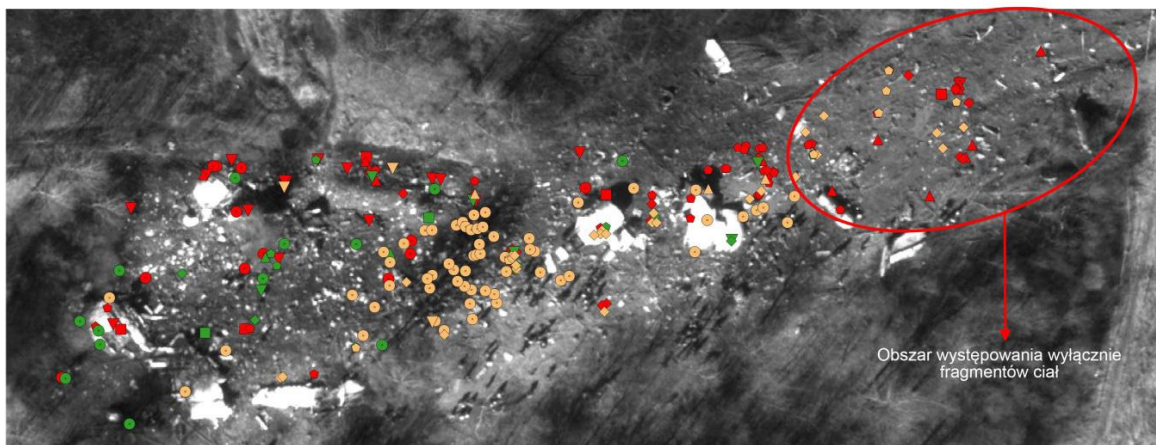
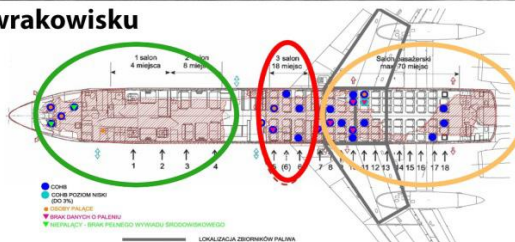
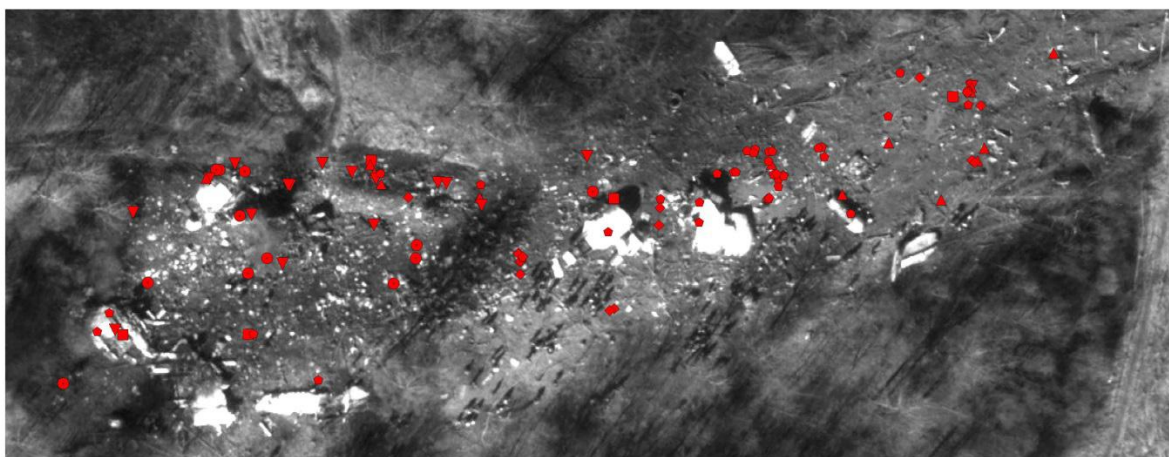
All 96 passengers and crew onboard the aircraft died. The remains were scattered outside of the fuselage, just as the seats on which they were sitting, as well as the floor-covering and insulation. At the beginning of the crash site, apart from pieces of the plane debris, only small, torn body parts of victims were found, including numerous, identified internal organs, which prove that even before the plane hit the ground, the bodies of the passengers sitting in the center part of the aircraft cabin (section no.3) were impacted and torn into pieces. (Fig. 46)

Fig.46. Location of bodies on the crash site. Only small body fragments and intestines were found in the area circled at the top picture often at a far distance from the main body. The fuselage was more than 6m above the ground when passing this area. Whole bodies are marked with a red circle.

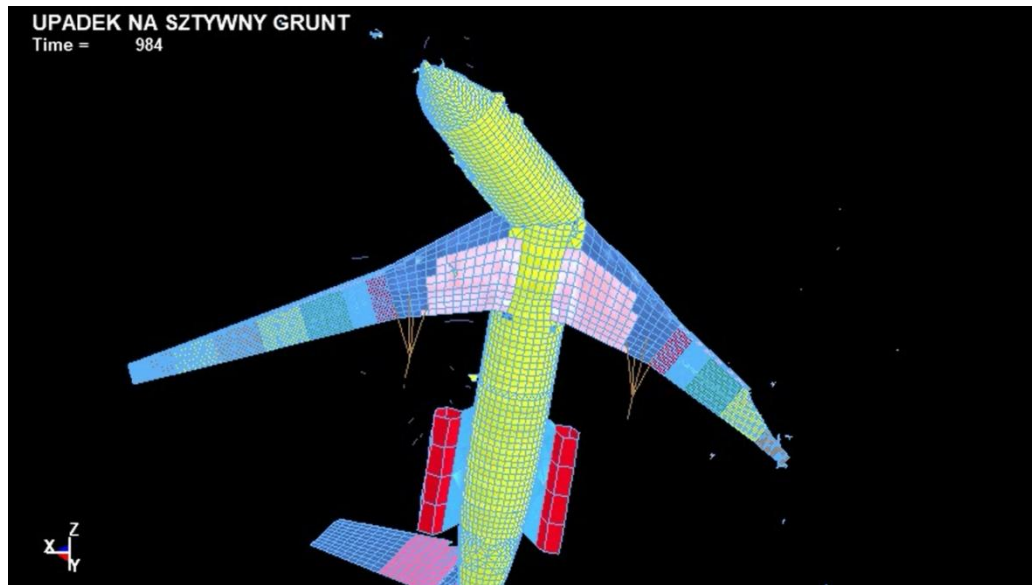
Fig. 47. Simulation of the disintegration of an airplane hitting the ground (concrete). The aircraft breaks into only a few parts.

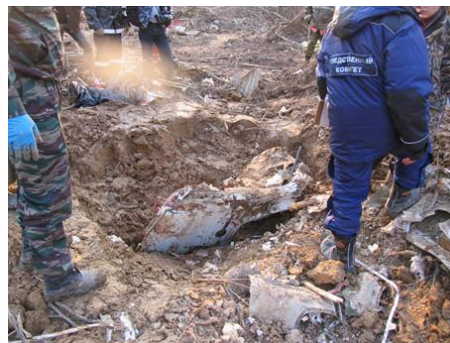
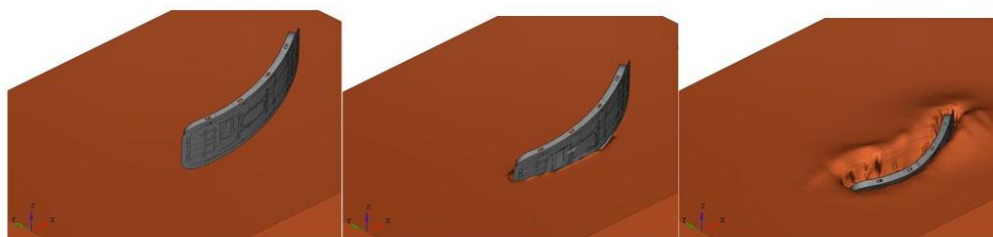
Figure 48 shows results from NIAR's simulation of the door hitting soft ground and the door 1meter in the ground as Russians were digging it out by hand.

When pulling the left passenger door 2L, driven over 1m into the ground, a human hand and forearm were found near the door handle. Source: Images of the door driven into the ground

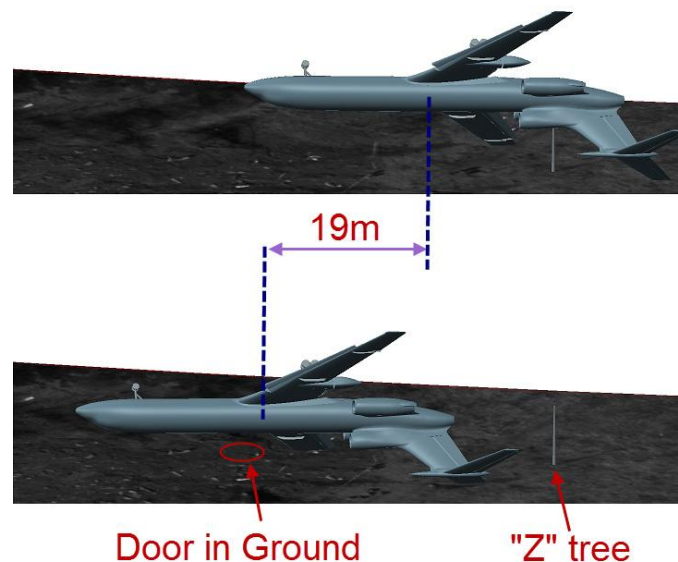
Fig. 49. The position of the plane the moment it passes the Z tree and the position of the plane above the rammed door.

The distance between the trees west of the street and the tree marked "Z" is about 103m. and the time it takes to travel this distance can be found as $\Delta t = 103\text{m}/75\text{m/s} = 1.37\text{s}$

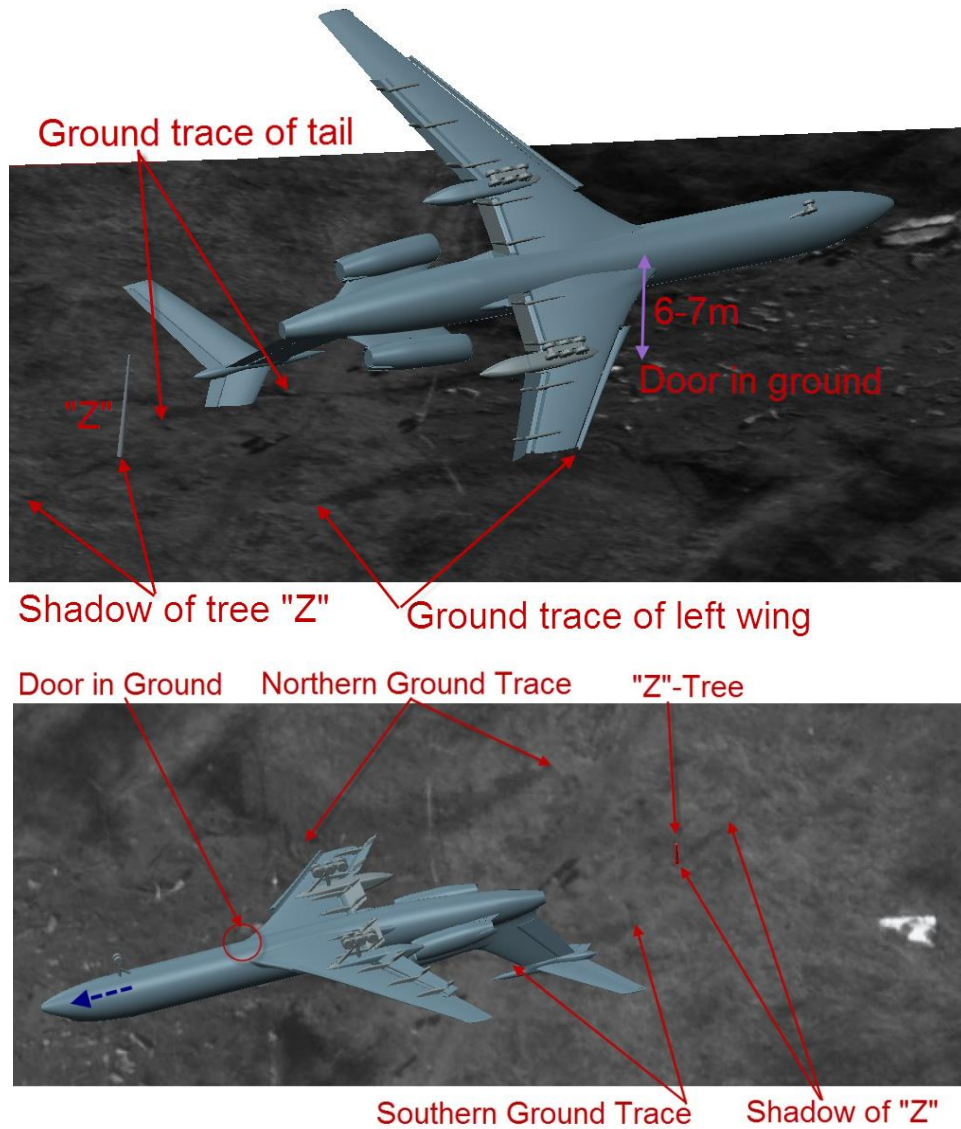
Pic.50. The moment the plane hits the ground

Analysis of the traces in the ground indicates the left roll of the aircraft to be about 130° when the remains of the left wing touched the ground at the beginning of the main crash site. They indicate the height above the ground of about 6-7m when the fuselage is positioned with the left passenger door above the location it was in the ground.

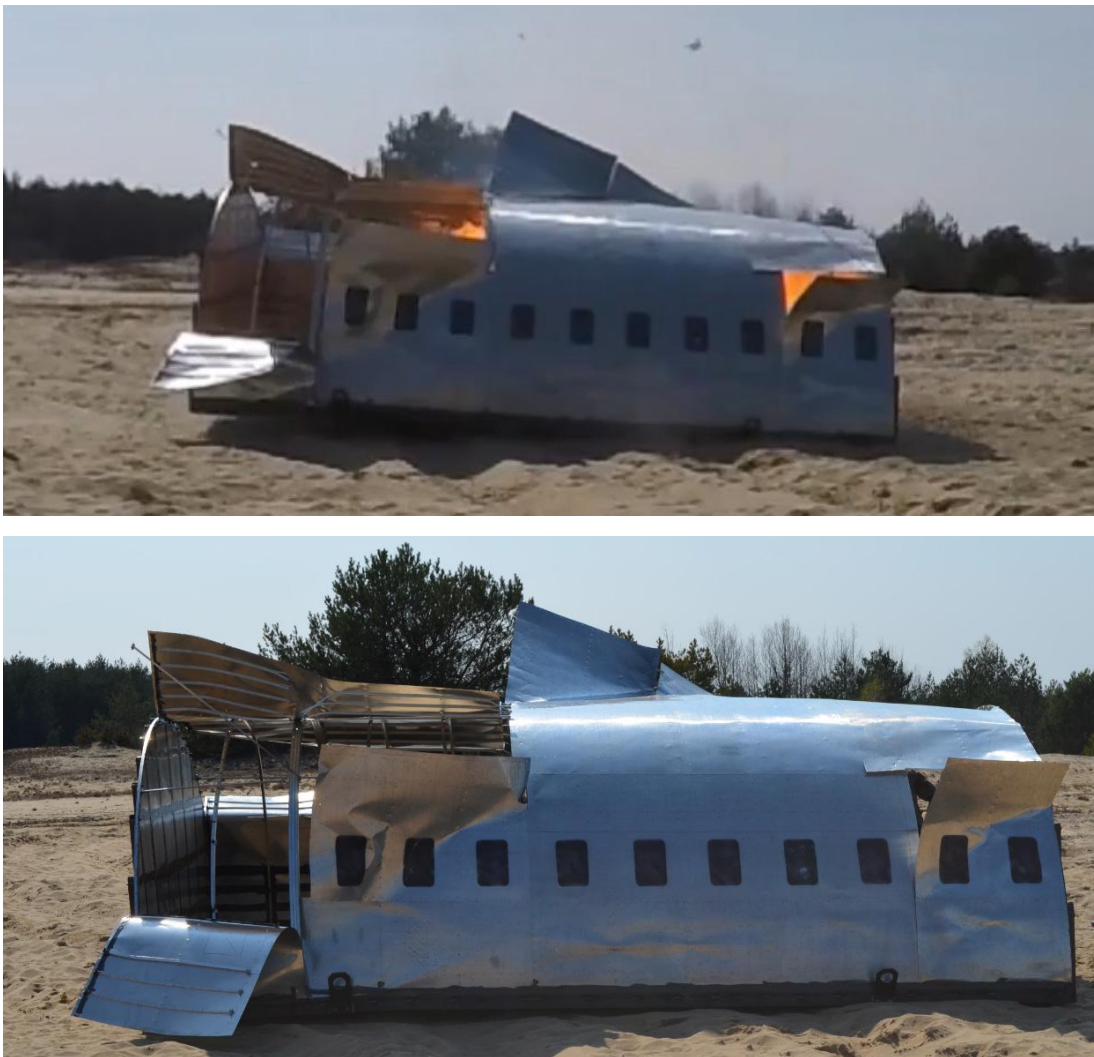
Experiments carried out by the Committee on a model of the passenger part of TU154M on a 1:1 scale show that the destruction of the plane in Smolensk could not be the result of a fuel explosion. (Fig. 51).

Fig.51. The outcome of an explosion of jet-fuel in the cabin of the fuselage resulting in a large opening but no destruction into small pieces.

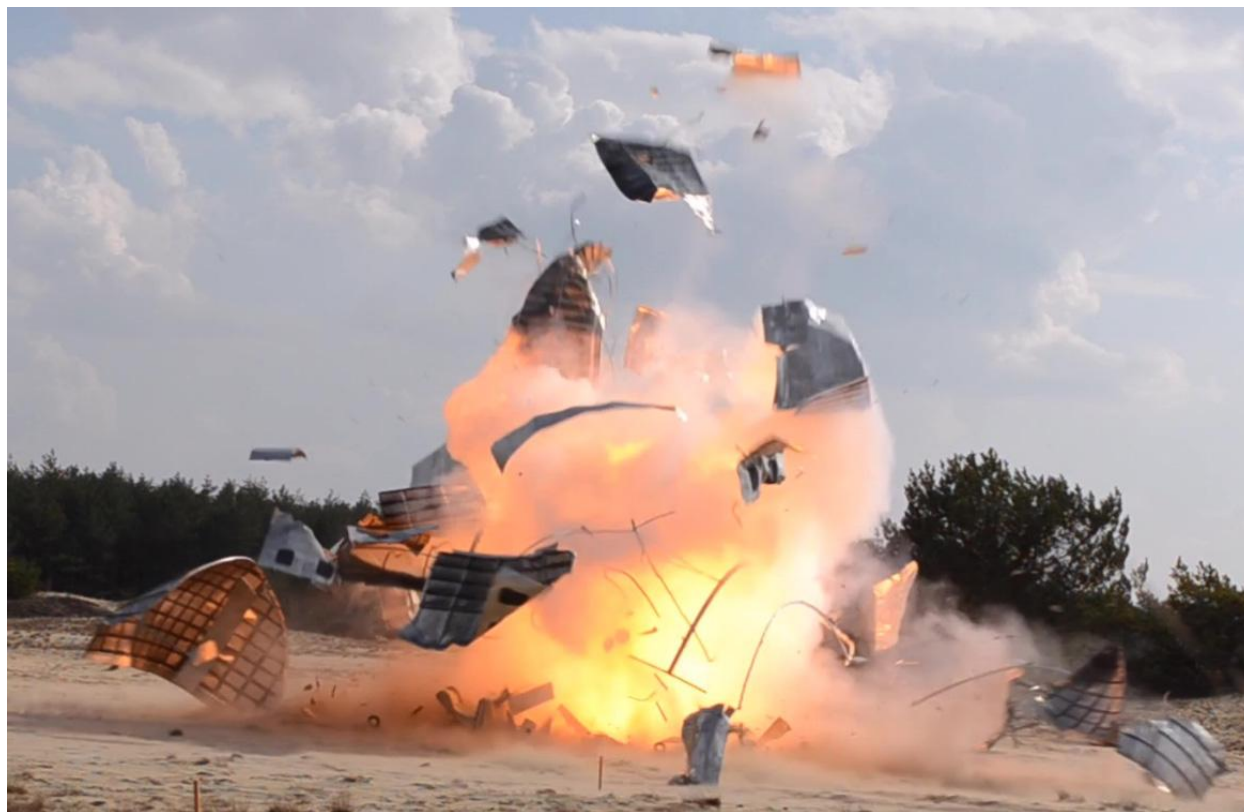
Experiments conducted by the Committee on a 1:1 model of the passenger's part prove that such disintegration, as observed in Smolensk, can be the effect of one or many detonations of air-fuel charges, with special consideration of a thermo-baric charge with a longer tension and impulse propagated inside the fuselage before hitting the ground. (Fig. 52)

Fig. 52 The outcome of an explosion of a thermo-baric charge in the cabin of the fuselage resulting in the complete destruction of the fuselage and the formation of a large quantity of small debris.

The same experiments show that a thermo-baric explosion can leave only minor traces of explosive materials on the debris of the plane, which are visible only in minor quantities during spectrometric analysis. (Source: Reports on explosive experiments of an object imitating the cabin of the fuselage)

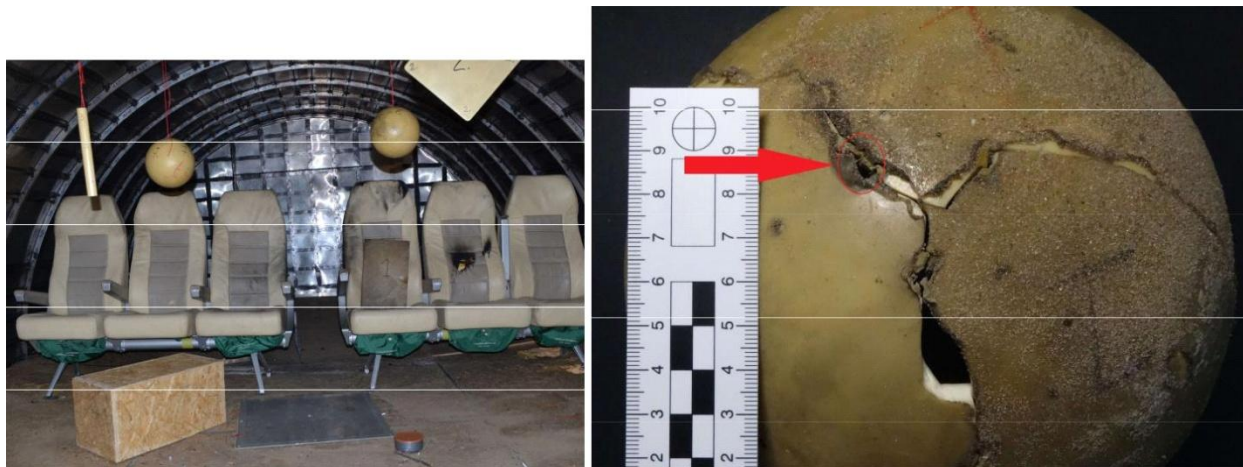
Fig. 53 Medical phantoms inside the model of the aircraft cabin.
