Mad River Reach Assessment and Restoration Strategy

DRAFT REPORT

July 2018

Inter-Fluve
Hood River, OR

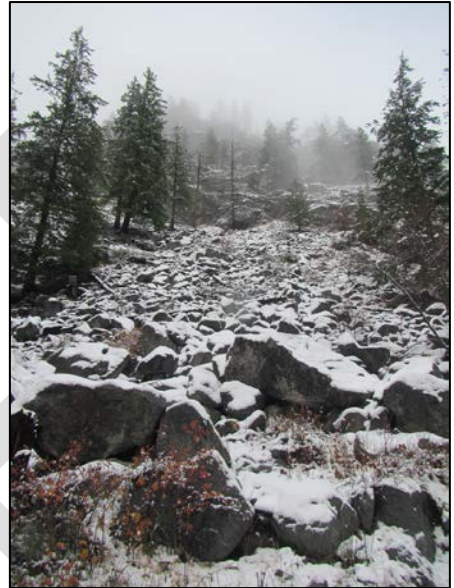
The hillslopes that contribute sediment to and host tributaries of the Mad River assessment area are relatively steep. Their geologic composition is mostly granitic as well as gneiss and schists from metamorphosed sedimentary and volcanic parent material (see Geology, Section 3.1). These bedrocks are generally erosion resistant and thus often form high, steep hillslopes and walls over millennia of channel downcutting. The hillslopes and valley of the Mad River were created by the gradual process of downcutting via fluvial erosion, mass wasting, and subtle faulting. Glaciers did not extend into the assessment area during the last glacial period. As a result, hillslope-valley form is basically “V” shaped instead of “U” shaped. As a result, there is a high degree of hillslope channel coupling that controls channel form, shape, confinement, and sediment supply. Hillslope and tributary contributions in the form of landslides, rock-fall, debris flows, and bedload has, and will continue to, influence river morphology through sediment and wood routing into the channel. Land use (i.e. logging and road building) as well as wildfires (natural and human started) are known to trigger increased temporary sediment and wood inputs into steep montane systems similar the Mad River (Beschta et al., 2004; Silins et al., 2009).

Figure 13. Hillslope along the Mad River, (Photo: IFI 11/9/2017)

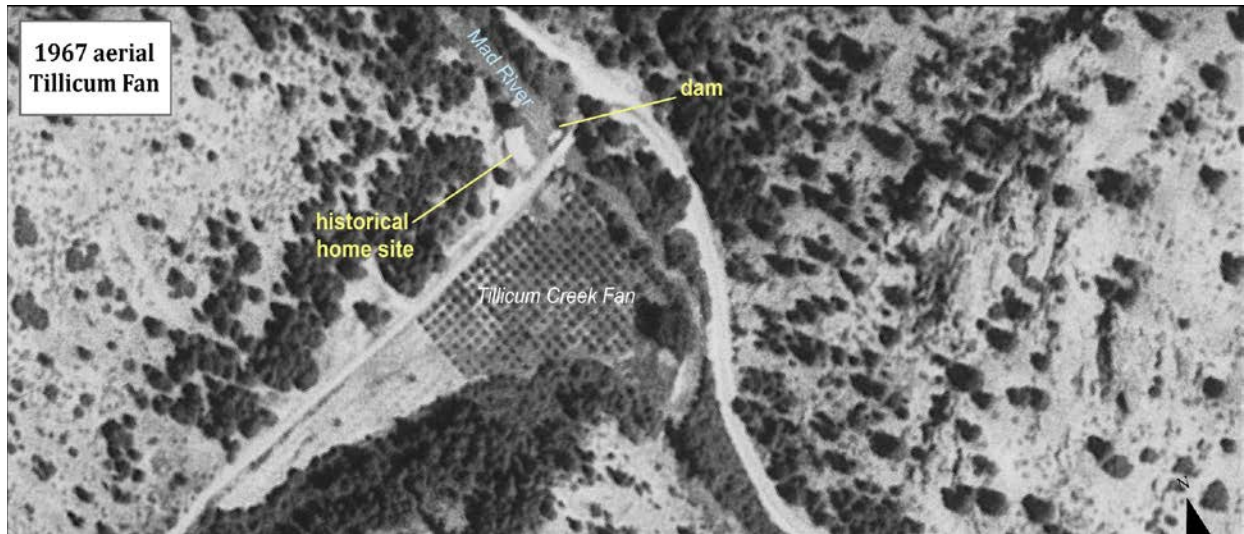
At the old homestead site located on the toe of the Tillicum Fan at RM 2, a dam was constructed on the mainstem Mad River. The date of construction and deconstruction of this dam are unknown. A local resident described it as “about 10 feet high and not good for fish wanting to get upstream” (conversation with unnamed resident at the site on 11/09/2017). The dam is visible in historical aerial imagery from 1967 (Figure 15). It is likely that this dam was a fish barrier for the duration of its existence.

Figure 15. Tillicum Fan - 1967 aerial photo. On the Mad River at RM 2. Historical dam and homestead identified.

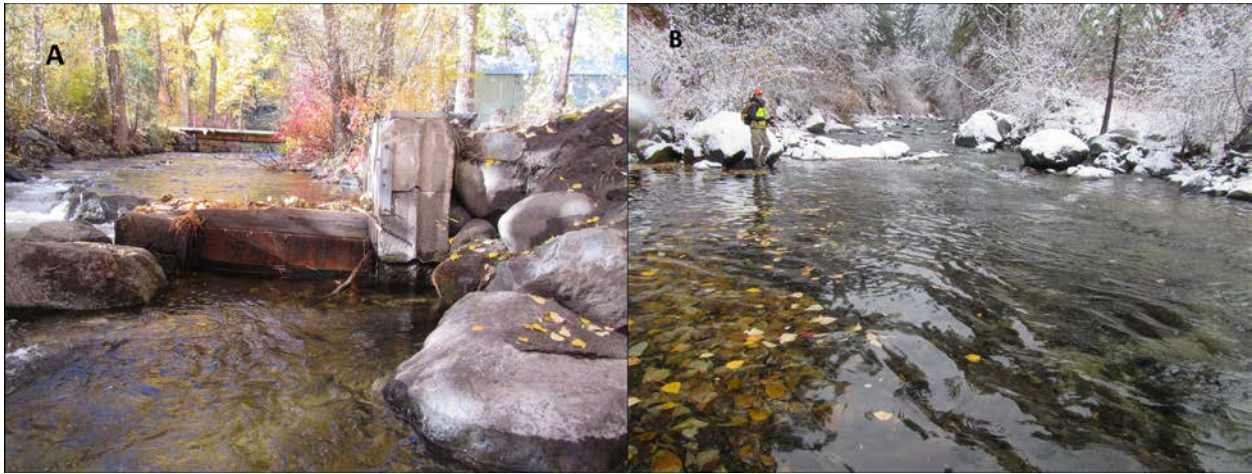
Channel complexity in Reach 1 is impaired. The 2017 Habitat Assessment (see Appendix ???) measured 84% of the channel as extended riffles while only 7% is pool habitat and the remaining 9% is glides. The four pools occur where large boulders and/or built features such as a collapsed bridge footing or an irrigation out-take weir create a stable grade control that produces scour on the downstream side. The bed of the channel is dominated by coarse alluvium (cobble and small boulders). Narrow gravel-cobble bars form at the inside bends of the subtle meanders at RM 0.15 and 0.22, as well as at the mouth of the channel. Otherwise, the only other gravel accumulations observed occur at the grade control and eddies associated with the four small pools – confirming that gravels are mobilized through Reach 1 but that retention is limited and local generation of sediment is likely minimal. Based on bed and bank material, hyporheic flow is expected to occur between the channel bed, bars, and floodplain surfaces.

Figure 20. Two of the four pools in Reach 1: A) Small pool downstream of Irrigation out-take weir and related boulder spur at RM. 0.27 (10/24/2017); B) Pool downstream of hillslope contributed boulders at RM 0.39 (11/9/2017).

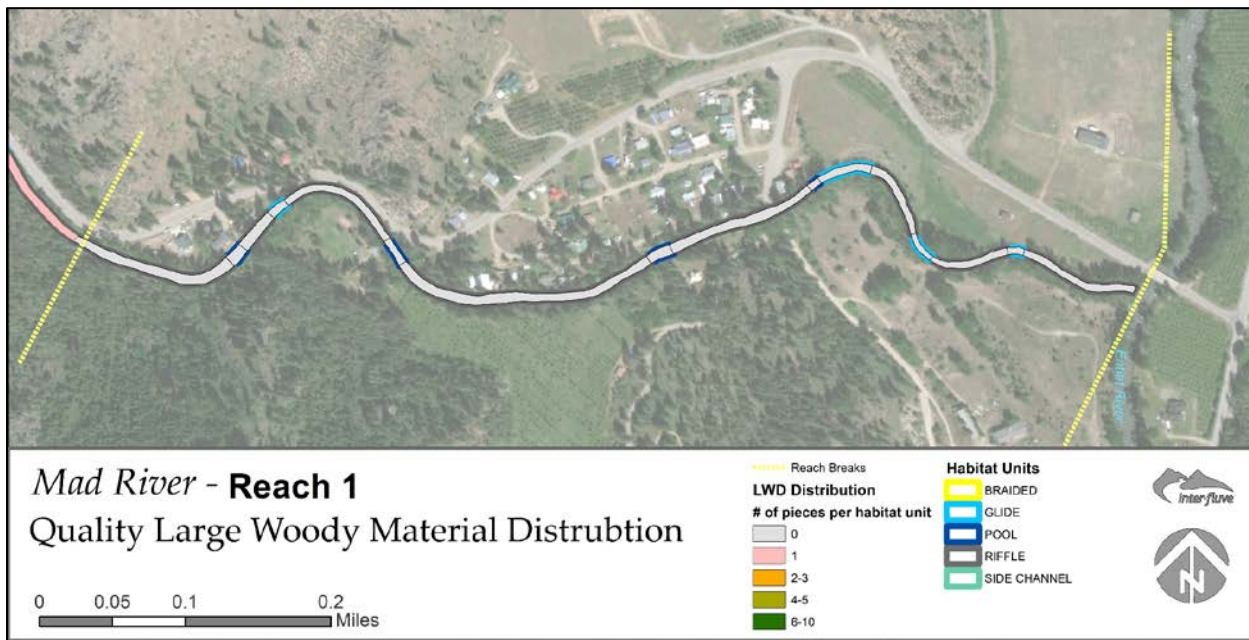
The lack of mature or large trees (21-32-inch dbh), narrowness of the vegetated riparian zone, and lack of lateral channel process limits local source and recruitment potential of large woody materials (LWM) into the channel. A total of only 11 pieces of wood and no log jams were observed in the channel during the survey (10/24/2017). All 11 pieces were in the small size class (9 to 12-inch dbh). No quality large woody material (>12-inch dbh and at least 35 feet long) were observed in the channel (Figure 21). Due to the small size and scarcity of large wood material (LWM), it plays only a minor temporary role in aquatic habitat and geomorphic complexity in Reach 1. The lack of LWM in Reach 1 is the result of past riparian vegetation removal, lack of mature trees in the riparian corridor, lack of channel migration capacity, and periodic “cleaning” of wood from the channel. Clearing large wood from the channel has been a common practice in places where infrastructure such as bridges or culverts exist.

Figure 22. Reach 1 – Quality Large Woody Material (>12-inch dbh and at least 35 feet long) distribution by number of pieces per mapped habitat unit per the 2017 survey.

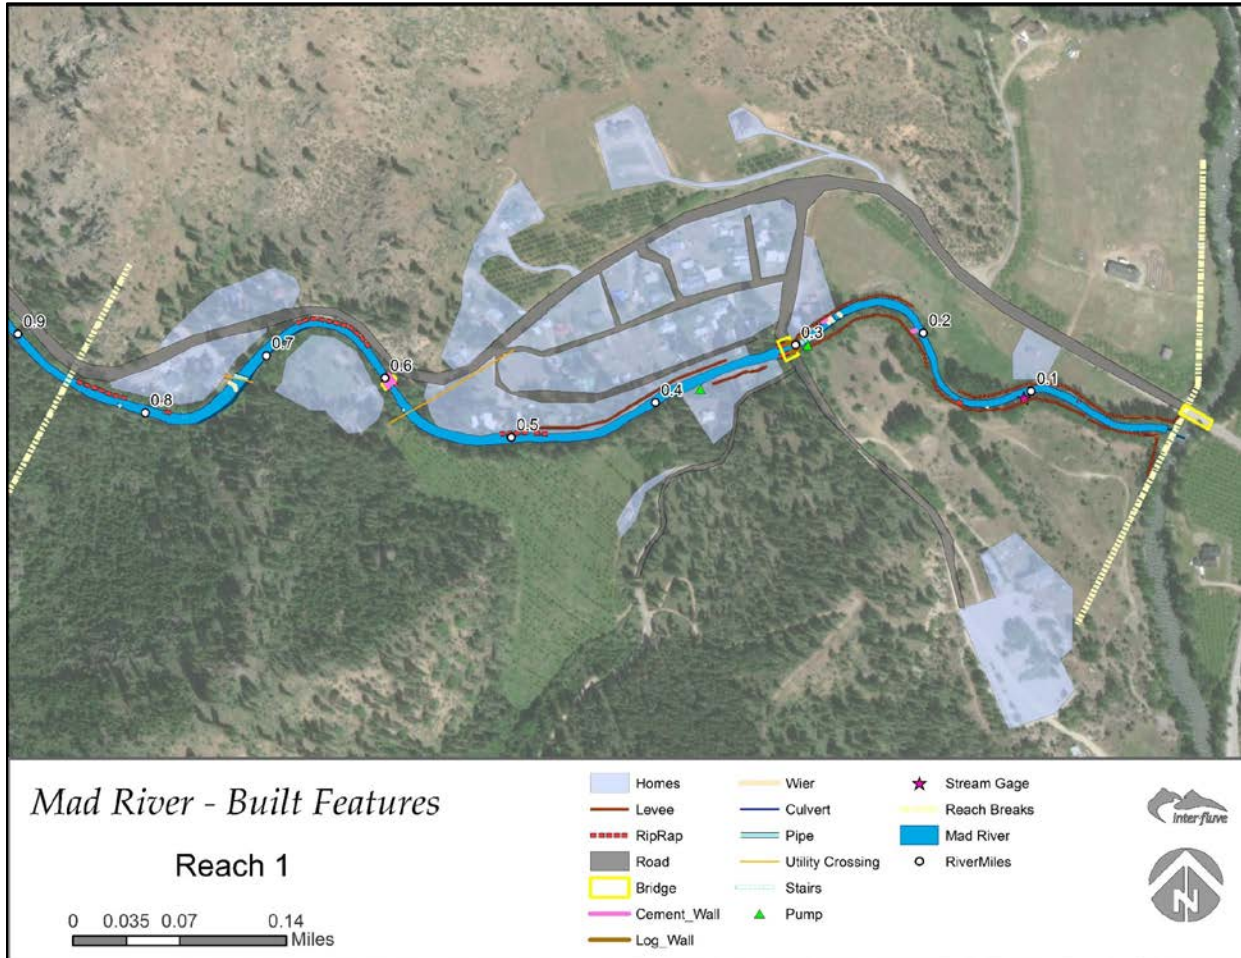
Figure 23. Reach 1: anthropogenic built features. Basemap: ESRI World Imagery

Reach 1 contains the most anthropogenic built-feature impediments compared to the other reaches in the assessment area. In addition to clearing and altering the valley floor and riparian vegetation, anthropogenic features in Reach 1 include buildings, roads, bridges, levees, bank protection, weirs, irrigation, and utility crossings (Figure 22). Levees of up to 3.5-foot high and constructed of material excavated from the channel line both sides of the river bank from RM 0 – 0.3. Additional similarly-constructed levees exist on river right from RM 0.34 to 0.36 and on river left from RM 0.35 to 0.49. Two railroad-car bridges have footings of cement, wood, and/or rock that protect the bank and confine the channel near RM 0.3 and RM 0.6 (Figure 23). At the bridge near RM 0.6, an old cement footing collapsed into the channel and remains in place under the bridge, armoring over half of the channel bed.

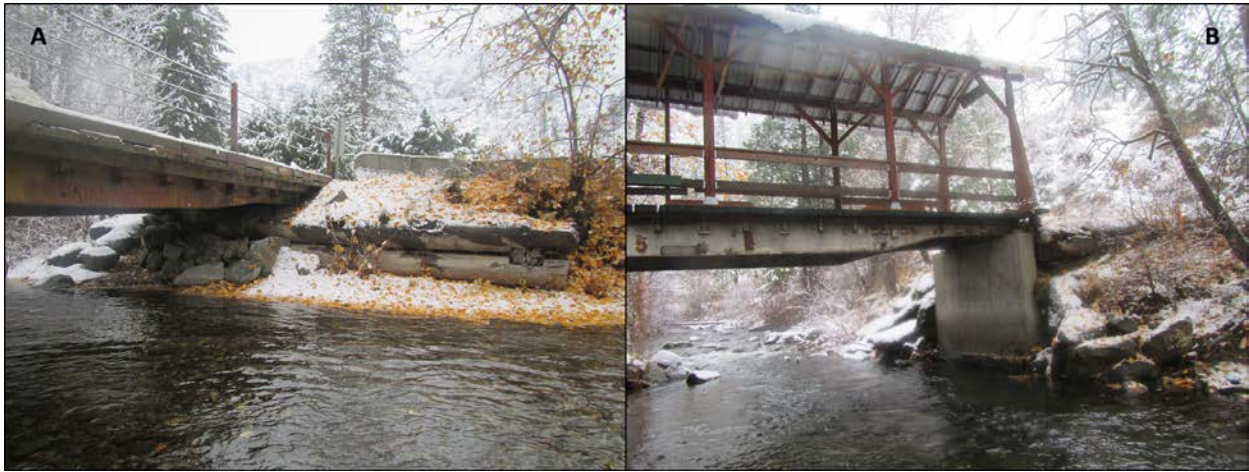
Figure 24. Railroad-car bridge crossings: A) near RM 0.3 with log, cement, and riprap footings and bank protection. Logs are old footings from historical bridge crossing, and B) near RM 0.6 with cement footings and large boulder riprap. (Photos: IFI 11/9/2017)

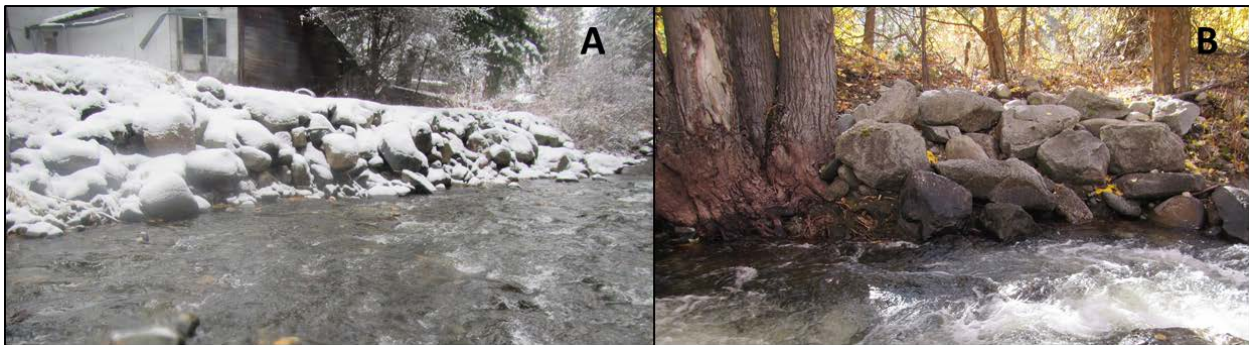
Additional bank protection occurs throughout Reach 1. Large boulder riprap has been placed along the banks at RM 0.28 in correlation with a cement-walled irrigation out-take and weir. Riprap is also present at RM 0.48 to 0.51 on river left in front of homes where the banks are low, at RM 0.63-0.67 and RM 0.82-0.85 on river left to protect the Mad River Road and homes (below), and at RM 0.15. On river left at RM 0.78, pieces of steal and cabling are buried into and protecting the bank. Cement blocks on river right at RM 0.2 also add bank protection to an already anthropogenically-confined reach.

Figure 25. Riprapped banks: A) river left at RM 0.51 (11/9/2017), and B) river left at RM 0.28 (10/24/2017).

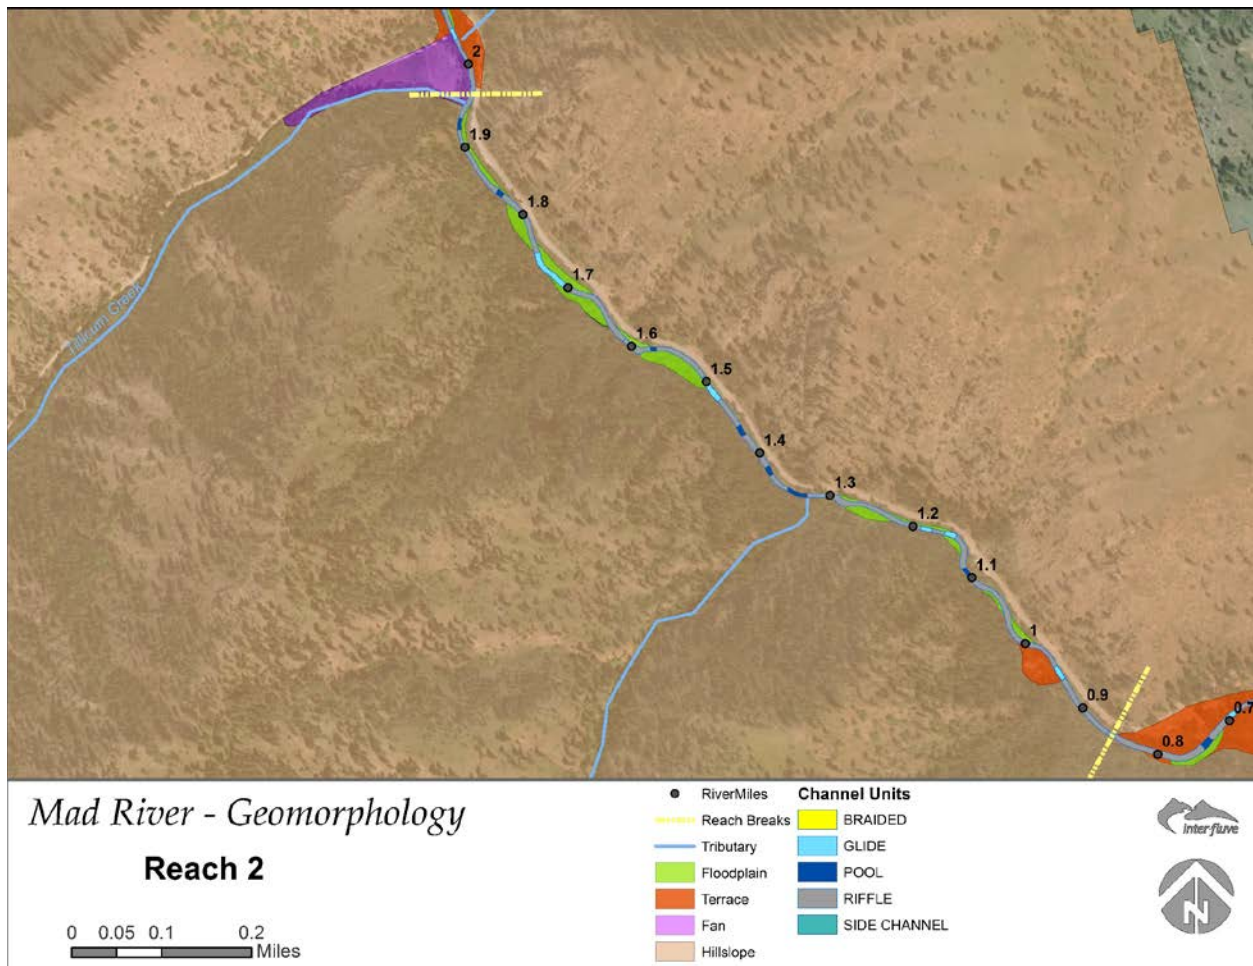
Figure 26. Reach 2: Geomorphic surfaces and channel units. Basemap: ESRI World Imagery

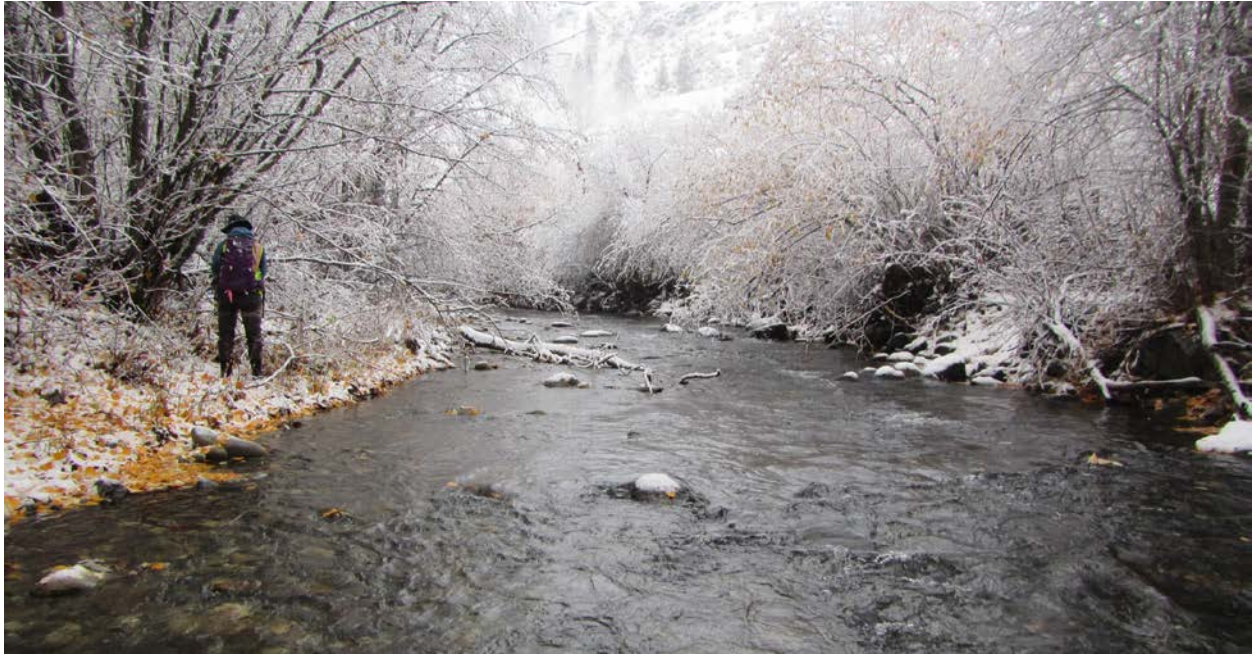
Figure 28. Reach 2 at RM 1.68, vegetated floodplain – looking upstream. (Photo: IFI 11/9/2017)

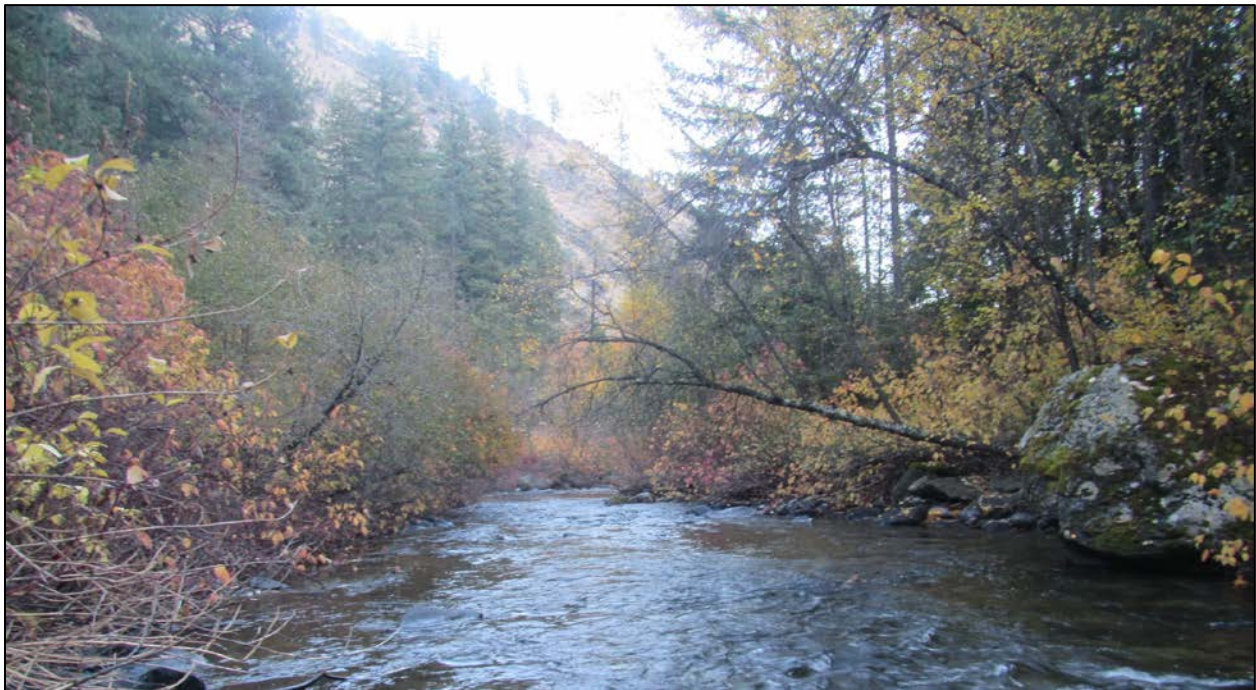
Figure 30. Riparian vegetation example in Reach 2, at RM 1.6. (Photo: IFI 11/24/2017)

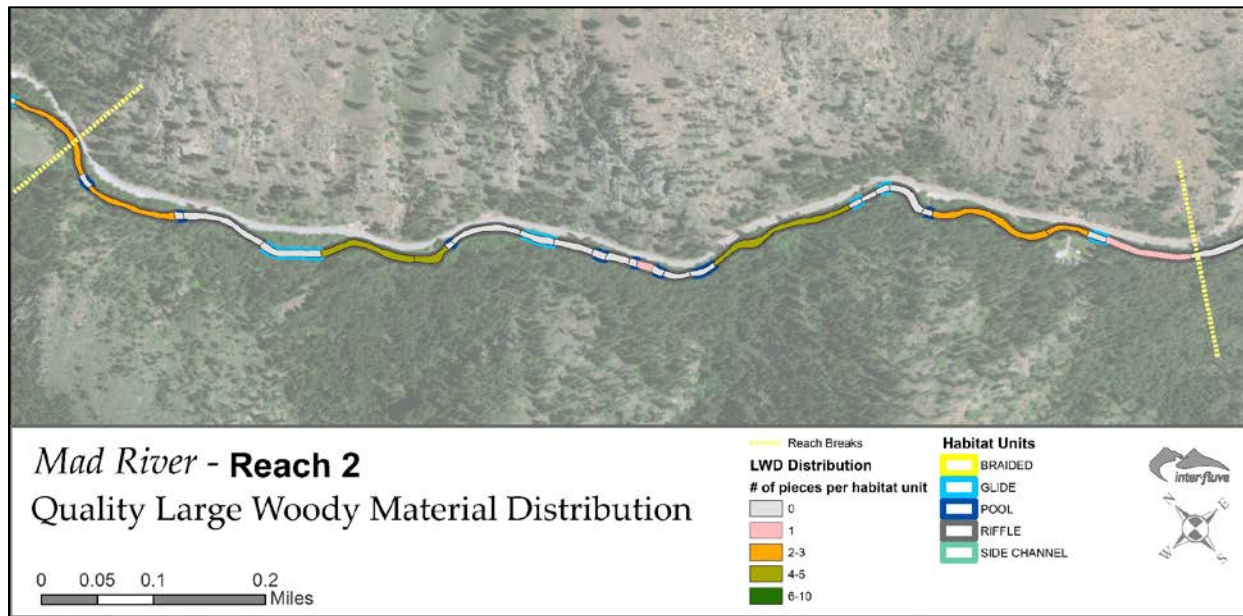
A total of 49 pieces of woody material and only one log jam was observed in the channel during the survey (10/24/2017). Of the 49 pieces, only three classified as large size class (≥ 20 -inches dbh and >35 feet long), 19 were classified as medium size class (12 to 20-inch dbh and at least 35 feet long), and the rest were all small size classified (9 to 12-inch dbh). See Figure 30 for distribution of quality large woody material (>12-in dbh and at least 35 feet long) per mapped habitat unit throughout the reach. The lack of LWM in Reach 2 is the result of past riparian vegetation clearing, lack of mature trees in

Figure 31. Reach 2 – Quality Large Woody Material (>12-inch dbh and at least 35 feet long) distribution by number of pieces per mapped habitat unit per the 2017 survey.

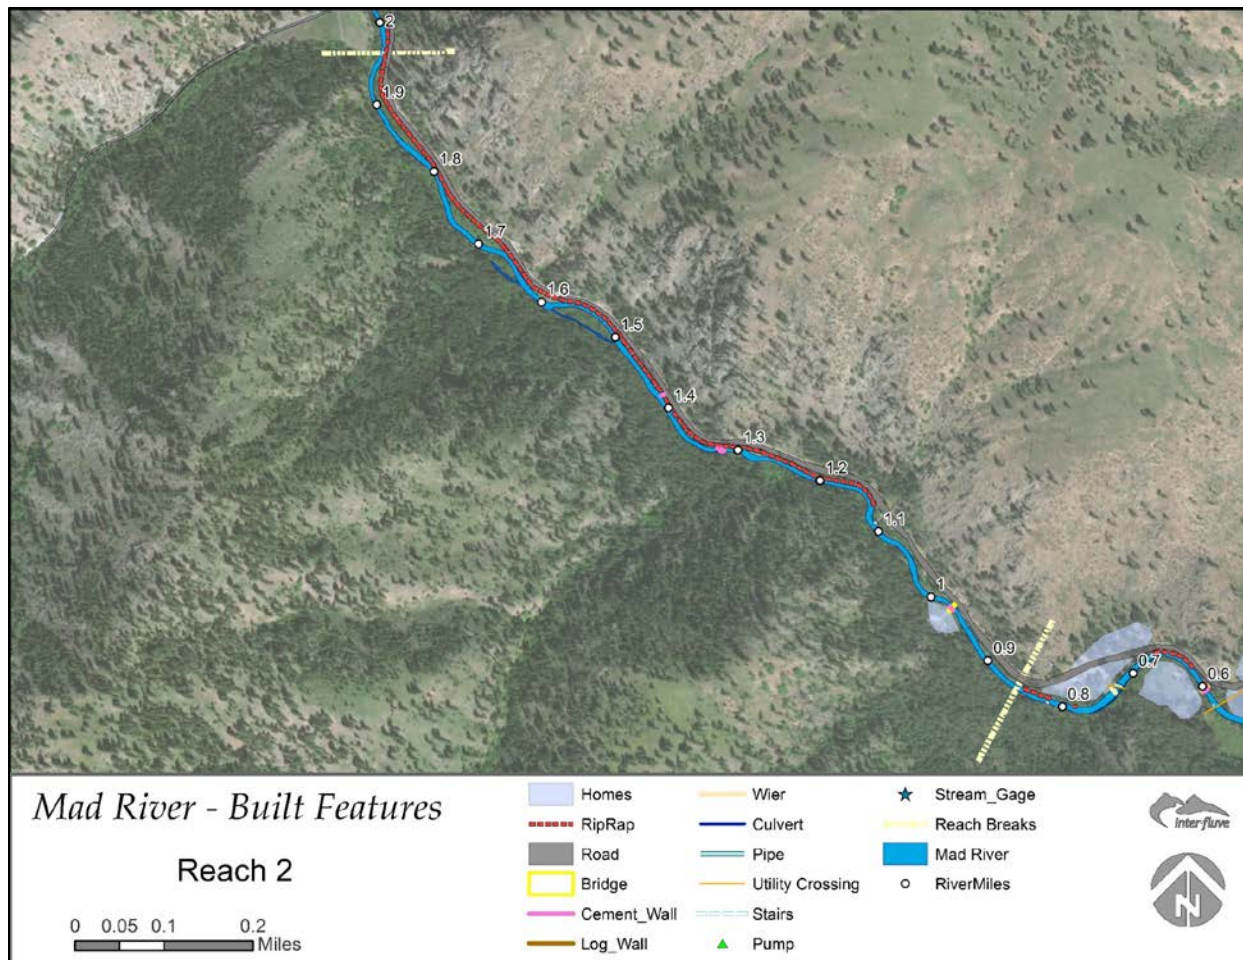
Figure 33. Reach 2: anthropogenic built features. Basemap: ESRI World Imagery

Anthropogenic features in Reach 2 include the Mad River Road, bank riprap, a bridge crossing, a homesite development, related vegetation clearing, and cement wall bank and bed armoring. The Mad River Road occupies approximately half of the available valley floor from RM 0.86 to 1.65 and from RM 1.65 to 1.93 it occupies approximately a third of it (Figure 33A). From RM 1.13 to 1.93 the road bank is armored with large-boulder riprap. The bridge crossing at RM 0.98 includes cement, steel beam, log, and large-boulder riprap footings and bank protection (Figure 33B). A homesite located on a low terrace on river right at the bridge crossing (RM 0.98) includes riparian vegetation clearing. A remnant cement wall extends from the road perpendicular to flow on the river-left bank at RM 1.42 but it does not contact the channel at normal or low flows (Figure 34A). Another cement slab was observed on the channel bed with steel pipe embedded into it at RM 1.33. The slab is creating a grade control with a step-pool on the downstream side and accumulated gravels and cobbles on the upstream side (Figure 34B).

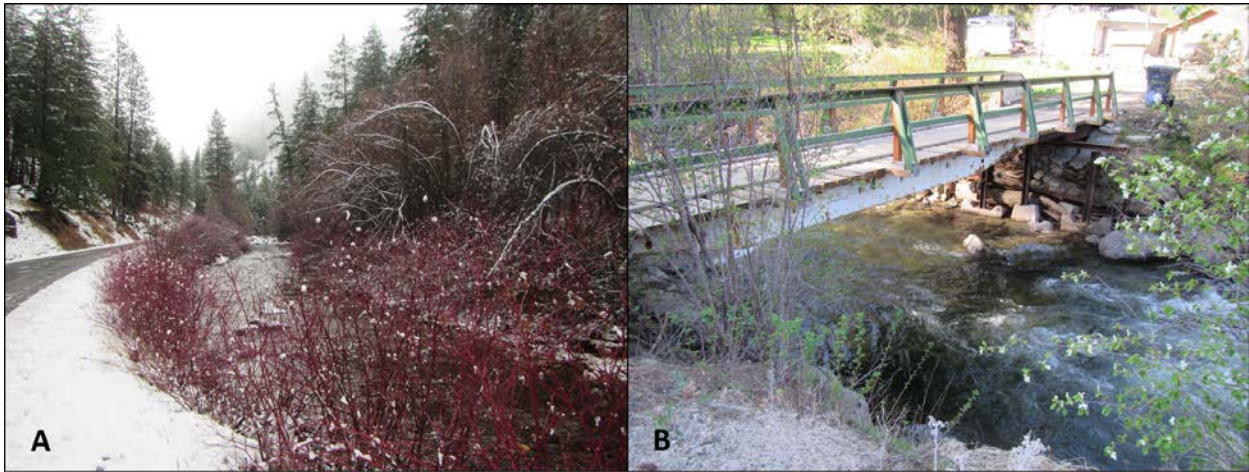
Figure 34. A) Mad River Road along Reach 2 occupying $\frac{1}{2}$ of valley floor at RM 1.55 (Photo: IFI 11/9/2017); B) bridge crossing at RM 0.98 (Photos: IFI 4/25/2018).

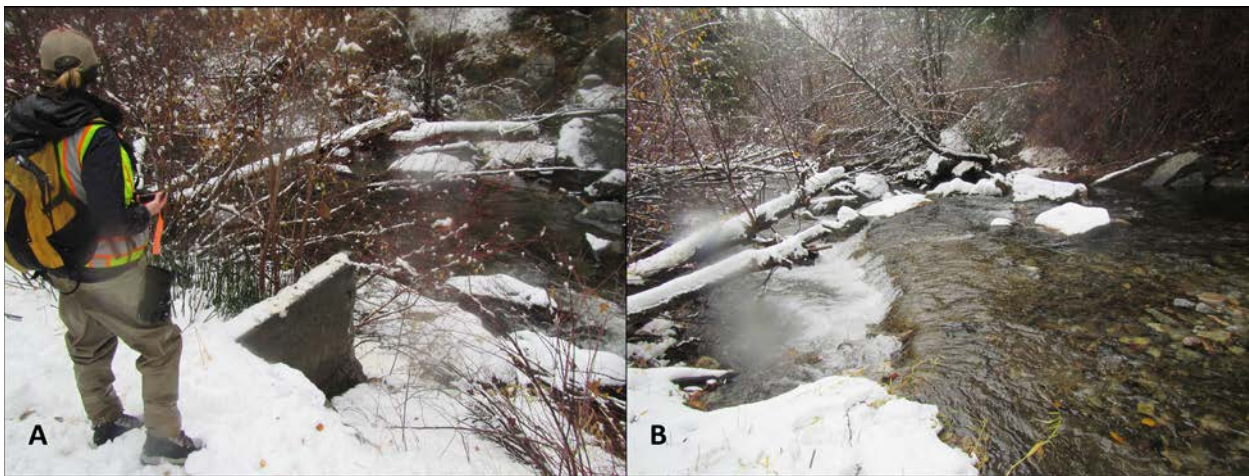
Figure 35. A) cement wall on bank at RM 1.42; B) cement slab on channel bed at RM 1.33. (Photos: IFI 11/9/2017)

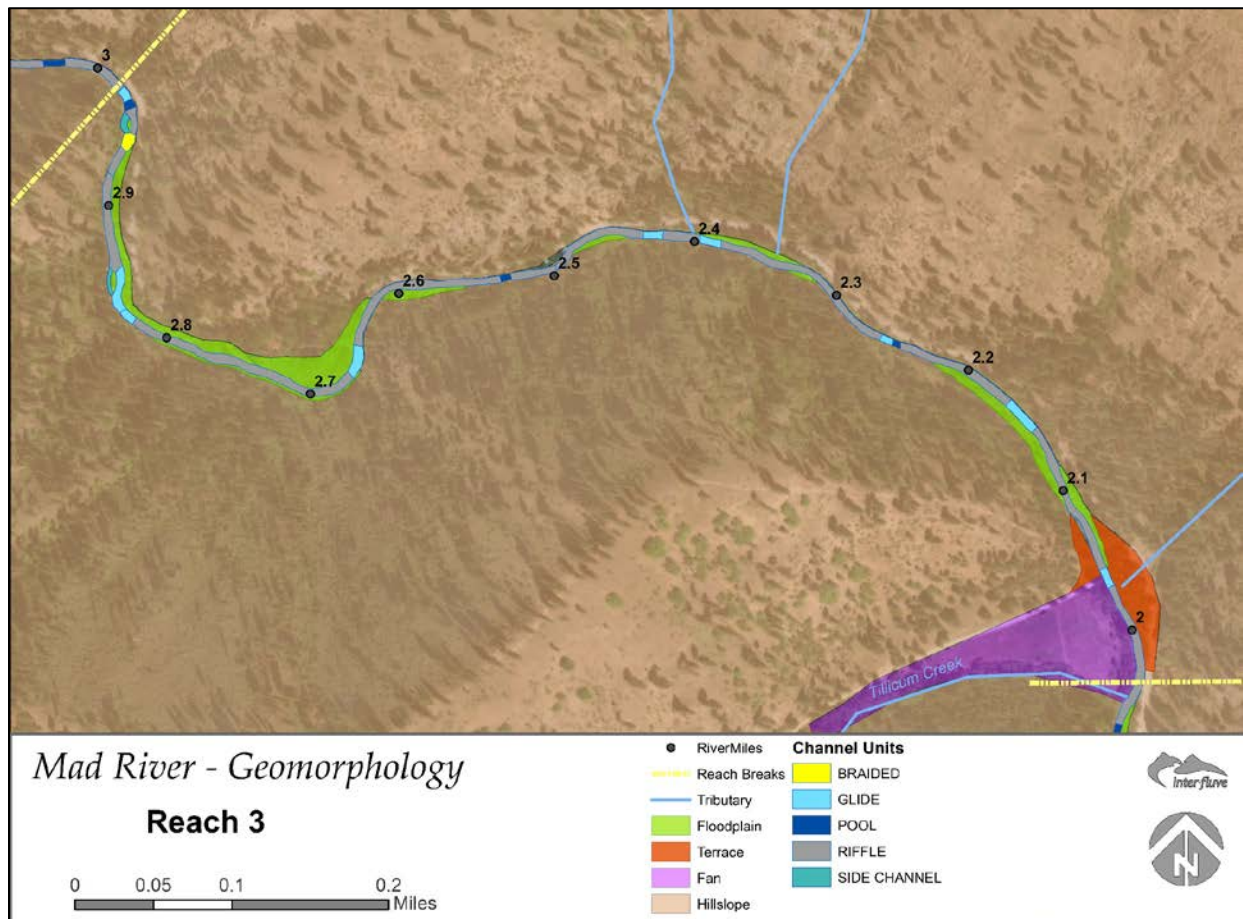
Figure 36. Reach 3: Geomorphic surfaces and channel units. Basemap: ESRI World Imagery

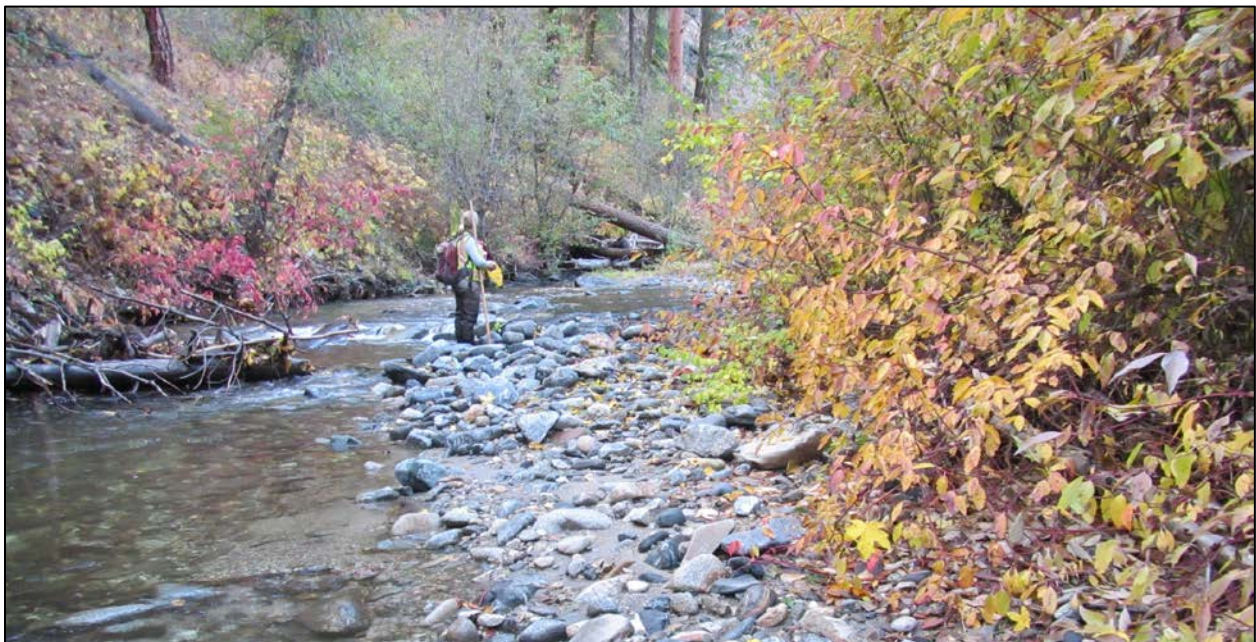
Figure 39. Mad River at RM 2.7 looking upstream: hillslope on river right and vegetated floodplain on river left. (Photo: IFI, 11/25/2017)

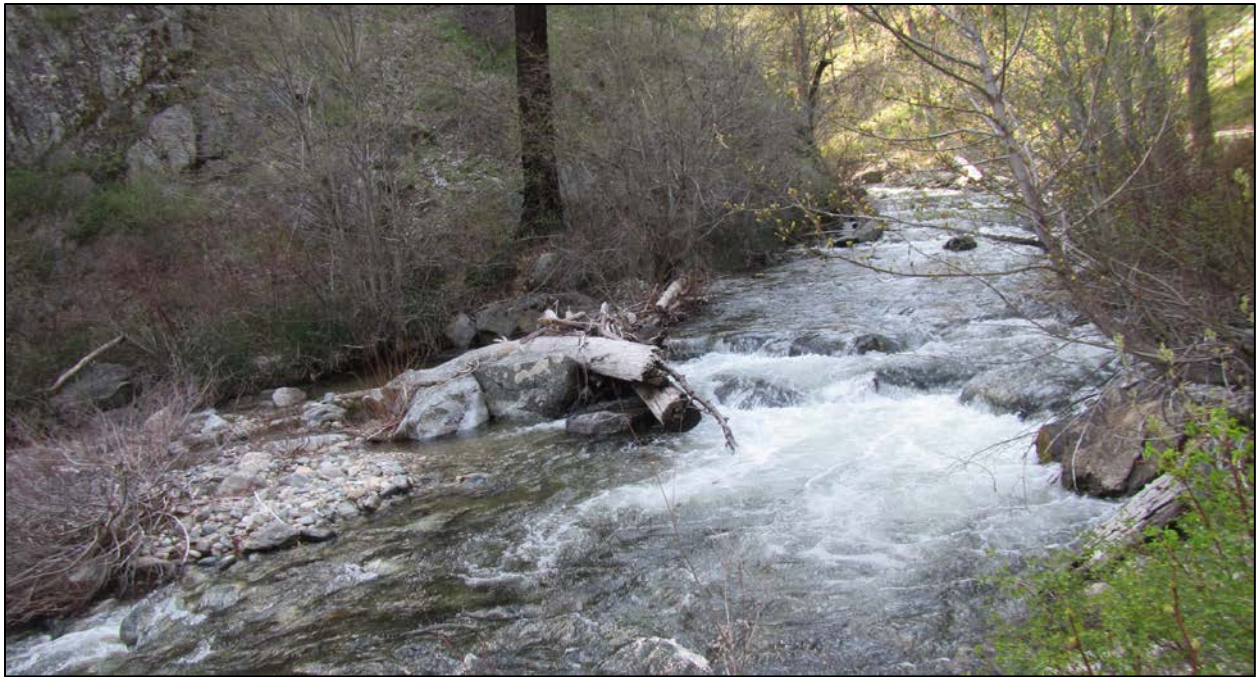
Figure 41. Boulder step, pool, and gravel accumulations at RM 2.96 behind boulders and wood accumulation (Photo: IFI 4/24/2017)

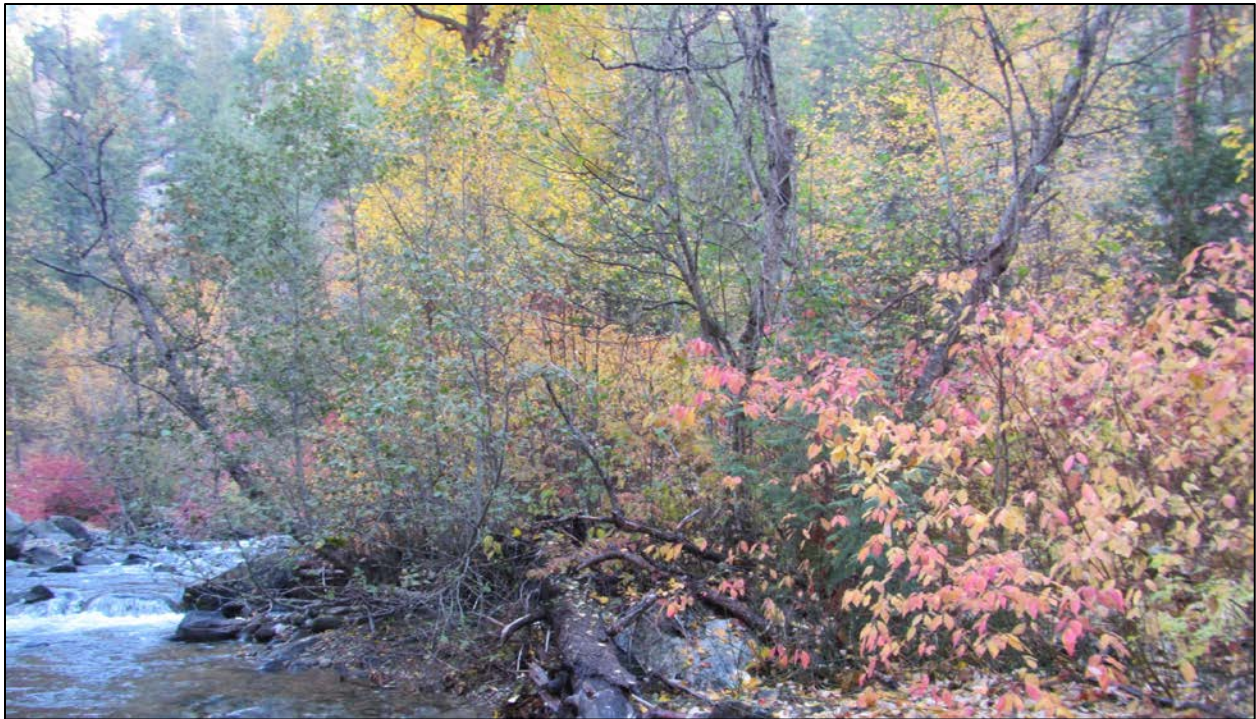
Figure 42. Riparian vegetation on floodplain at RM 2.84. (Photo: IFI 11/25/2017)

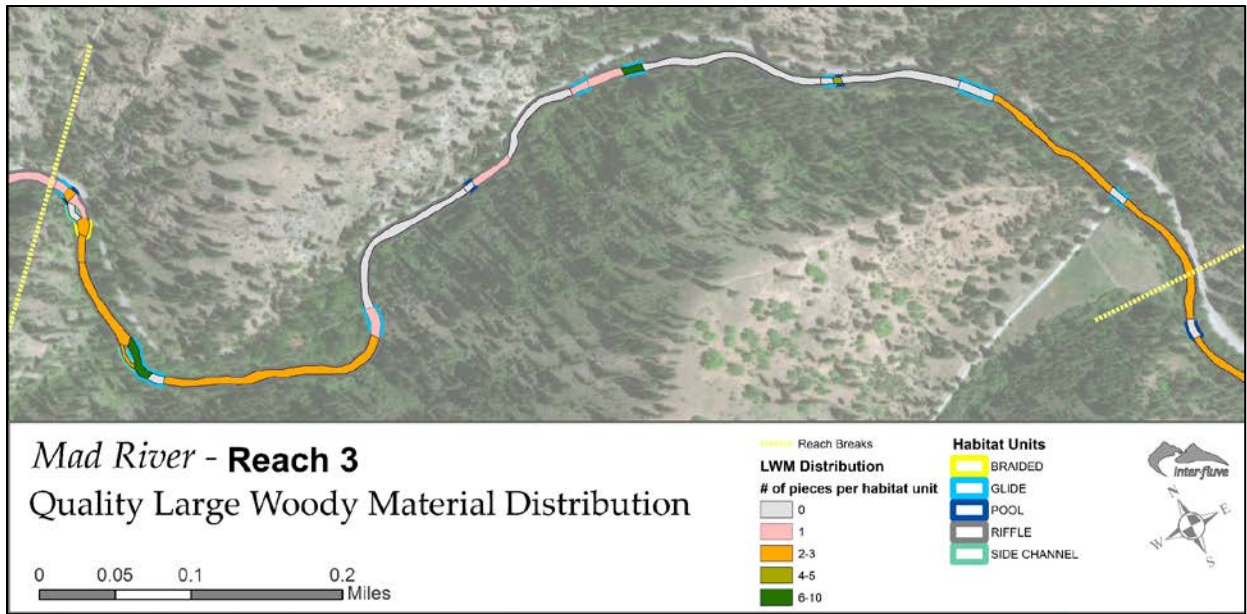
A total of 89 pieces of wood were observed in the channel during the survey (10/25/2017). Of the 89 pieces, fourteen pieces classified as large size class (≥ 20 -inches dbh and >35 feet long), 30 were classified as medium (12 to 20-inch dbh and at least 35 feet long), and 45 were all small size classified (9 to 12-inch dbh). However, no wood accumulations that constitute a log jam were observed. See Figure 42 for distribution of quality large woody material (>12 -in dbh and at least 35 feet long) per mapped habitat unit throughout the reach. Note that LWM distribution is correlated to less-confined sections with floodplains. Where LWM exist, it plays an important role in aquatic habitat and geomorphic channel complexity. According to the 2017 survey, Reach 3 is lacking in large wood jams. This is likely due to past riparian vegetation removal for the construction of the Mad River Road, lack of mature forests within the riparian corridor, increased confinement of lateral process by the Mad River Road, and potentially periodic “cleaning” of wood from the channel. Cleaning of LW from the channel has been a common practice where infrastructure such as roads and bridges exist.

Figure 43. Reach 3 - Quality Large Woody Material (>12-inch dbh and at least 35 feet long) distribution by number of pieces per mapped habitat unit per the 2017 survey.

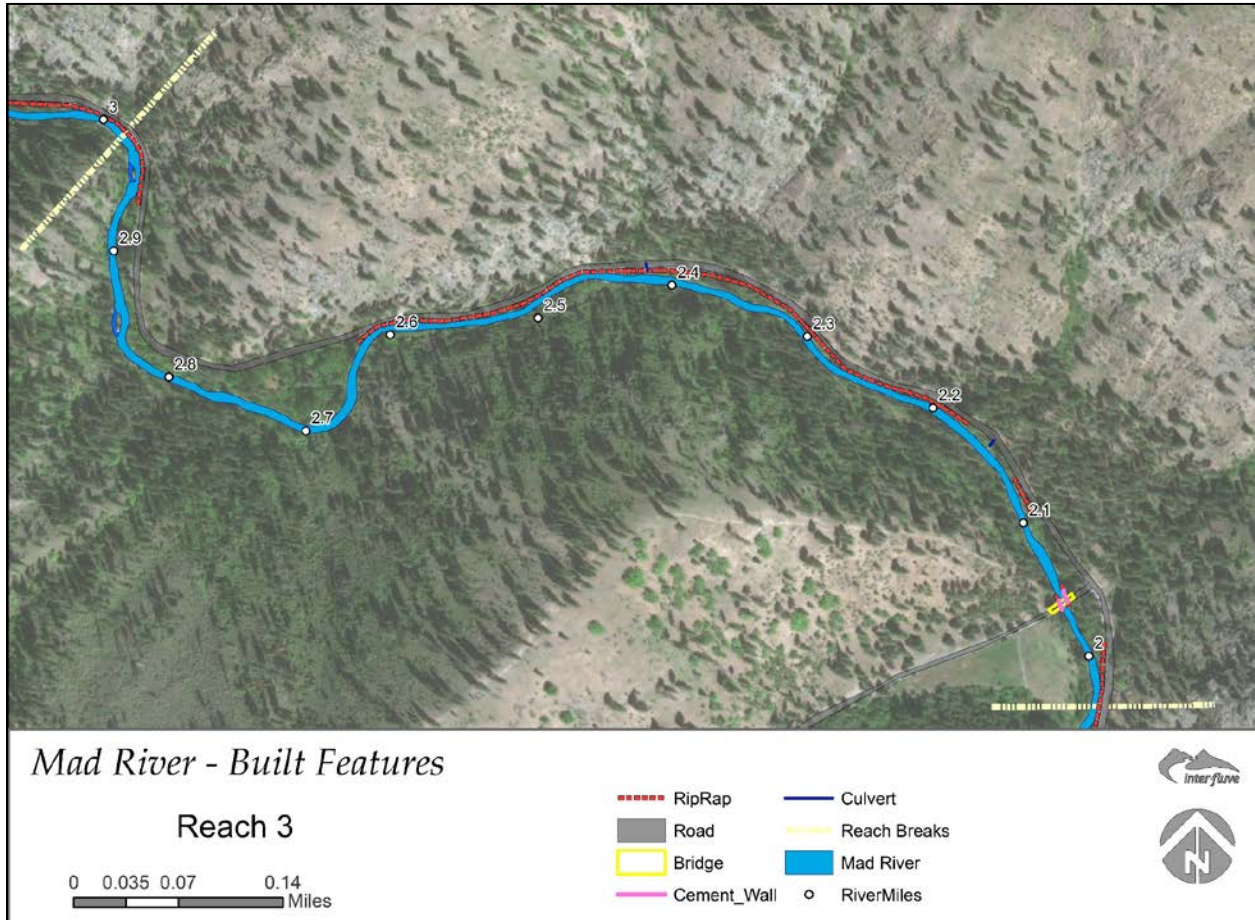
Figure 44. Reach 3: anthropogenic built features. Basemap: ESRI World Imagery

Anthropogenic features in Reach 3 include the Mad River Road, bank riprap, a bridge crossing, an abandoned homesite, and related vegetation clearing. The Mad River Road occupies up to half of the available valley floor in the most confined sections of Reach 3. From RM 2.1 to 2.13, RM 2.17 to 2.63, and RM 2.93 to 3.14 the road bank is armored with large-boulder riprap which further limits the bank from contributing sediment or supporting riparian vegetation. Culverts under the Mad River Road at RM 2.15 and 2.42 control surface water contribution points from the hillslopes into the Mad River. The Tillicum Road bridge crossing at RM 2.04 includes cement footings and large-boulder riprap bank protection that locally confine the channel and control its pathway. This, in conjunction with a dam that was located immediately upstream of the bridge until the 1970's, has resulted in channel entrenchment and simplification in this area. A public day-use area on river right, immediately upstream of the bridge, is the site of an historical homestead. The home has been removed but the area remains mostly cleared of vegetation. A public parking and day-use area on river left immediately downstream of the bridge is also cleared of surface vegetation.

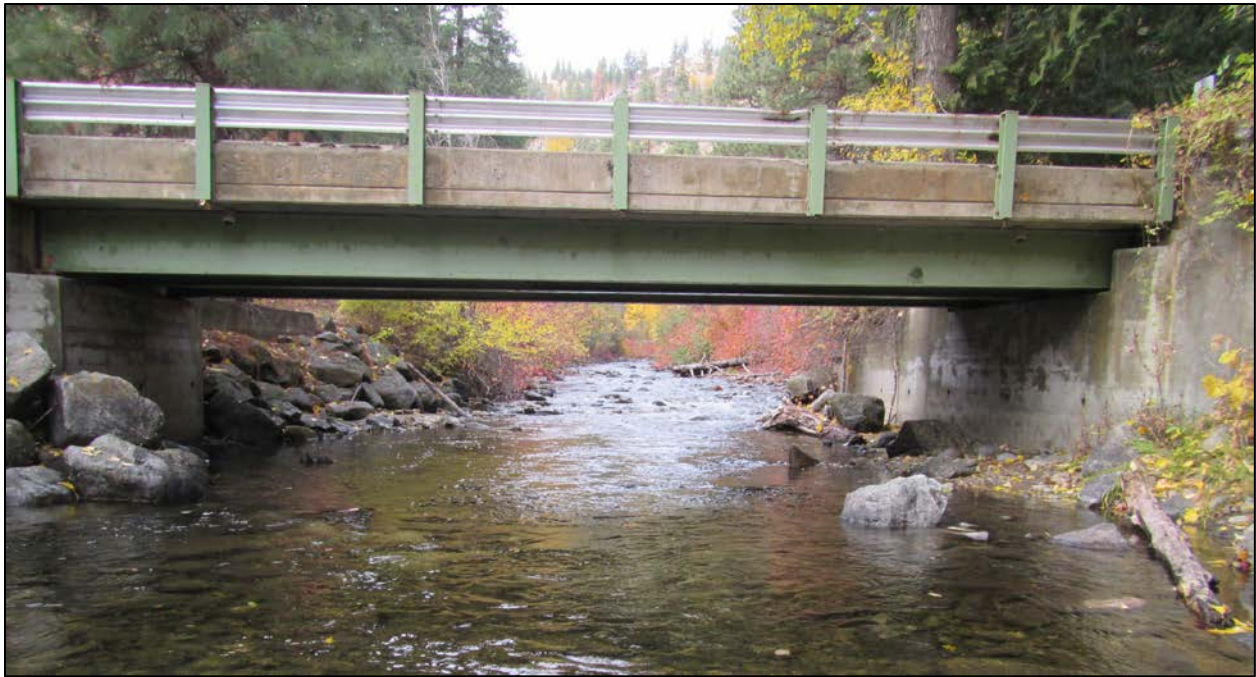
Figure 45. Tillicum Road bridge crossing at RM 2.04, looking upstream. (Photo: IFI 11/25/2017)

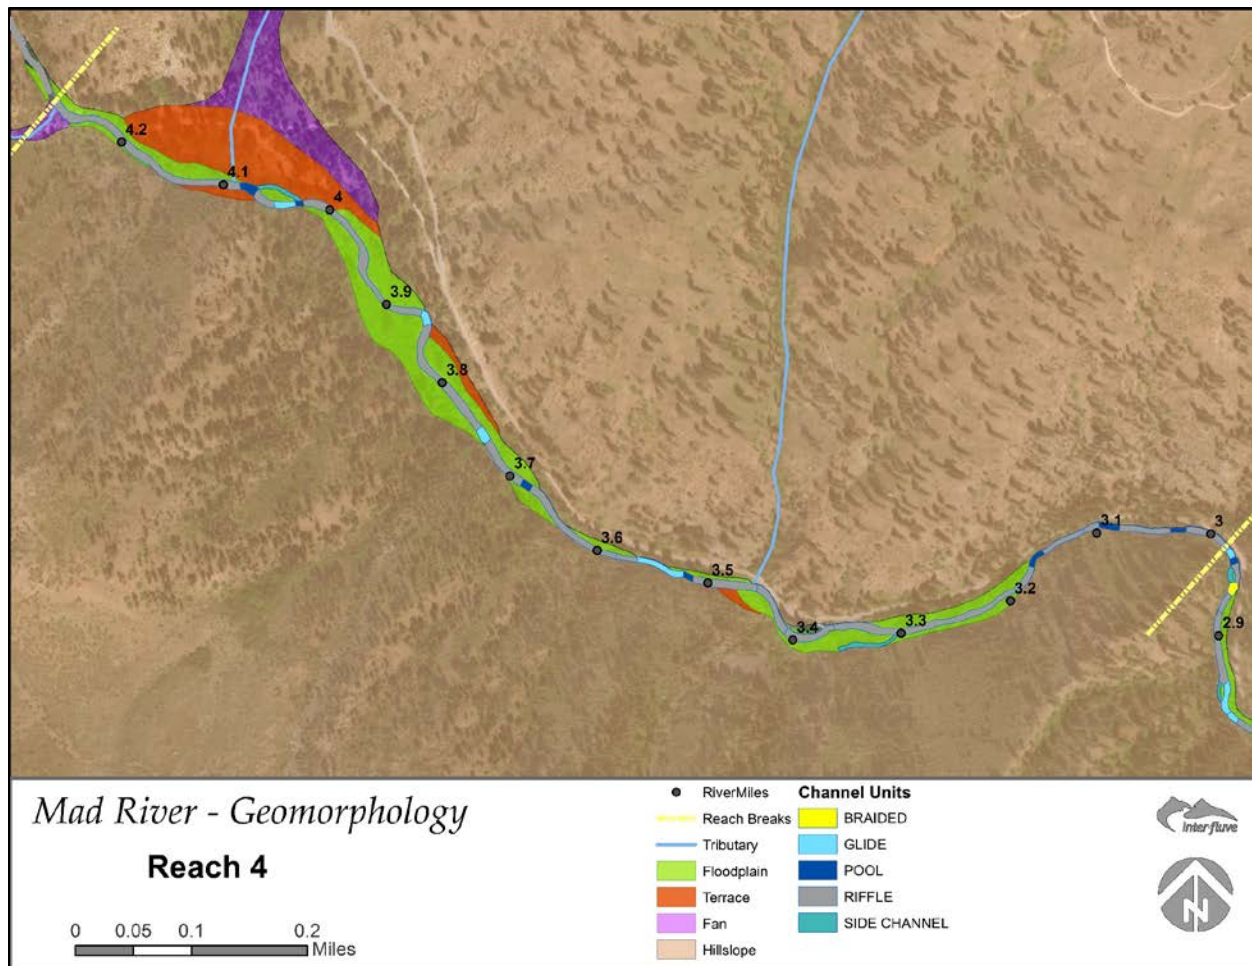
Figure 47. Reach 4: Geomorphic surfaces and channel units. Basemap: ESRI World Imagery

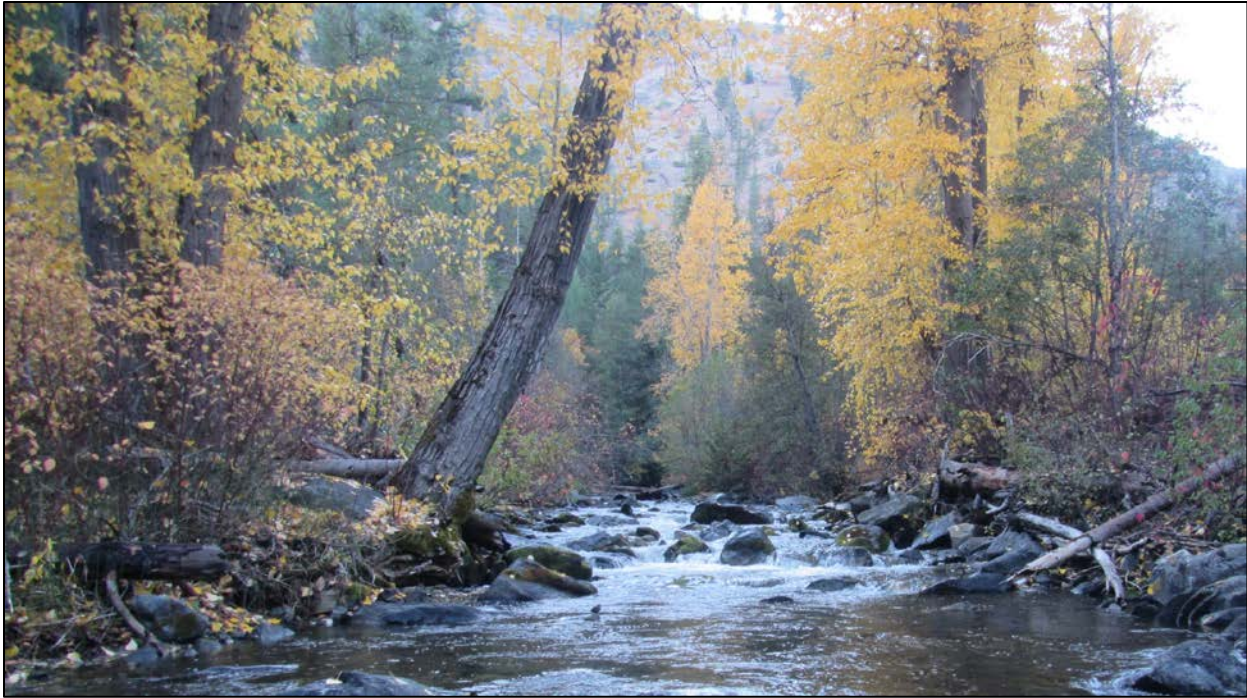
Figure 48. Boulder colluvium creating cascade step into small pool at RM 4.08. (Photo: IFI 10/26/2017)
