Mad River Reach Assessment and Restoration Strategy

DRAFT REPORT

July 2018

Inter-Fluve
Hood River, OR

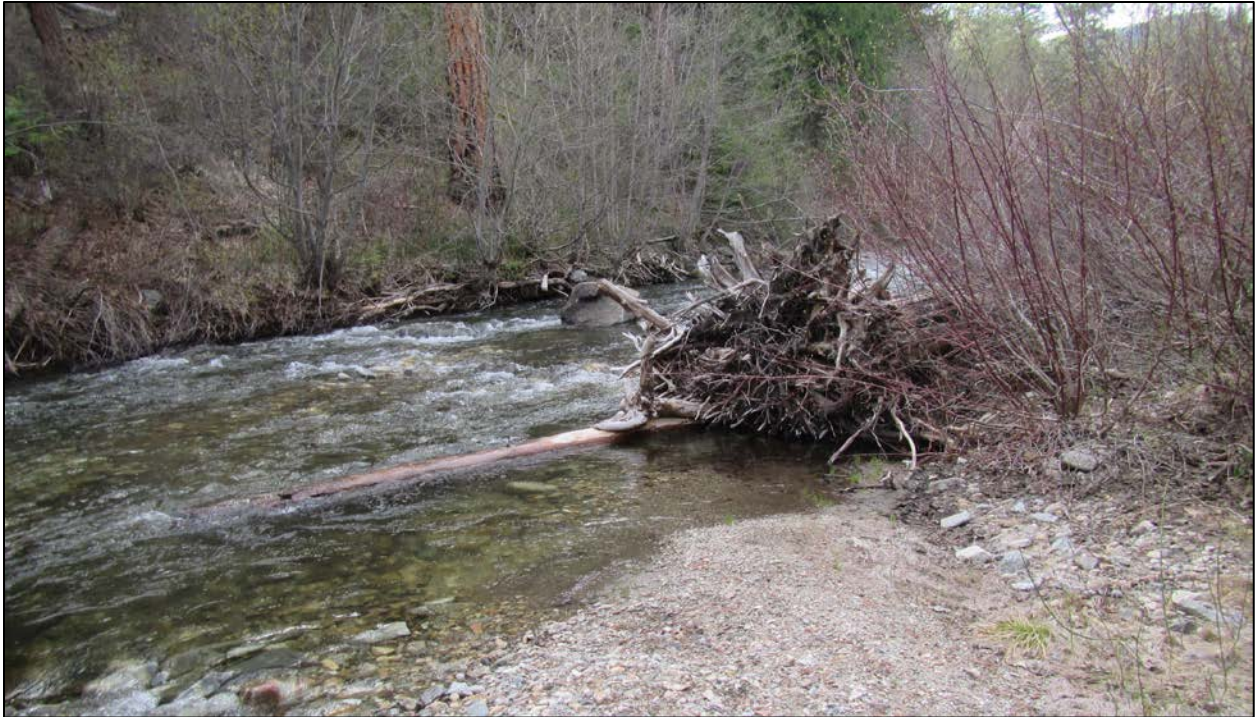
Figure 49. At RM 3.86: Hillslope contact on river right, boulder colluvium, large wood piece with gravel bar accumulation in front of active floodplain on river left. (Photo: IFI 4/24/2018)

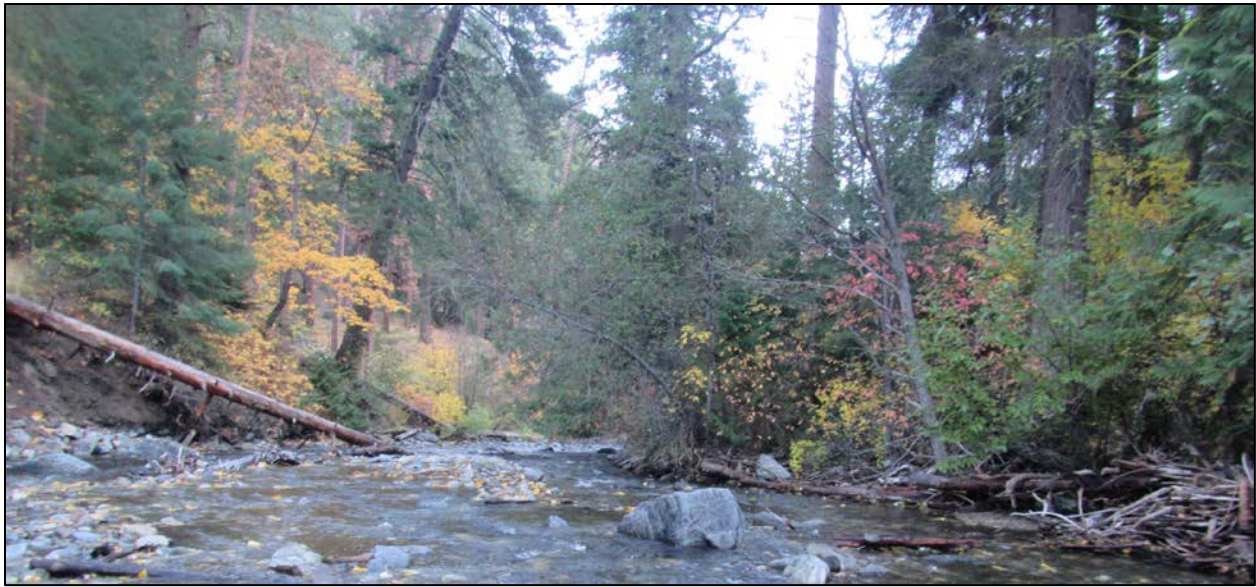
The riparian vegetation in Reach 4 is dominated by mature trees with an understory of dense shrubs. The overstory trees are composed of fir, cedar, ponderosa pine, and cottonwood. The understory is a mix of small trees and shrubs made up mostly of dogwood, alder, cedar, and maple. Where the channel is bordered by the Mad River Road in the downstream portion, riparian vegetation is marginalized and lacking in overstory trees (river left, RM 2.98-3.16). The existing overstory of large-mature trees and the established understory provide a shade canopy for the channel during summer months, except in patches adjacent to the Mad River Road. It is assumed that the riparian forest along the Mad River Road was removed during its construction. The well-vegetated floodplains and hillslopes upstream of the area confined by the Mad River Road offer large wood for recruitment potential to the mainstem channel.

Figure 51. Example of riparian forests in Reach 4 – at ~RM 4.0 looking downstream. (Photo: IFI 10/26/2017)

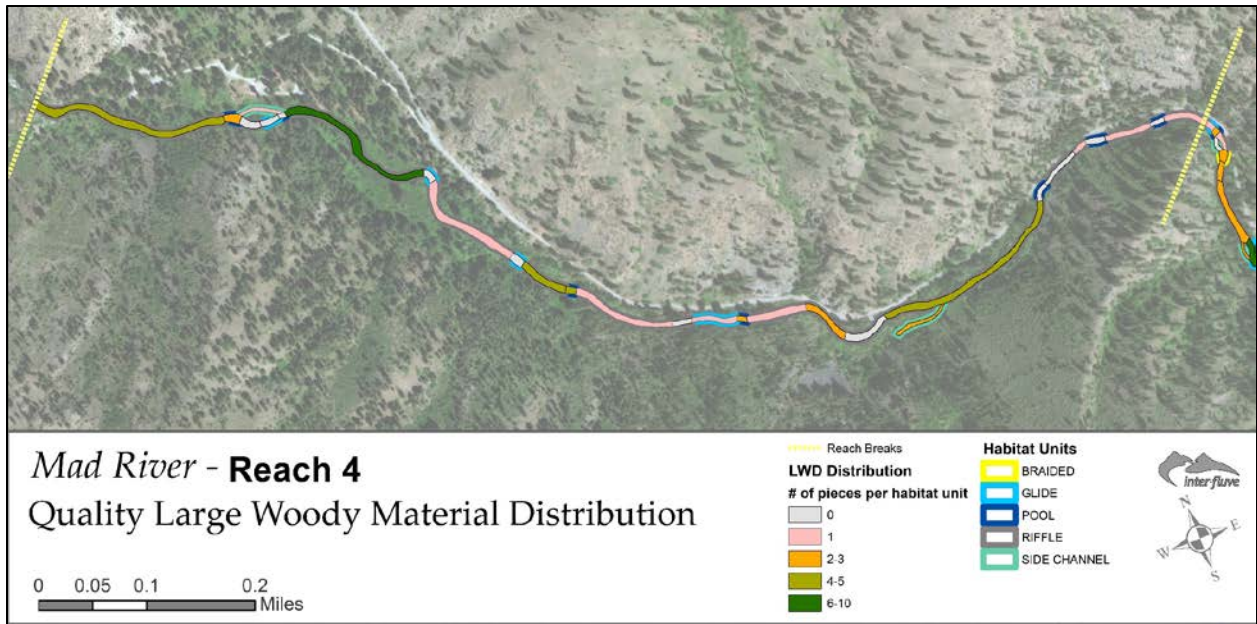
A total of 137 pieces of wood were observed in the channel during the habitat survey (10/26/2017). Of those pieces, 31 classified as large size class (>20-inches dbh and >35 feet long), 43 as medium (12 to 20-inch dbh and at least 35 feet long), and 63 as small (9 to 12-inch dbh). Three large wood jams were counted and additional small wood accumulations were observed along the channel margins. A channel spanning large wood jam at RM 3.18 created a grade control pool and upstream gravel accumulations (Figure 51). See Figure 52 for distribution of quality large woody material (>12-in dbh and at least 35 feet long) per mapped habitat unit throughout the reach. Note that LWM distribution is correlated to less-confined sections with vegetated floodplains. The availability of mature forests combined with lateral bank processes increases large wood recruitment potential in Reach 4 compared to downstream reaches.

Figure 53. Reach 4 - Quality Large Woody Material (>12-inch dbh and at least 35 feet long) distribution by number of pieces per mapped habitat unit per the 2017 survey.

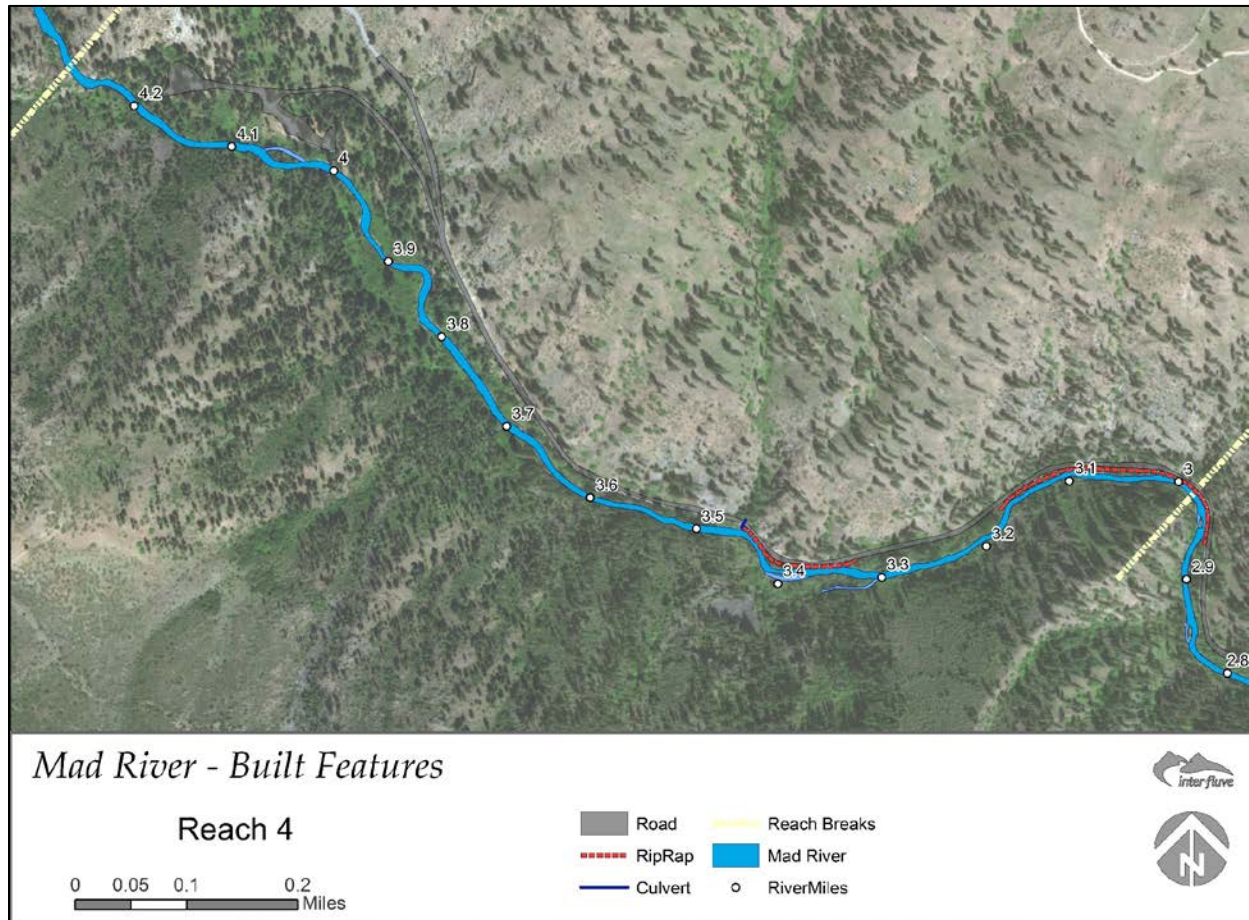
Figure 54. Reach 4: anthropogenic built features. Basemap: ESRI World Imagery

Anthropogenic features in Reach 4 include the Mad River Road, bank riprap, a culvert, Pine Flats Campground, and related vegetation management. The Mad River Road occupies up to half of the available valley floor from RM 2.98 to 3.16, exaggerating channel confinement here. Between RM 3.34 and 3.46 the Mad River Road and its related bank rip rap border the channel in this less-confined section before it leaves the floor of the valley and continues up-slope. A culvert passes hillslope surface water contributions under the Mad River Road at RM 3.16. Pine Flats Campground occupies the terrace and part of the floodplain on river left between RM 4.0 to 4.2. The campground includes cleared dirt and gravel roads, campsites, trails parking areas and a built pit outhouse. It is unknown if water quality issues exist related to the campground and outhouse but the porosity of the floodplain material suggests that periodic testing may be warranted.

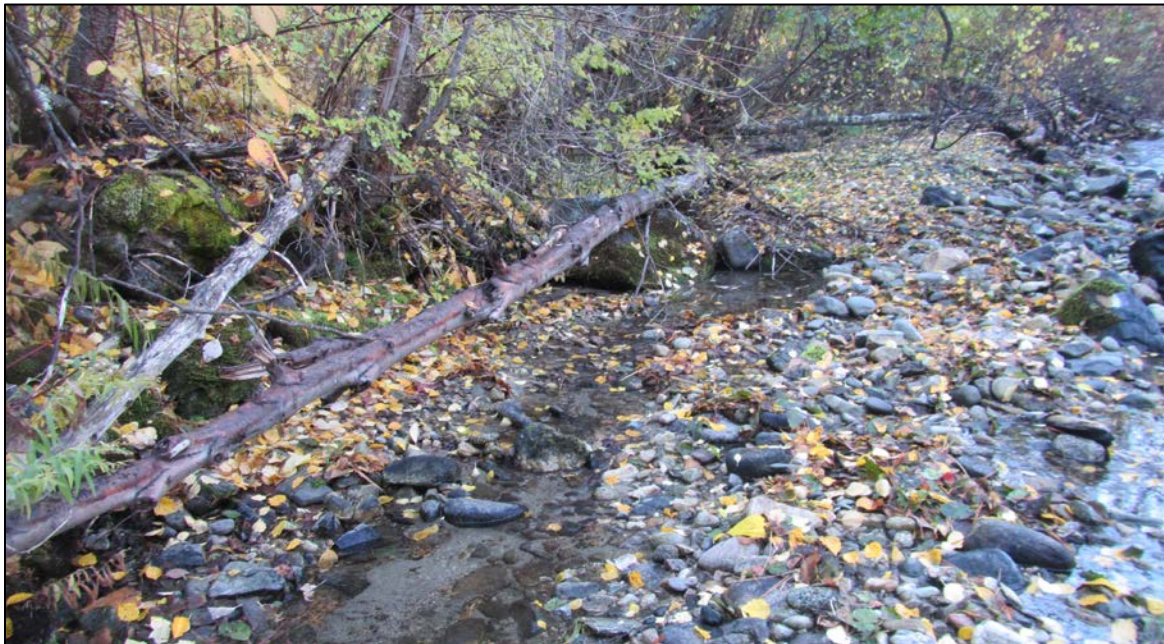
Figure 3. 300-foot long side channel in Reach 4 with low flows during the time of survey. (Photo: IFI staff – 10/26/2017)

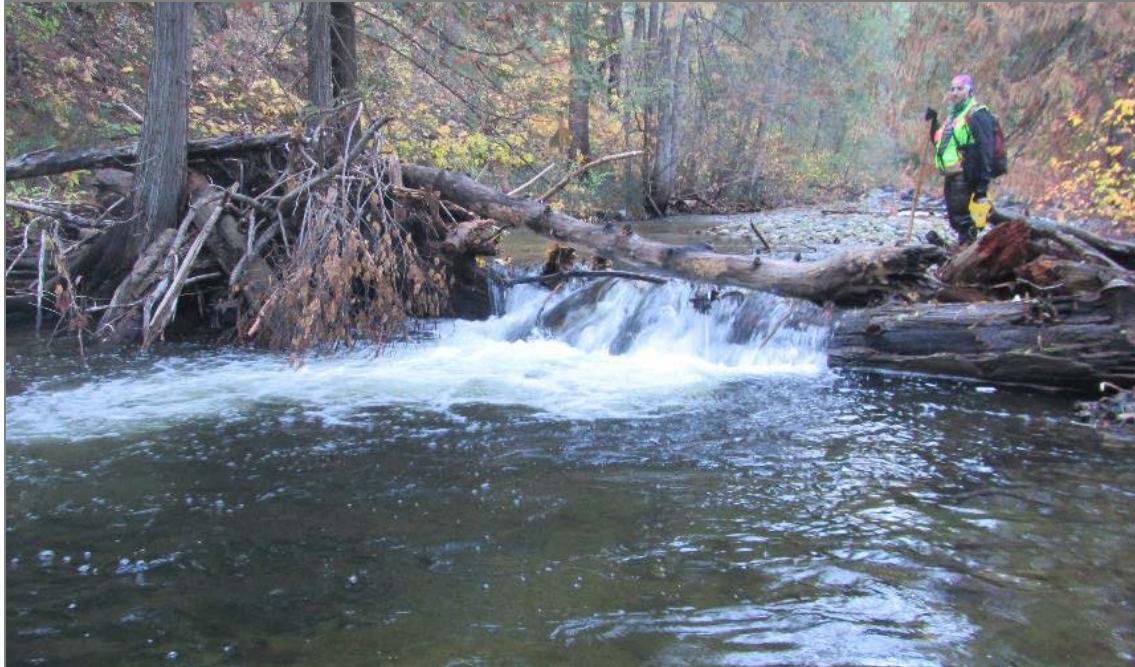
Figure 5. Large in-channel woody material in Reach 4; photo by IFI staff on October 26, 2017.

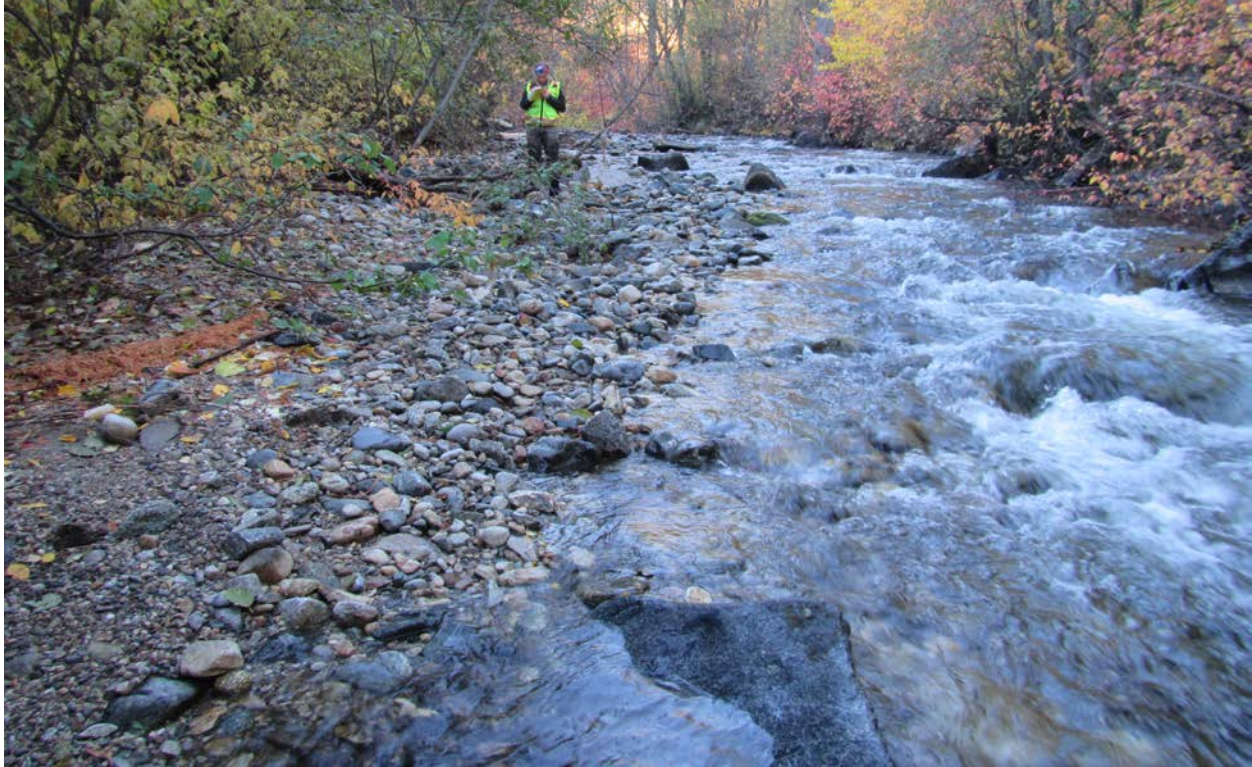
Figure 8. Gravel Count 4.1 (in Reach 4) location on an exposed bar. Photo by IFI staff on October 26, 2017.

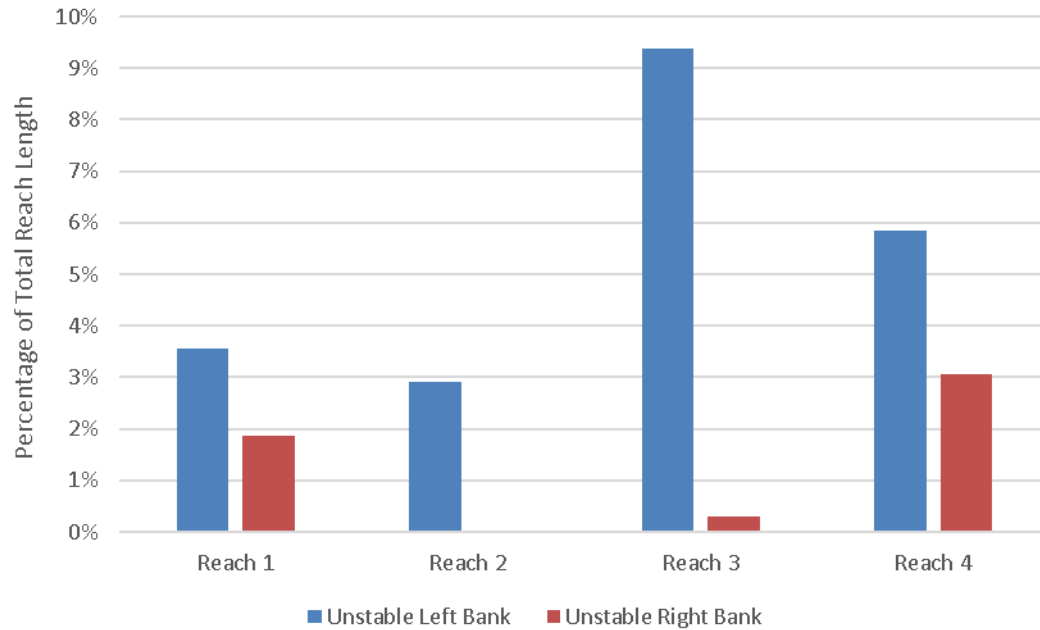
The habitat team estimated the extent of bank erosion (instability) on both the left and right banks at each channel unit. The length of the unstable (eroding) left and right banks was then divided by the total length (left and right bank) of each reach to determine the percentage of each reach that had eroding banks. Overall bank instability is low, averaging only 3.5% throughout the study area (Figure 9. Total percentage of right and left-bank erosion for each reach. Percentages are based on left and right bank ocular estimates measured at each unit throughout the study area.). The highest percentage of erosion was in Reach 3 on the river left bank (9.4%), while Reach 2 had no unstable banks on river right. Although large portions of it are protected with Mad River Rad riprap, river left generally had a higher proportion of unstable banks throughout the project area.

Figure 9. Total percentage of right and left-bank erosion for each reach. Percentages are based on left and right bank ocular estimates measured at each habitat unit throughout the project area.

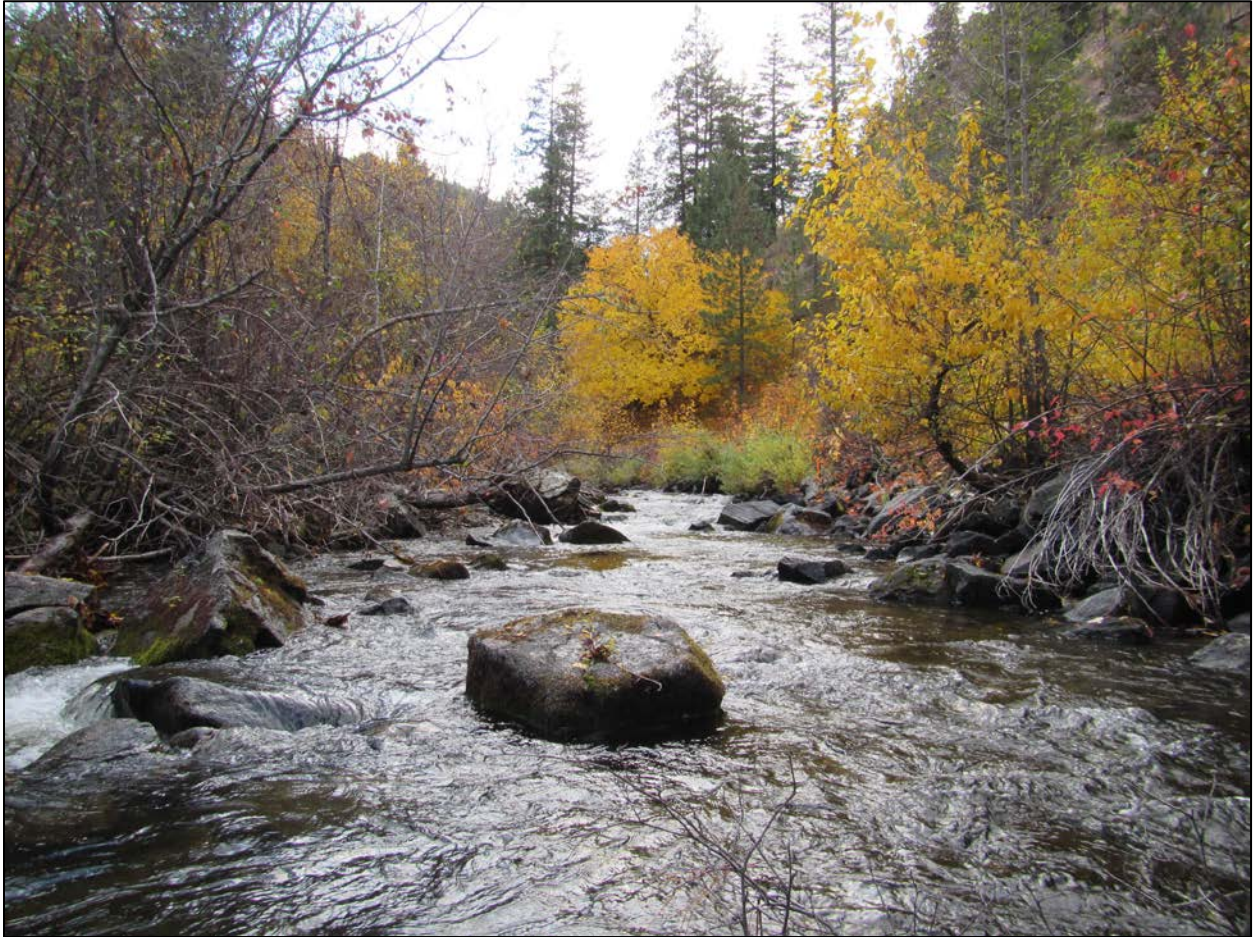
Figure 30. Representative view of Reach 3. (Photo: IFI staff – 10/26/17)

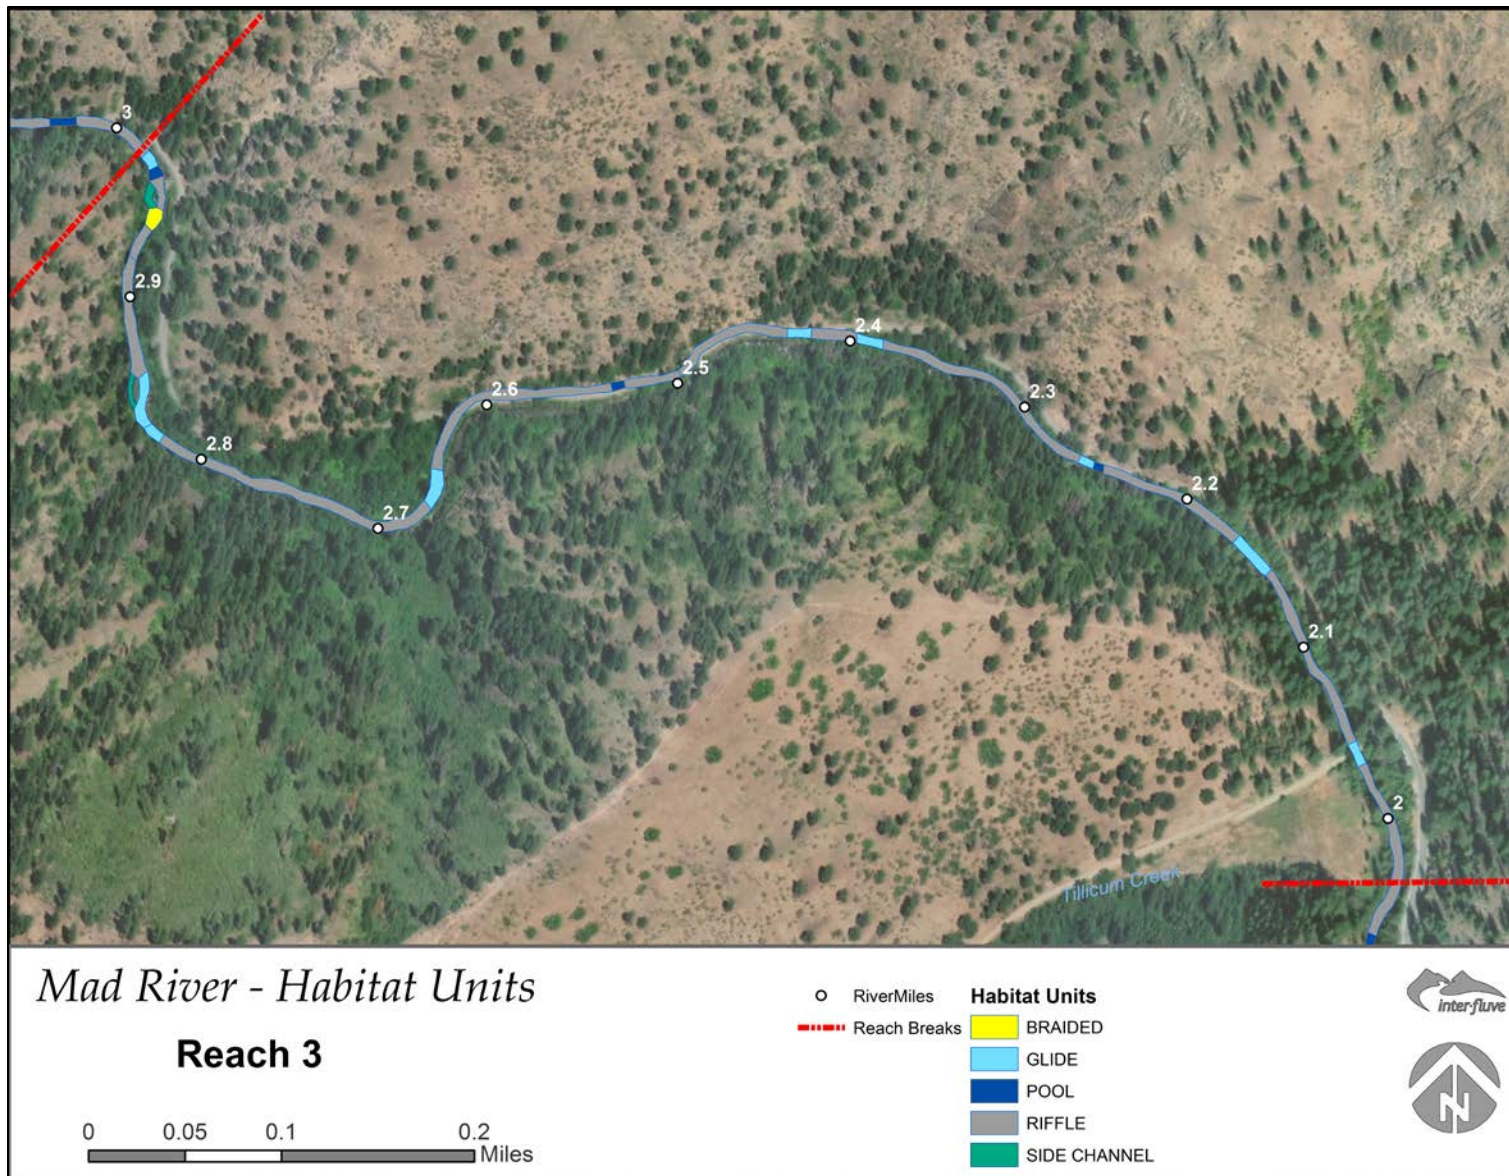
Reach 3 is the third longest reach delineated in the study at 1.05 miles long. Nearly all of the Reach 3 habitat area was identified as fast water, either riffles (82%) or glides (17%). Only 1% of the habitat area was identified as pools, the lowest of all reaches (Figure 31). The stream gradient of 2.35% in Reach 3 is the highest within the study area.

Figure 31. Mad River, Reach 3 -- channel unit distribution: RM 1.93 – 2.98. Basemap: ESRI Bing imagery

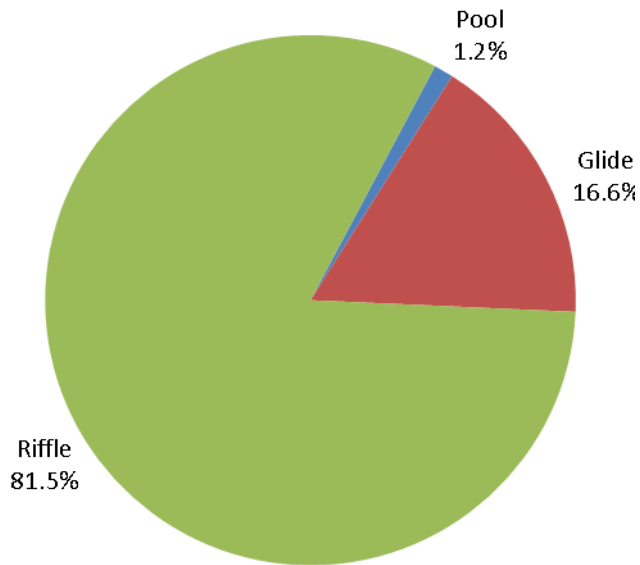
Figure 32. Stream habitat unit composition for Reach 3.

Side channel habitat in Reach 3 accounted for 1% of the habitat area (Figure 32). Only two side channels were recorded, totaling 164 feet in length (Table 8). One side channel was identified as a slow water unit, while the other was identified as a predominantly fast water unit. Two pieces of medium LWM were observed in the slow side channel and one piece of small LWM in the fast side channel.

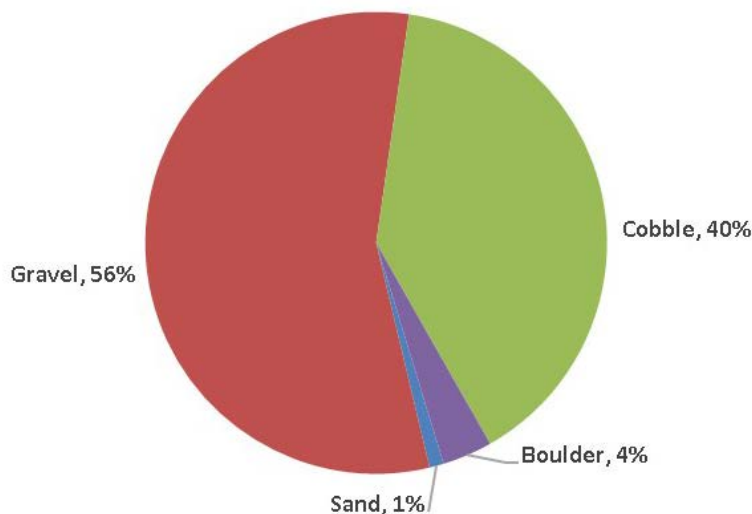
Two gravel counts were performed in Reach 3 on exposed bars. When the gravel counts are combined, gravel was the dominant substrate (56%) with 40% cobble, 4% boulder, and 1% sand in Reach 3 (Figure 33). The cumulative distribution and grain size composition of the gravel counts completed in Reach 3 are provided below in Figure 34 and Table 10.

Figure 33. Percent composition of bed substrate based on two gravel counts at exposed bars in Reach 3.

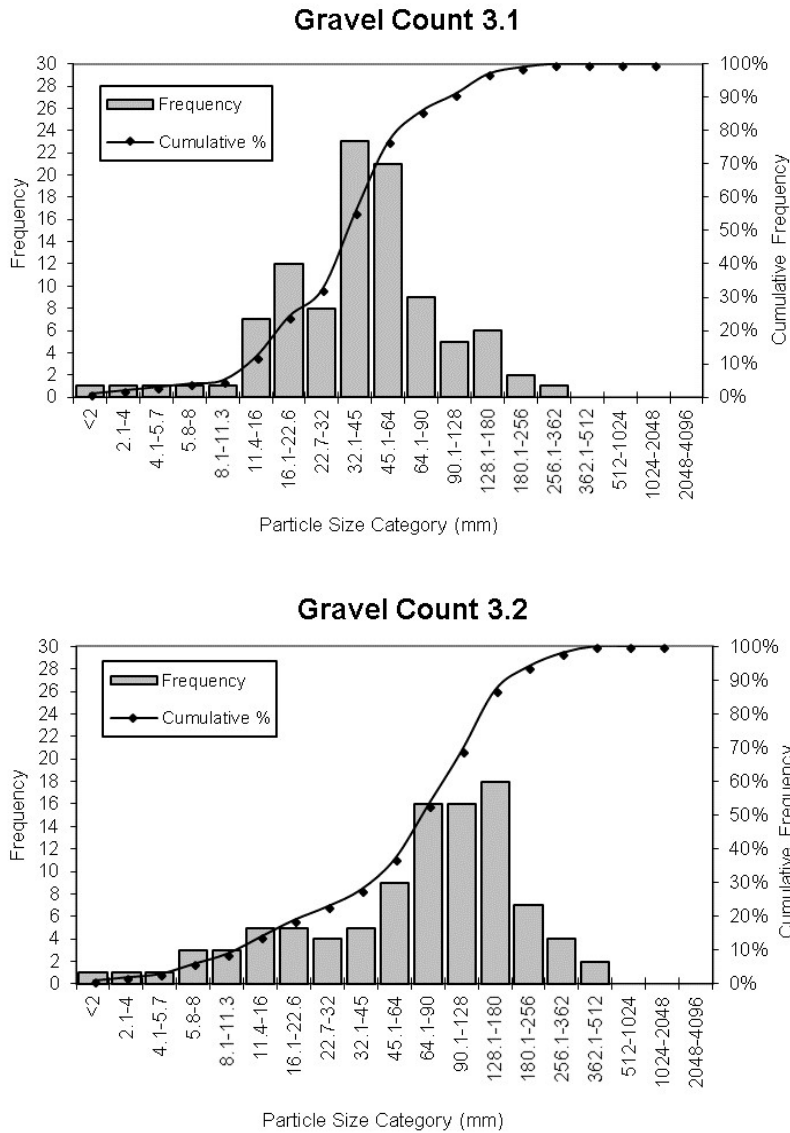
Figure 34. Cumulative grain size distribution for Gravel Count 3.1 and Gravel Count 3.2.

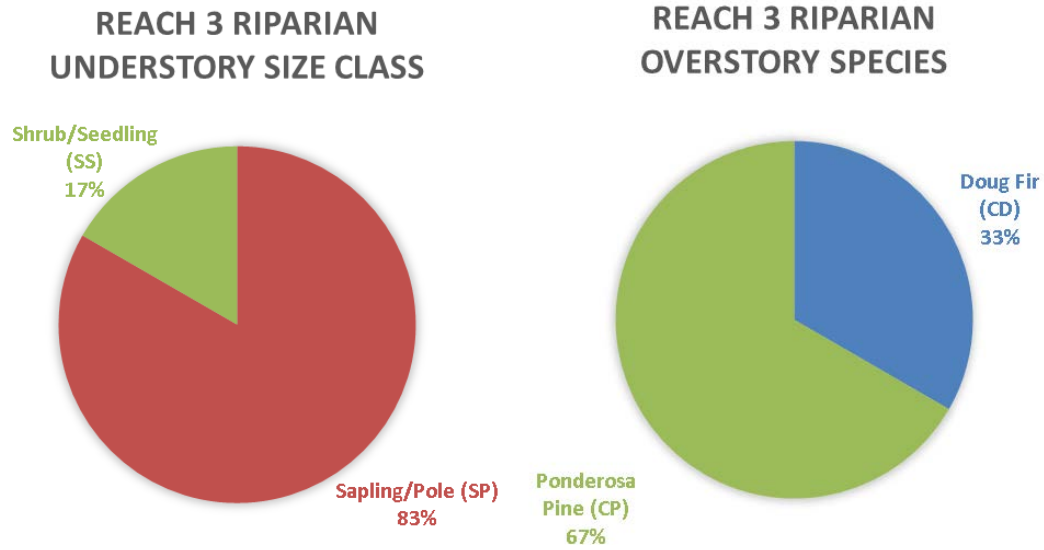
Based on sixth unit measurements, 100% of the riparian vegetation identified within 100 feet of the creek throughout Reach 3 was small tree (9.0 – 20.9 in. diameter). Ponderosa pine was the primary overstory species (67%), with the remaining 33% Douglas fir (Figure 35). The understory was mostly sapling/pole (83%; 5.0 – 8.9 in. diameter), with 17% shrub/seedling (1.0 – 4.9 in. diameter). The understory was dominated by alder (67%). Other species observed included dogwood (17%), and bigleaf maple (16%) (Figure 35).

Figure 35. Dominant overstory riparian vegetation size and species identified within 100 feet of Mad River based on nth unit ocular estimates.

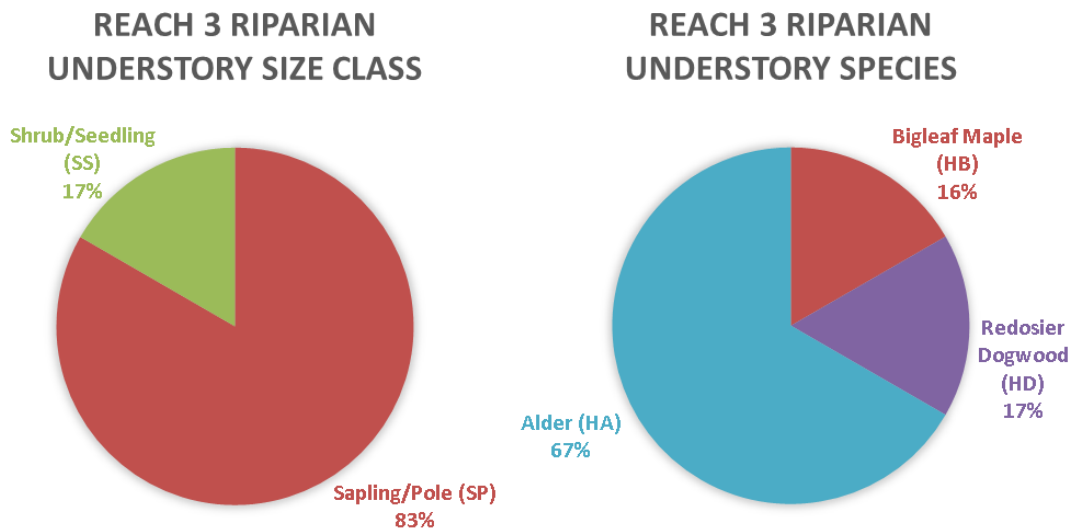
Figure 36. Dominant understory riparian vegetation size and species identified within 100 feet of Mad River based on nth unit ocular estimates.

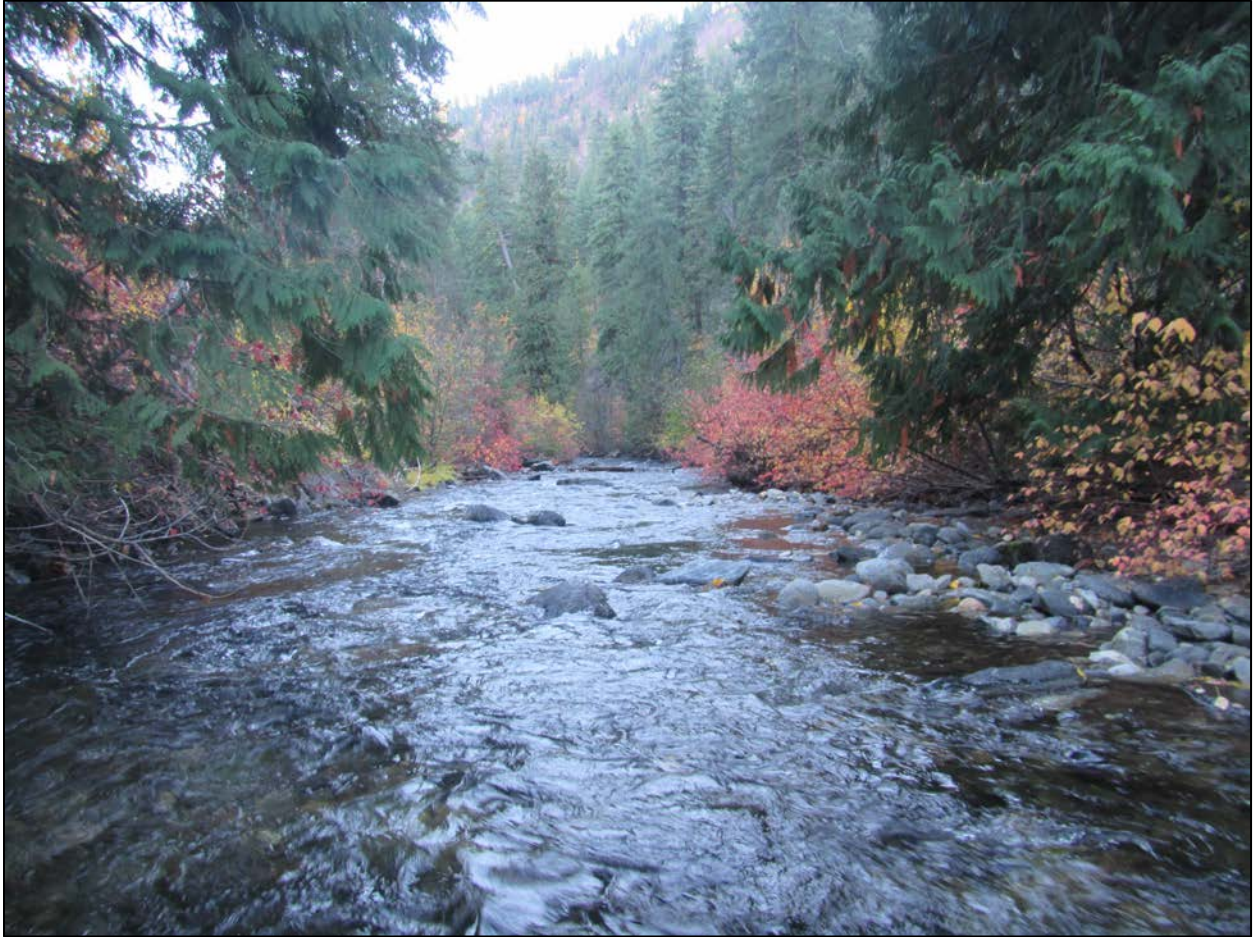
Figure 37. Representative view of Reach 4. (Photo: IFI Staff – 10/26/2017)

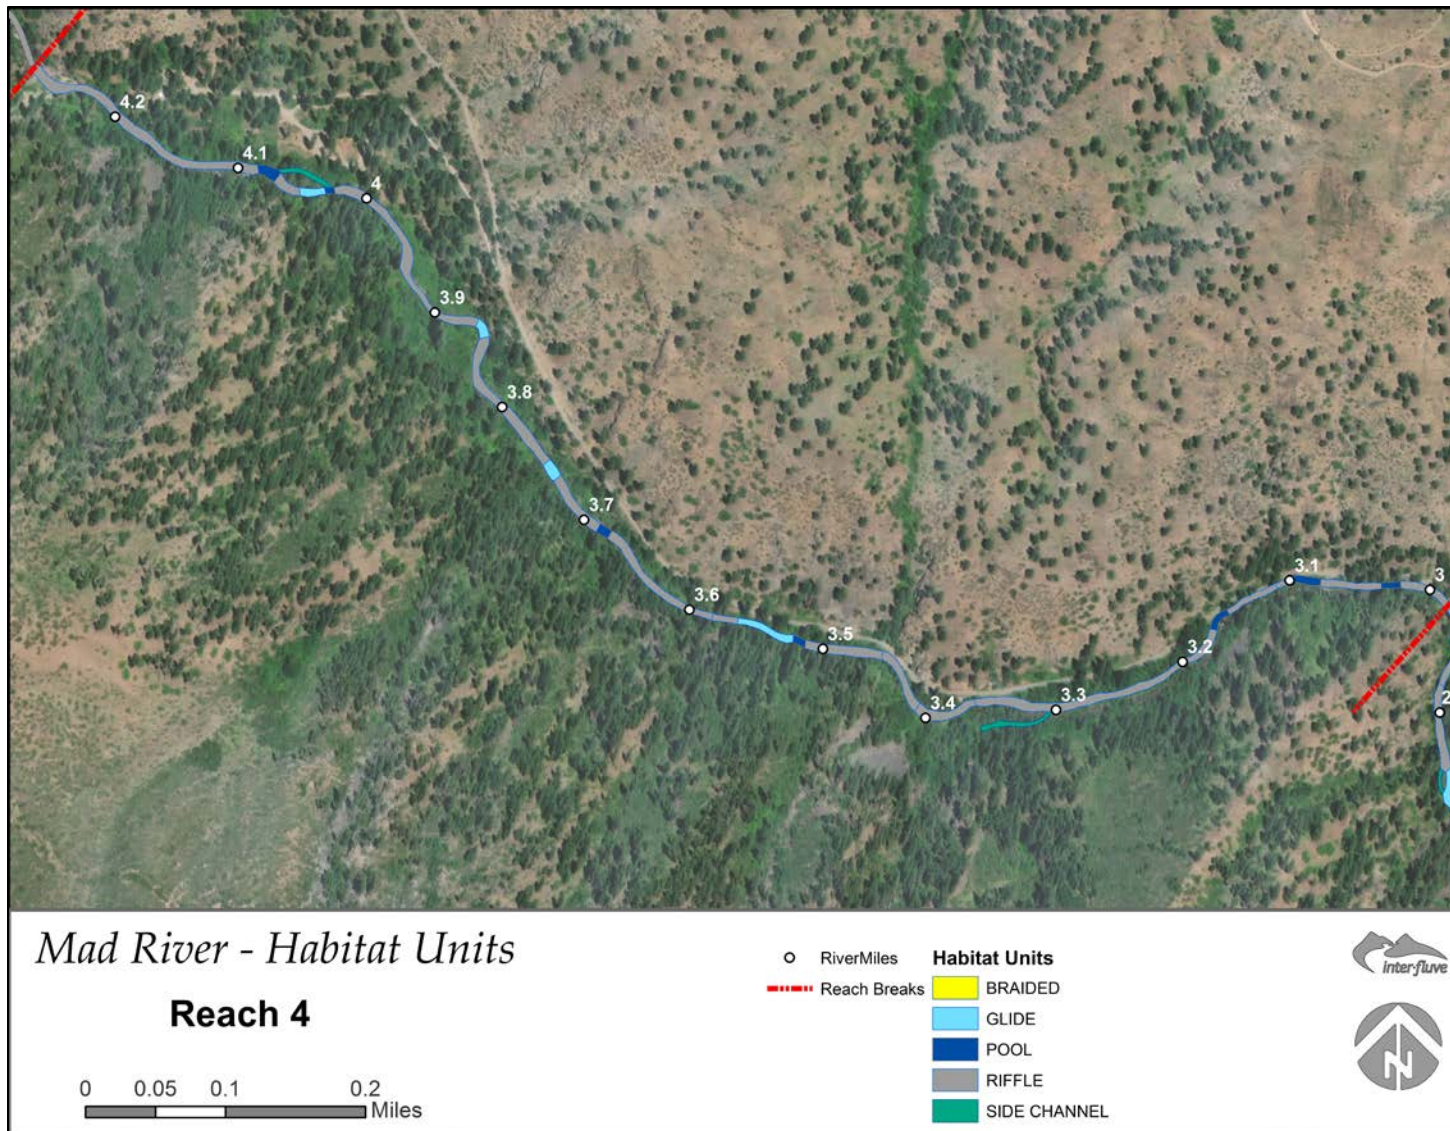
Reach 4, the longest reach in the study area, is 1.32 miles long (Figure 38). This reach was riffle-dominated: composed of 87% riffle, 7% pool, 5% glide, and 1% side channel (Figure 39). Reach 4 has the third steepest gradient in the project area at 1.65%.

Figure 38. Mad River, Reach 4 -- channel unit distribution: RM 2.98 – 4.3. Basemap: ESRI Bing imagery

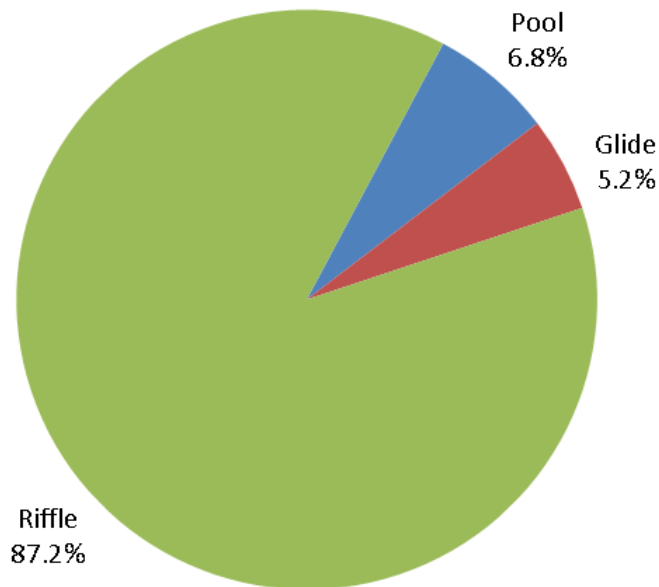
Figure 39. Stream habitat unit composition for Reach 4.

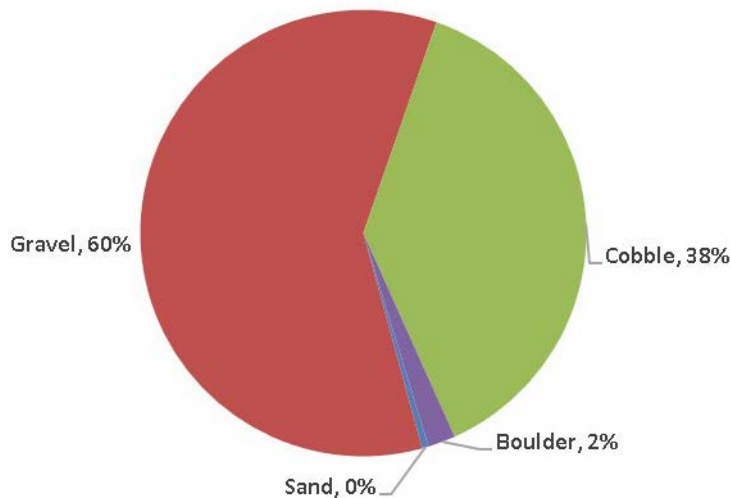
Two gravel counts were performed within Reach 4 at exposed bars. The dominant substrate type observed was gravel (60%) with additional 38% cobble, and 2% boulder (Figure 40). No bedrock or sand were identified in either gravel count. The cumulative distribution and grain size composition of the gravel counts completed in Reach 4 are provided below in Figure 41 and Table 13.

Figure 40. Percent composition of bed substrate based on two gravel counts at exposed bars in Reach 4.

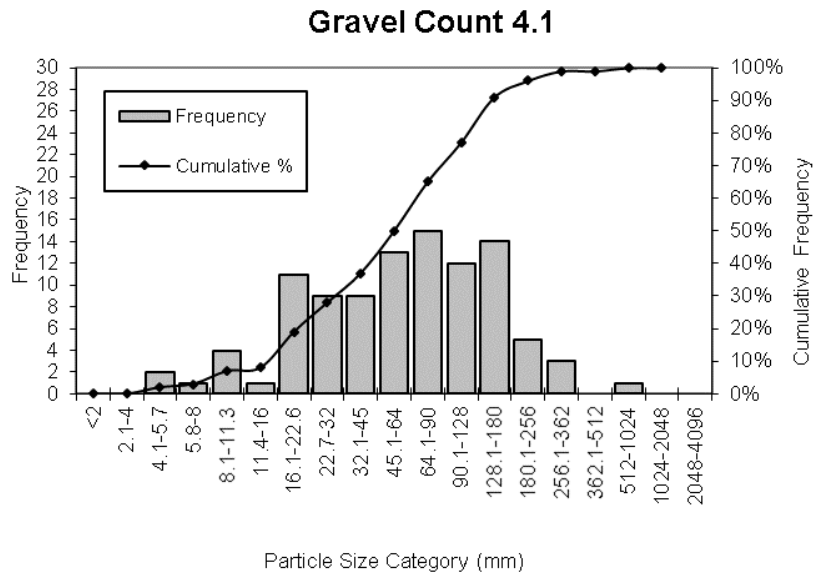
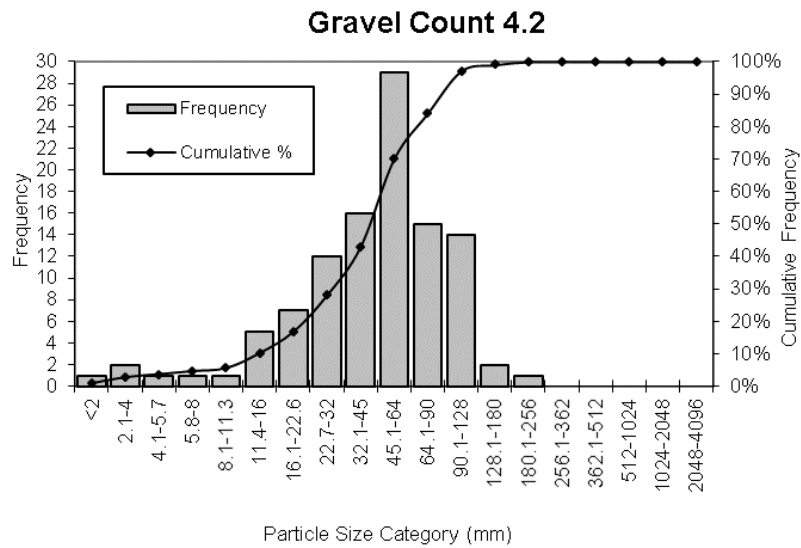
Figure 41. Cumulative grain size distribution for Gravel count 4.1 and Gravel Count 4.2.

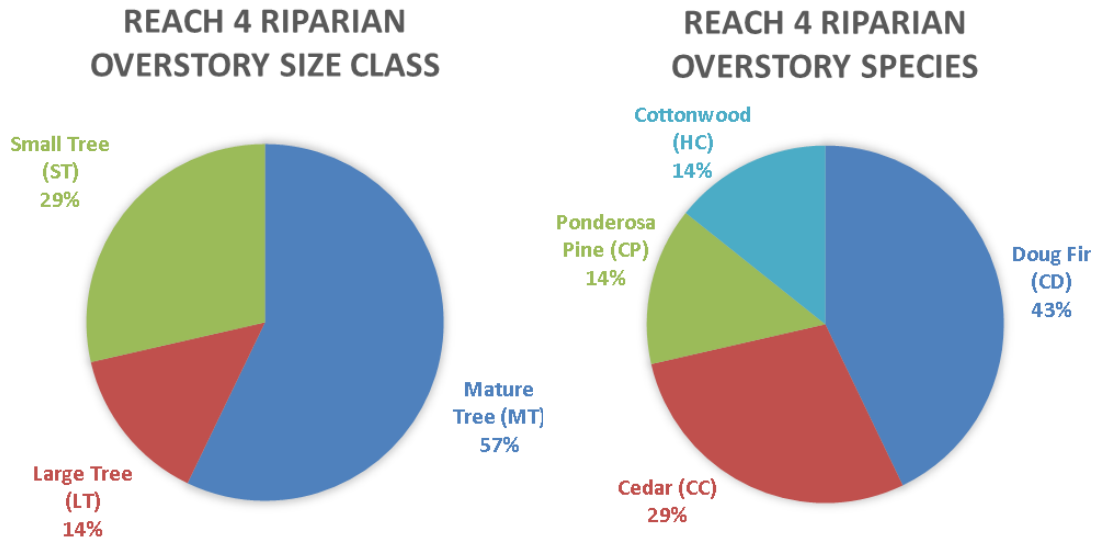
Based on seven nth unit measurements, 76% of the riparian vegetation identified within 100 feet of the river in Reach 4 was shrub/seedling (1.0 – 4.9 in. diameter). The remaining vegetation observed was 14% grassland/forb and 10% small tree (5.0 – 8.9 in. diameter) (Figure 41). The understory was dominated by willow (76%) with 10% dogwood, 10% grassland/forbs, and 5% alder. Reach 4 maintained the highest percentage (62%) of no identifiable overstory in the project area. Observed overstory species included alder (29%), and oak (9%). Oak became visible in Reach 4 and prevalent on floodplain and terrace surfaces but oak was rarely the dominant overstory species, especially within the 100-foot riparian buffer.

Figure 42. Dominant overstory riparian vegetation size and species identified within 100 feet of Mad River based on nth unit ocular estimates.

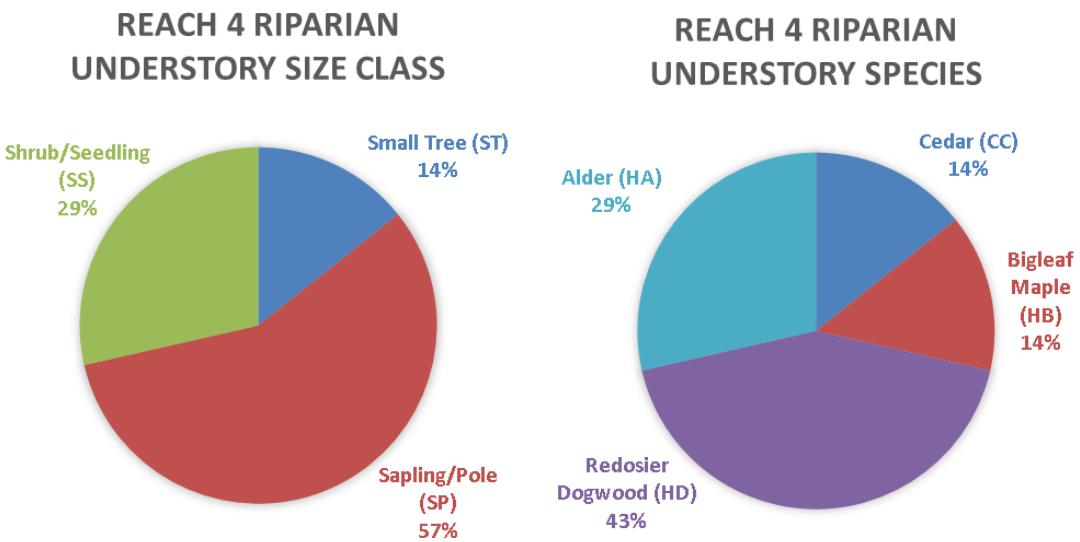
Figure 43. Dominant understory riparian vegetation size and species identified within 100 feet of Mad River based on nth unit ocular estimates.
